SERIOUS INCIDENT

Aircraft Type and Registration:	Boeing 737-33A, G-CELC	
No & Type of Engines:	2 CFM56-3B2 turbofan engines	
Year of Manufacture:	1987	
Date & Time (UTC):	7 February 2010 at 1154 hrs	
Location:	On approach, Chambery Airport, France	
Type of Flight:	Commercial Air Transport (Passenger)	
Persons on Board:	Crew - 6	Passengers - 103
Injuries:	Crew - None	Passengers - None
Nature of Damage:	None	
Commander's Licence:	Airline Transport Pilot's Licence	
Commander's Age:	43 years	
Commander's Flying Experience:	3,446 hours (of which 2,696 were on type) Last 90 days - 94 hours Last 28 days - 33 hours	
Information Source:	AAIB Field Investigation

Synopsis

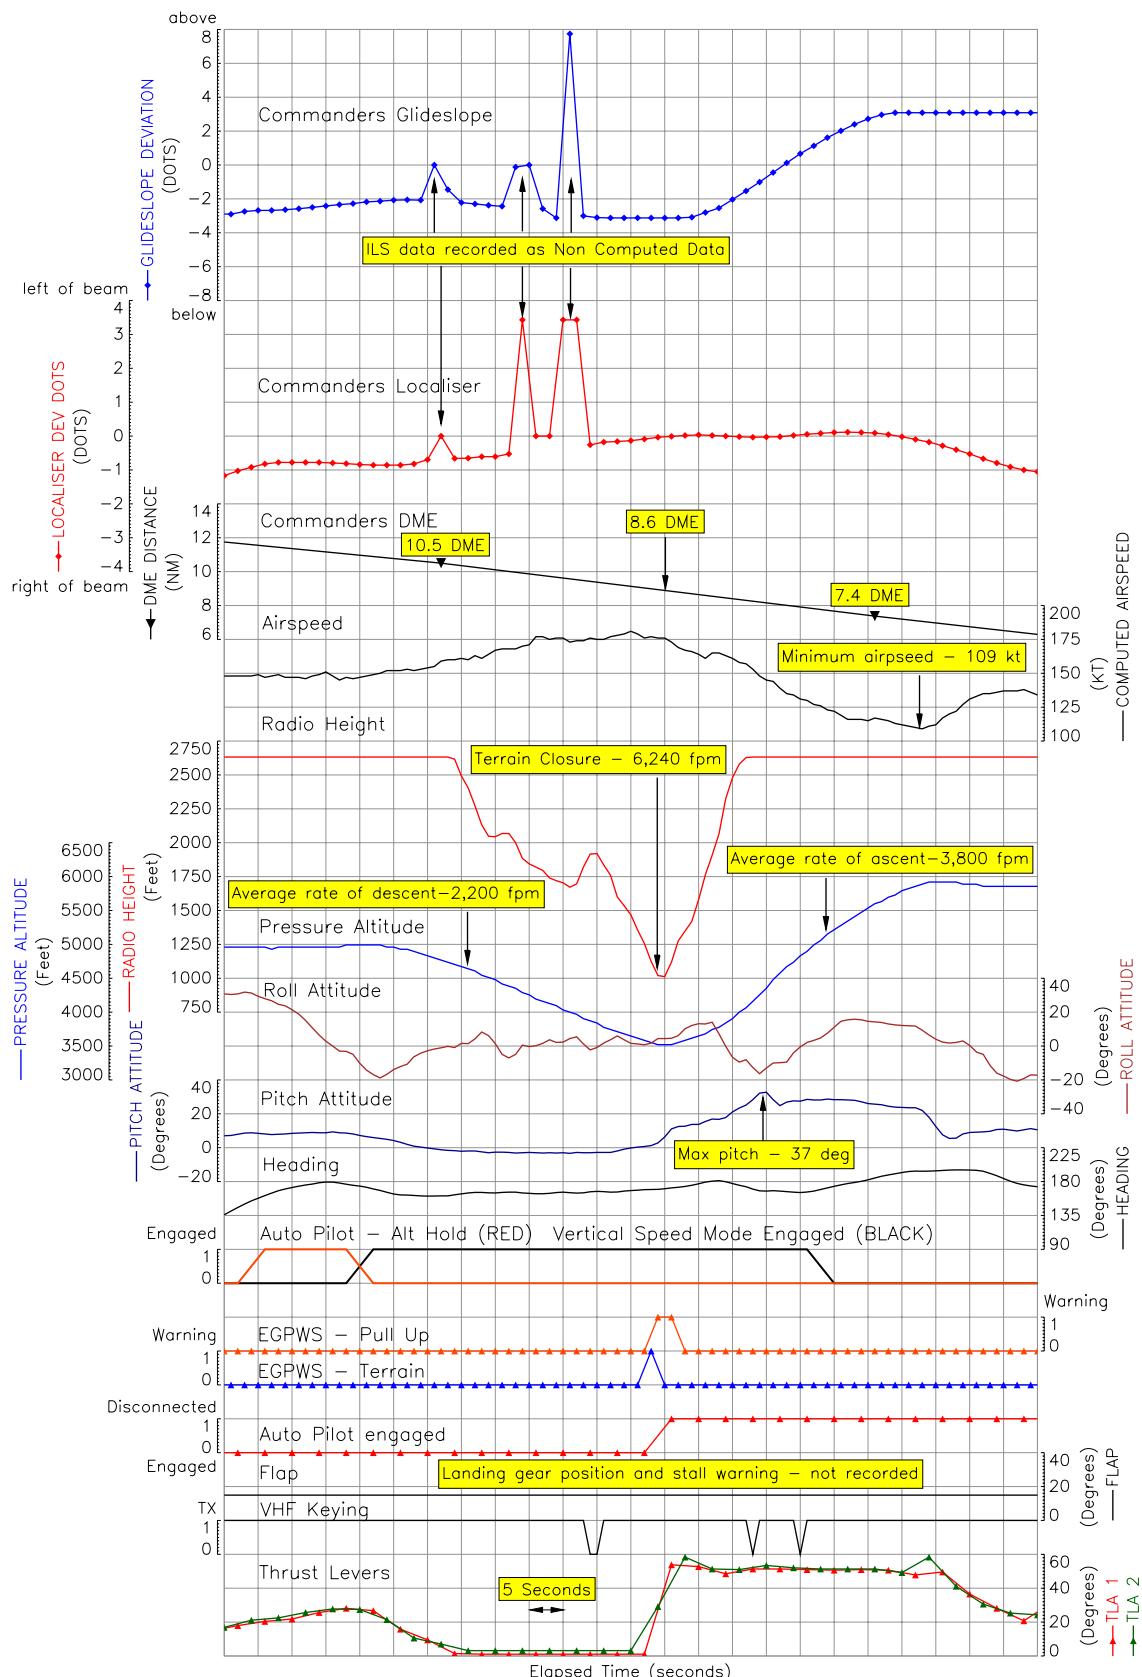
Figure 2

Approaching a range of 11 nm, the autopilot VS mode was engaged. At this stage, the aircraft was about 850 ft below the glideslope. The aircraft started to descend at about 2,200 fpm (see Figure 2). About ten seconds later, the commander's localiser and glideslope signals were both briefly recorded as non computed data (NCD) – indicative that the raw data was no longer reliable or not available. Recorded at almost the same time, the DME indicated 10.5 nm, which was accurate. Due to the low recording frequency of the DME parameter, the reliability of the data in the seconds prior to the descent could not be established. As the aircraft descended, two further recordings were made of the commander's localiser and glideslope signals temporarily being NCD.

Approaching the airport from the north, the aircraft is required to overfly a ridge of high ground to the east of Lake Bourget. As the aircraft descended, the terrain closure rate progressively increased to about 6,000 fpm. When the terrain clearance reached 1,125 ft, the EGPWS Mode 2 warning was activated. Almost simultaneously, the autopilot was disconnected and a go-around was carried out (due to the recording rates, it could not be determined if the go-around had been initiated before the EGPWS warning). The minimum terrain clearance was 1,112 ft.

Recorded FDR data for the (first) ILS approach to Chambery Airport
