Crash of Cessna 500, N113SH
Following an In-Flight Collision with Large Birds
Oklahoma City, Oklahoma
March 4, 2008

NTSB/AAR-09/05
PB2009-910405

Crash of Cessna 500, N113SH,
Following an In-Flight Collision with Large Birds,
Oklahoma City, Oklahoma,
March 4, 2008

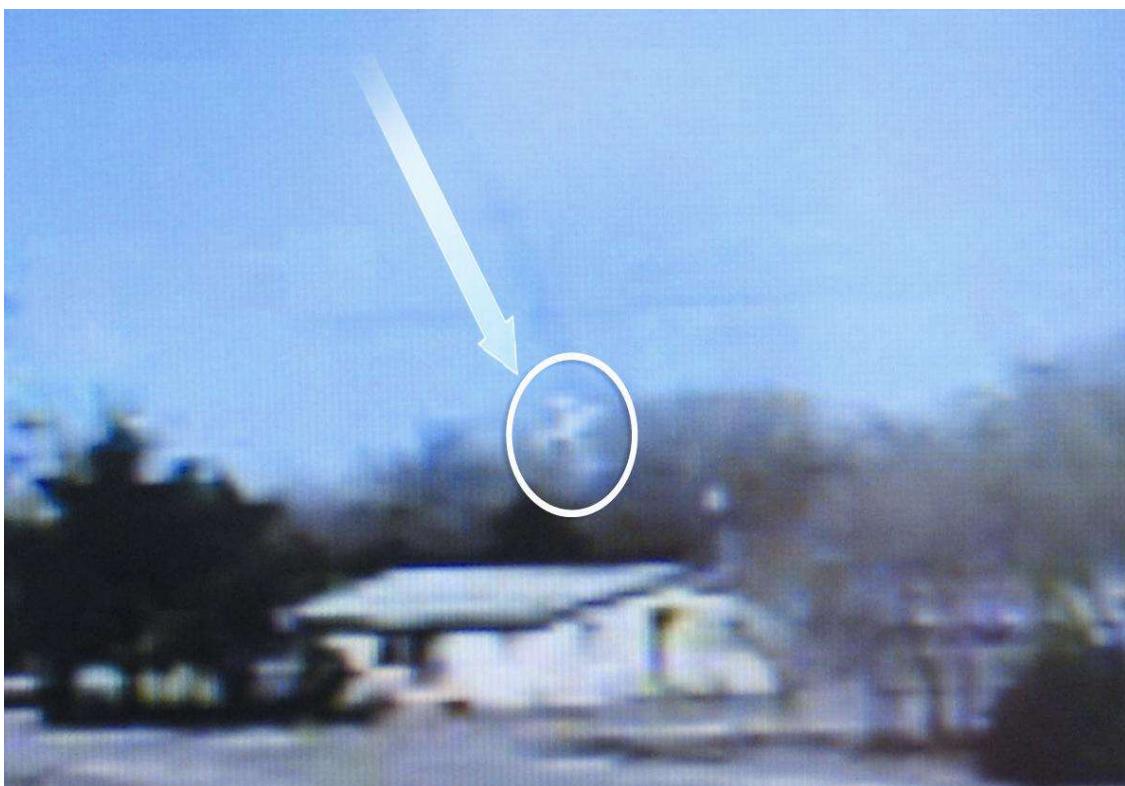
A security camera located about 1/2 mile southwest of the accident site captured images of the accident airplane descending steeply, nose down to the ground while emitting a visible trail. (See figure 1.) The video also showed that a large fireball followed the airplane’s impact.

Figure 1. Screen capture of a video image showing the accident airplane (circled) and the visible trail behind it (to the right of and approximately parallel to the arrow) before ground impact.

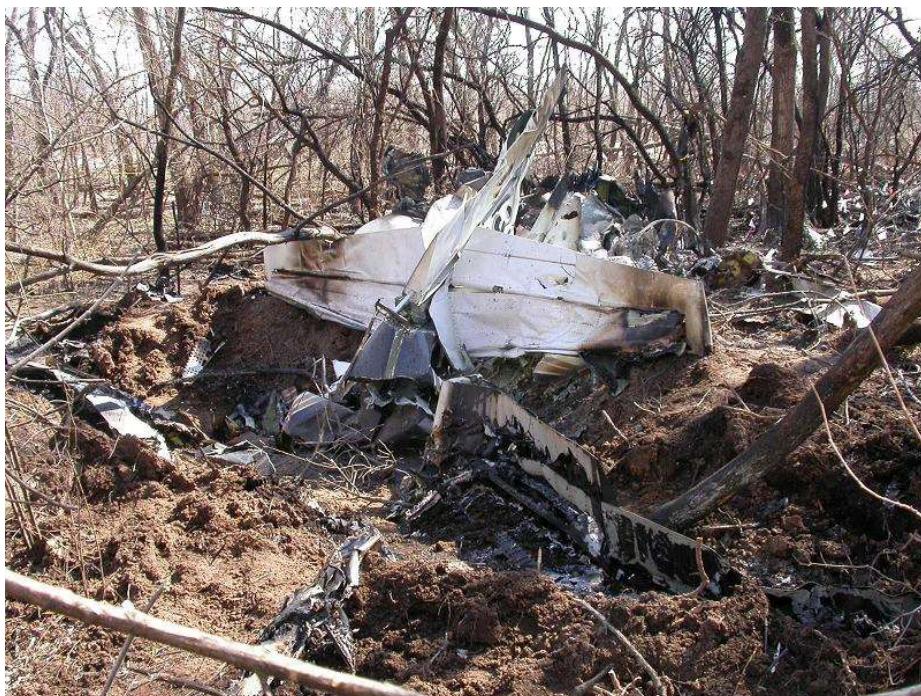
Examination of the airplane’s horizontal stabilizer at the accident site revealed that it was oriented leading-edge down on top of a ground crater that contained fire-damaged wreckage debris. Dark brown to black soot patterns on the left and right horizontal stabilizers and elevators corresponded to the location of fire-damaged wreckage in the crater below. Soot patterns that extended into crush-damage folds on the trailing edge of the left elevator skin corresponded to an area where a damaged tree or tree limb came to rest on top of the wreckage. (See figure 3.)

Figure 3. Horizontal stabilizers and elevators with fire-damaged wreckage below.

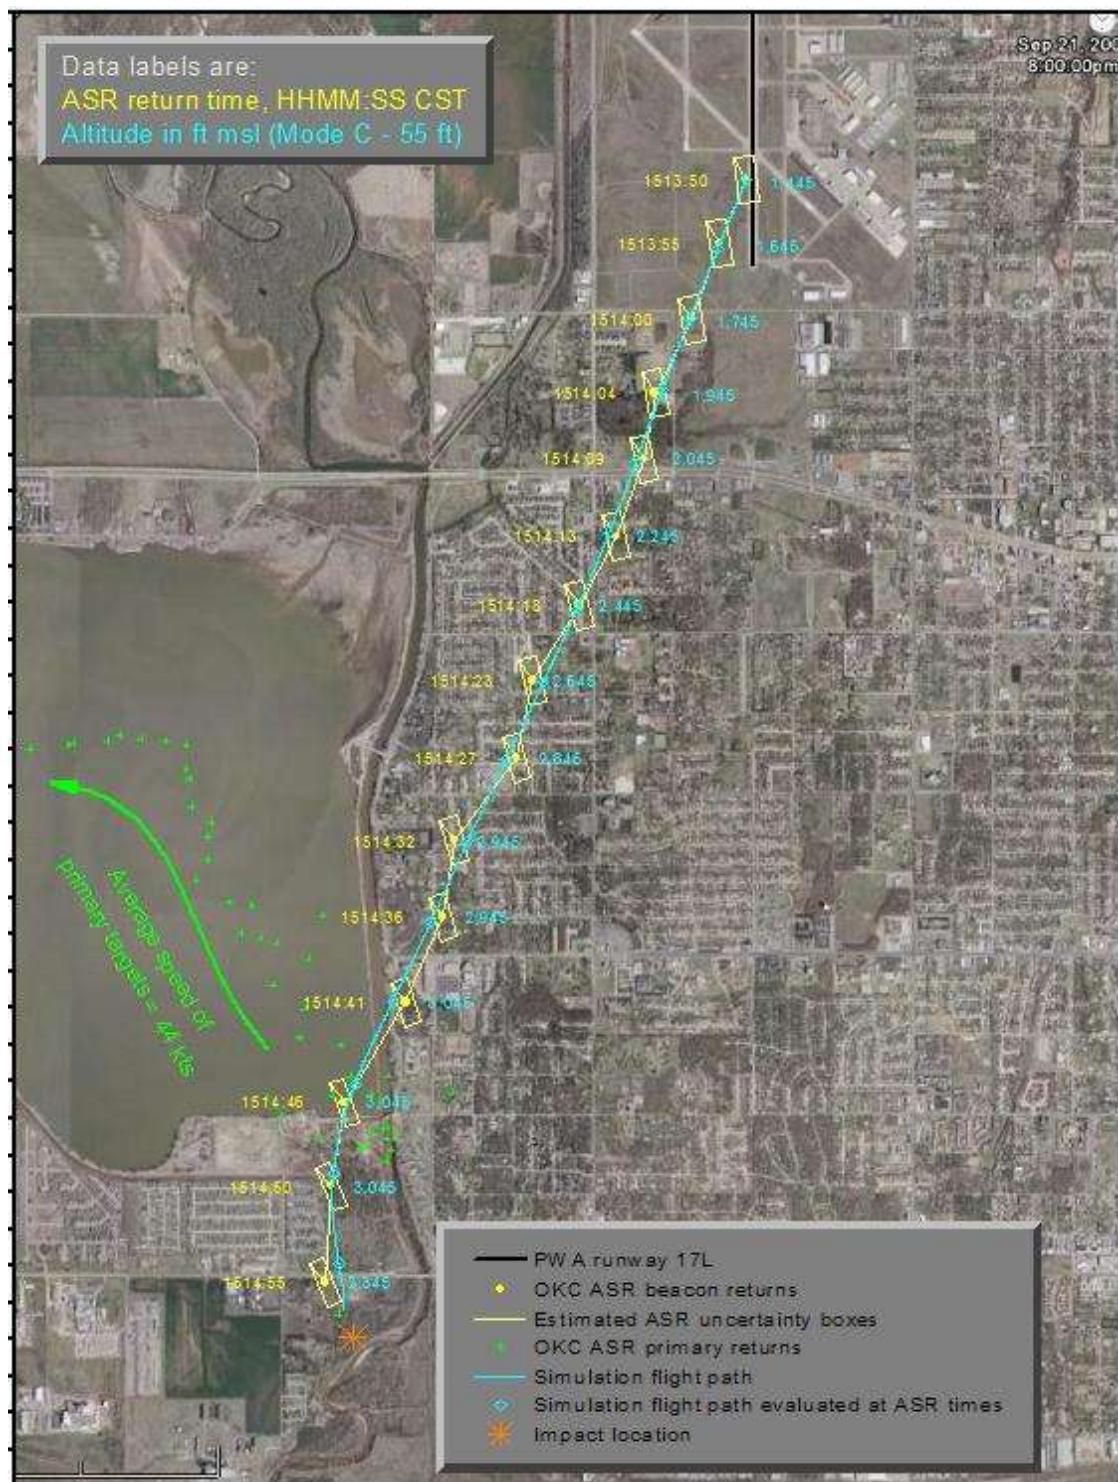
Review of available OKC ASR data, which included both primary and secondary returns,⁴² showed that the radar observed 5,985 primary targets in its coverage area during a 10-minute period about the time of the accident.⁴³ Of these thousands of primary targets, postaccident processing of the data identified that, between 1512:00 and 1514:59, 19 intermittent primary returns appeared within a 0.35-nautical-mile radius of the accident airplane's track over the southeast corner of Lake Overholser. About 1514:45, the airplane was headed south-southwest at an altitude of about 3,050 feet and was traveling about 190 kts calibrated airspeed (KCAS) when its flight track intersected the flight track of the primary returns. About that time, the airplane entered a rapid descent, and the primary returns moved from the area of the intersection toward the northwest, over Lake Overholser. (See figure 4.) Birds, such as the American white pelican, are capable of reflecting primary radar returns.

Figure 4. Plot showing primary and secondary radar returns with overlay of the simulation flightpath.

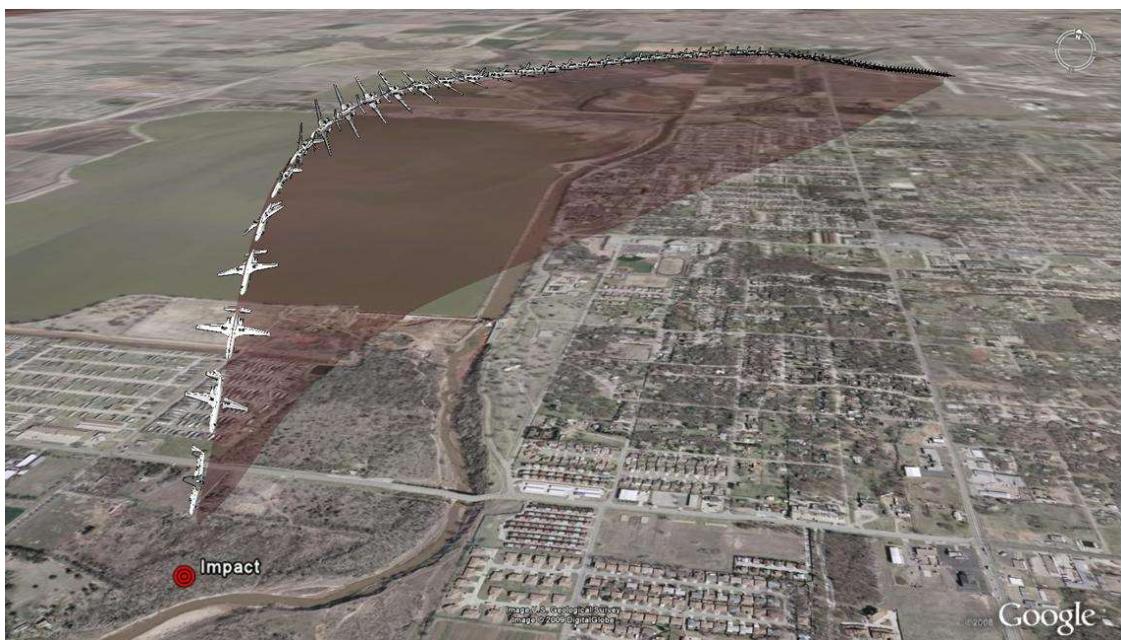
Figure 5. Simulation-based illustration of the airplane's descent and left roll through the inverted position.

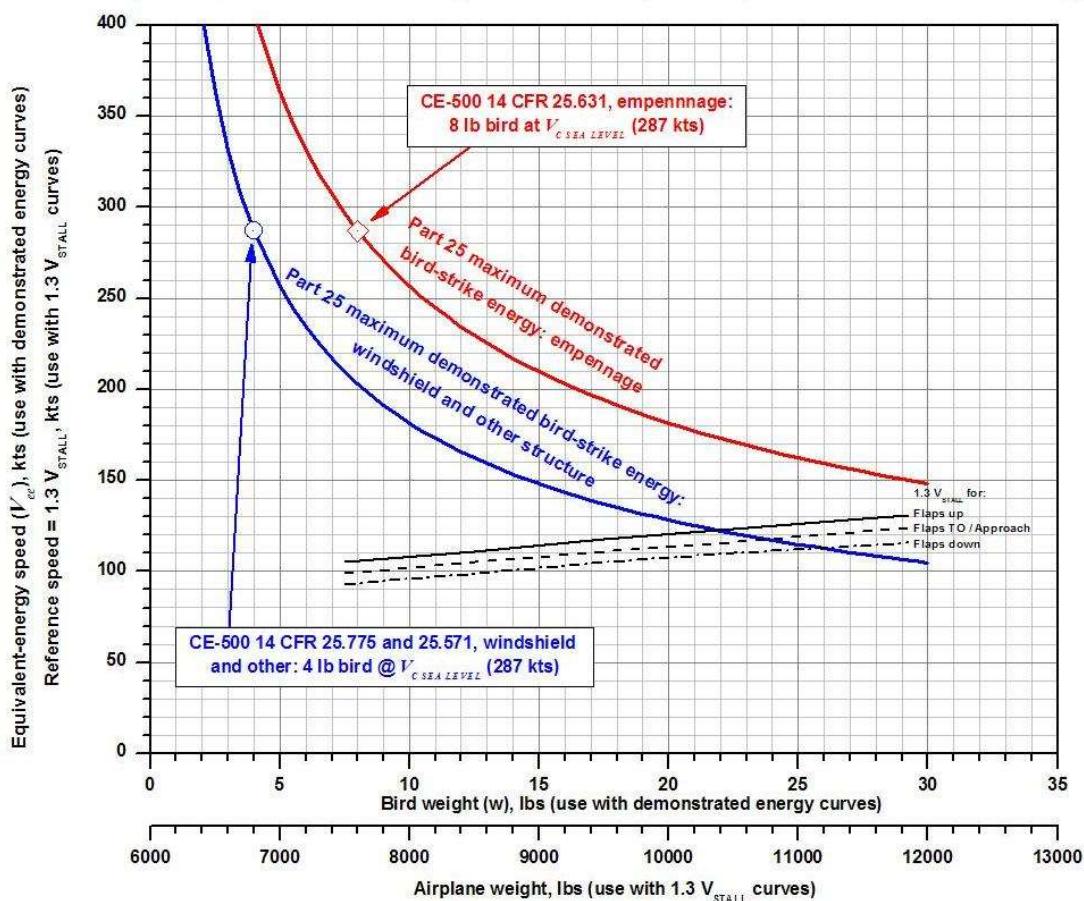
For example, figure 6 shows how these two sets of airspeeds can be illustrated for an airplane like the Cessna 500. The figure shows two bird-strike energy speed curves: The blue line corresponds to the certification standard for the airplane’s windshield, wing, and other structures (which are based on an impact from a 4-lb bird at 287 kts), and the red line corresponds to the certification standard for the empennage (which uses an 8-lb bird at 287 kts). The figure also shows the exemplar airplane’s minimum safe airspeed (defined as 1.3 times the stall speed), as a function of weight, in various flap configurations (shown in solid, dashed, or dotted black lines).

Figure 6. Exemplar reference chart showing airplane speed and bird-weight relationships for equivalent bird-strike energy.

Using this chart, if a pilot of the exemplar airplane operating at a gross weight of 11,200 lbs were concerned about the possibility of a collision on the airplane's wing structure with birds as large as 10 lbs during a flaps-up climb, then the pilot might choose an airspeed between about 129 to 180 kts until reaching an altitude where the risk of a bird strike is reduced; the limits of this range represent the airplane's minimum safe airspeed for the specified gross weight and the maximum airspeed that would allow for a collision with a 10-lb bird while remaining below the airplane's bird-strike energy for the wing structure demonstrated in compliance with regulations.⁷⁰ Similarly, using the same airplane scenario but assuming a 20-lb bird, the chart
