ESTONIAN SAFETY INVESTIGATION BUREAU

INVESTIGATION REPORT

SERIOUS INCIDENT, LOSS OF SEPARATION BETWEEN
BOEING 777-200 AND DASSAULT FALCON 900 NEAR
KIHNU ISLAND ON 17.10.2013

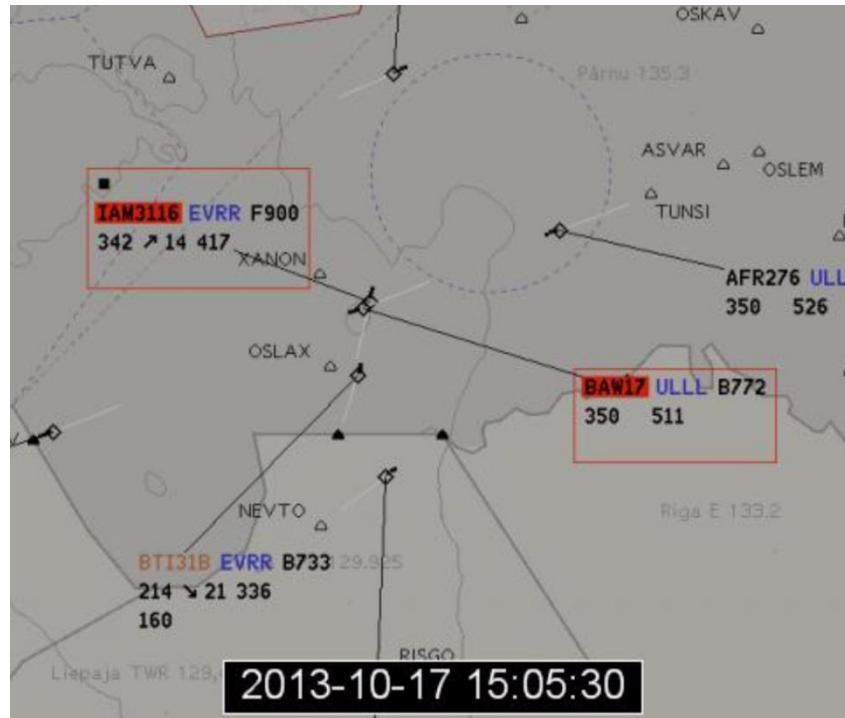
The radar recordings indicate that the conflict on airways L729 and UP862 between IAM3116 and BAW17 flights were displayed red (figure 1) to the ACC - indicating unsafe condition.

Figure 1: BAW17 and IAM3116 tracks and alerts on ATC radar screen

The radar recordings indicate that the conflict on airways L729 and UP862 between IAM3116 and BAW17 flights was displayed red (figure 1) to the ACC - indicating unsafe condition and drawing the air

traffic controllers attention to the conflict, however in this instance the STCA provided little help to the controller to avoid this conflict.

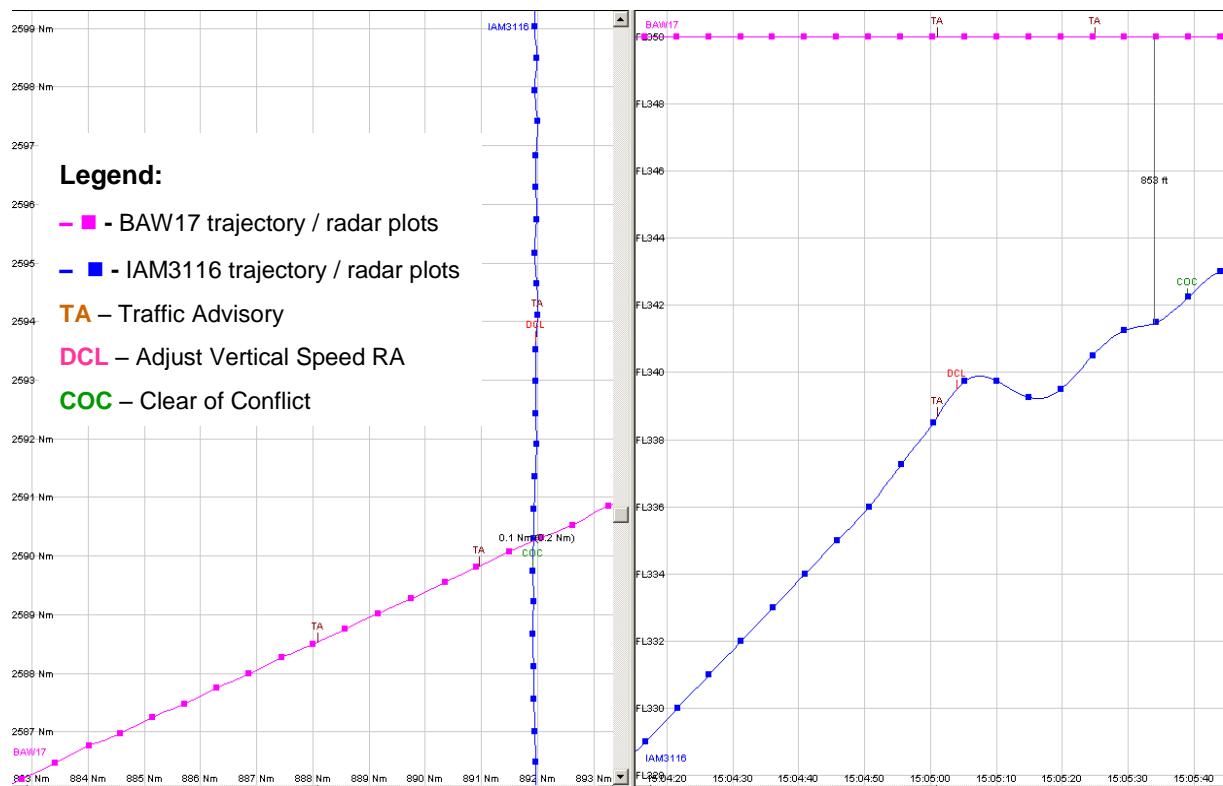
Figure 2: BAW17 and IAM3116 tracks. Source: ERGLI S-Mode Radar data, Eurocontrol InCAS 2.10

According to the recordings of ACC and IAM3116 communication (table 1), the AIM3116 *“had a TCAS conflict that commanded us to climb”*. The variations vertical speed and altitude of IAM3116 (figure 2) reflect the pilot action after receiving the RA. The flightpath indicates that immediately after receiving the RA, the AIM3116 reduces altitude from FL340 to 339 and then starts to climb again reaching FL343. According to ATC and radar information there was no other traffic below IAM3116, therefore ESIB considers it to be unlikely that TCAS generated an RA “Climb, climb; Climb, climb”. The most likely RA received by the IAM3116 crew must have been “Adjust vertical speed adjust” which always require reduction of vertical speed, and which was firstly followed by correct pilot action (by the IAM3116 crew) - reduction of vertical speed (figure 2) and then followed by unintentionally incorrect pilot response causing the aircraft to climb instead of levelling off (figure 2). The mode S downlink data (Ergli radar) confirms that “Adjust vertical speed, adjust” was issued to IAM3116 crew.

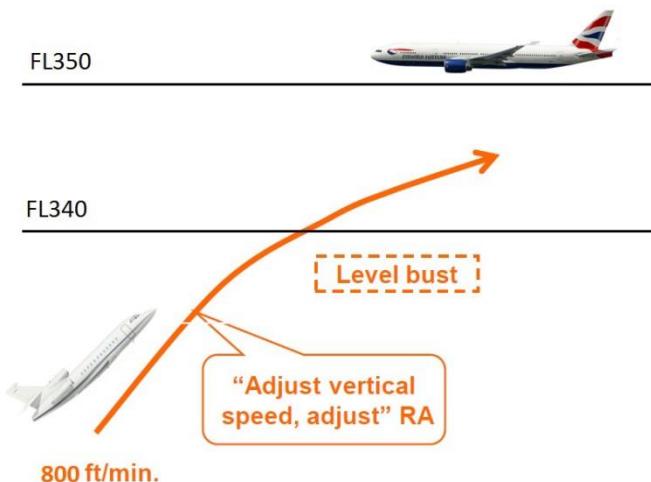
The two aircraft (IAM3116 and BAW17) were converging laterally, however the IAM3116 was predicated to pass safely beneath BAW17. At 15:04 the climbing IAM3116 at FL333 got instructions from air traffic controller to maintain FL 340, which the PIC (pilot in command) read back correctly. The aircraft continued climb (figure 2) to reach designated altitude. At 15:05 due to crossing flightpaths both aircraft (IAM3116 and BAW17) received a TCAS TA. Two three later the climbing IAM3116 received a TCAS RA. BAW17 did not receive any TCAS RA instruction (figure 3).

Figure 2: TCAS RA on IAM3116 climb

This incident is attributable of the fact that the crew of IAM3116 misinterpreted TCAS RA “Adjust vertical speed, adjust”, by increasing the rate of climb instead of levelling off.

The aural warning wordings of TCAS II Version 7.0 RA can be misleading. This might have contributed to the incorrect pilot response.

EU 1332/2011 is mandating TCAS version 7.1 to be used in European airspace on civil aircraft. State aircraft are subject to National-jurisdiction and no mandatory action can be enforced at EU level. Since the State transport aircraft may operate in the same airspace as civil aircraft, the adoption of TCAS version 7.1 on transport-type State aircraft may not be seen as mandatory in regulatory terms, but it is strongly recommended to all ICAO and EASA member states, that for safety reasons, all State aircraft should be upgraded to version 7.1 as soon as possible, including when forward-fit opportunities arise. Taking in account that “The Convention of International Civil Aviation” Article 3 and EC 216/2008 Article I exclude State aircraft, ICAO and EASA cannot mandate the implementation of TCAS version 7.1 on State aircraft, which decision at the moment is on the separate member states. It is therefore recommended to ICAO, EASA and European Commission to consider promoting member states to take further actions in enforcing the adoption of TCAS version 7.1 on State aircraft, when operating in common airspace to mitigate the risks of loss of separation between civil and State aircraft.
