FINAL REPORT

ON SERIOUS INCIDENT OF THE AIRCRAFT type LET-410, registration OK-LAZ

Dubrovnik Airport, 29 November 2018

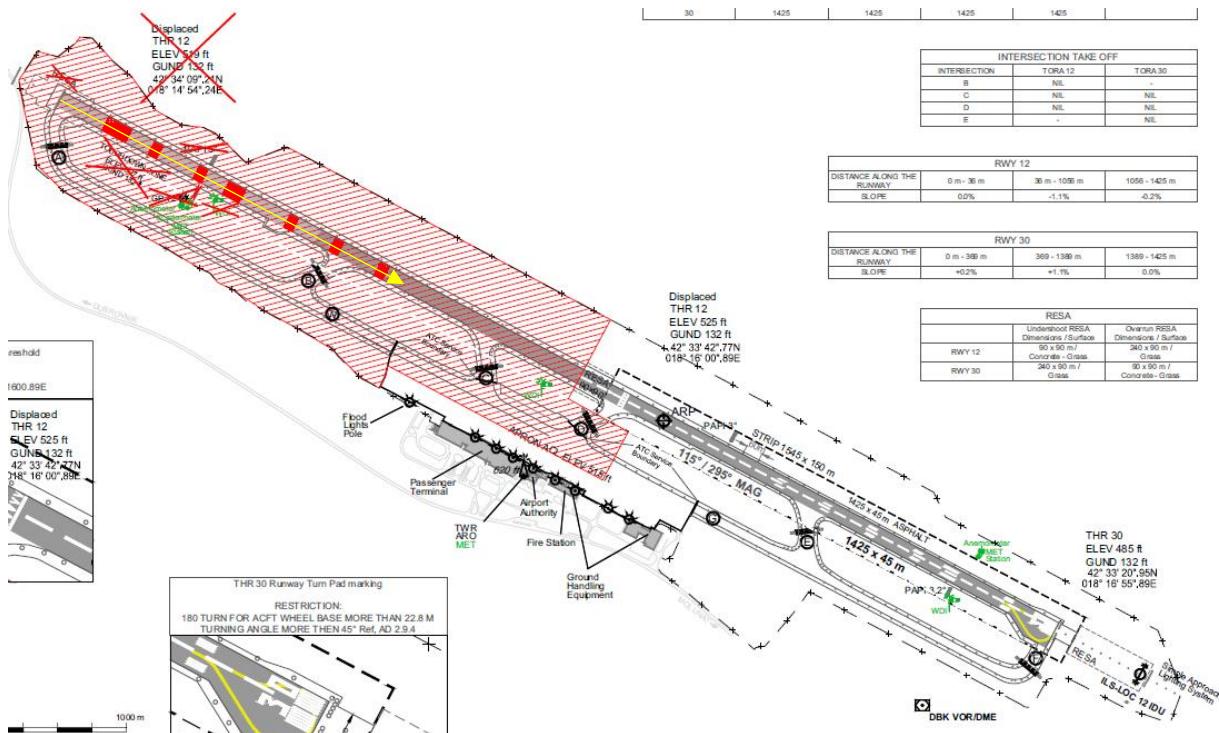
At 11:00 hours the aircraft departed from Split Airport (LDSP) to Dubrovnik Airport (LDDU), under flight number C3821, and call sign TDR821, in accordance with IFR flight rules. The crew decided to perform a visual approach considering a good visibility. During the approach, the first officer informed the captain of the aircraft (also the commander of the aircraft), who operated the aircraft, that the vehicles were located on the runway. The commander continued the landing, and the aircraft landed on the closed portion of the runway (Figure 01) where the construction works were being performed.

Figure 1 – Portion of the closed runway marked by yellow line (aircraft landing site)

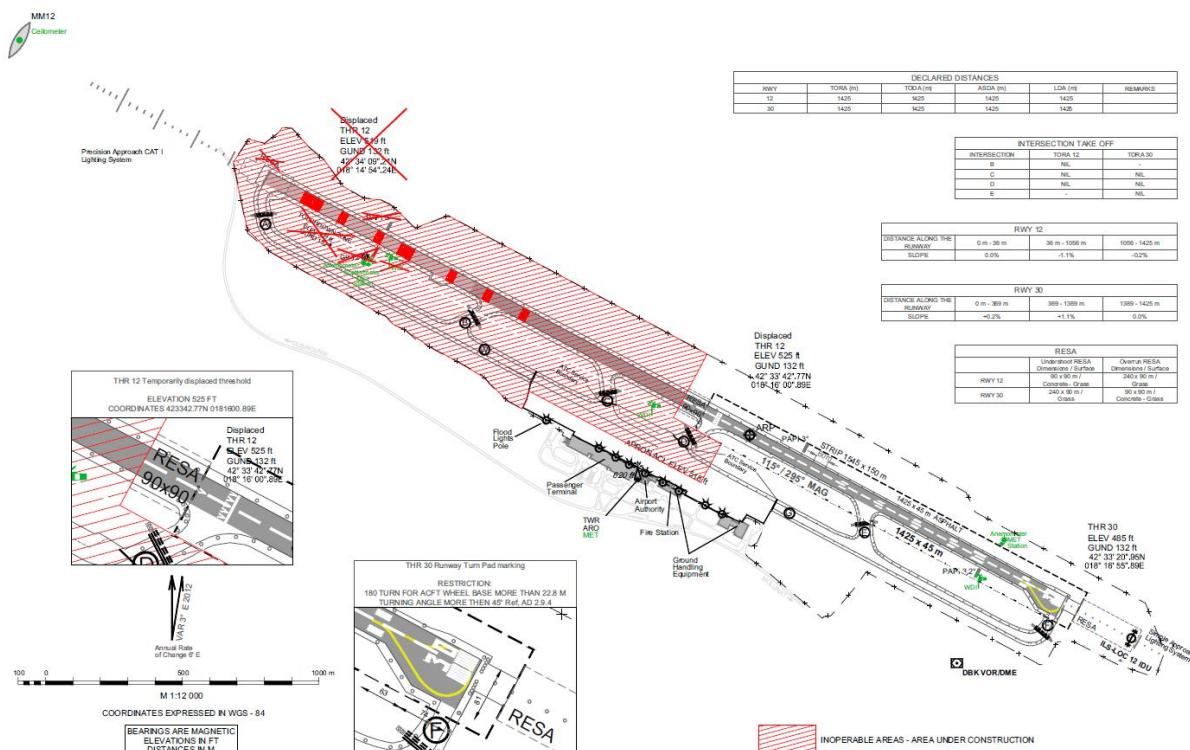
Figure 5 – Phase II of the construction works

The graphical representation of Phases I and II of the construction works shows that one of the differences between the said Phases was a displaced runway direction 12 threshold. A part of the runway used for landing in Phase I was closed in Phase II and the other half of the runway that was rebuilt during Phase I was used for operations.

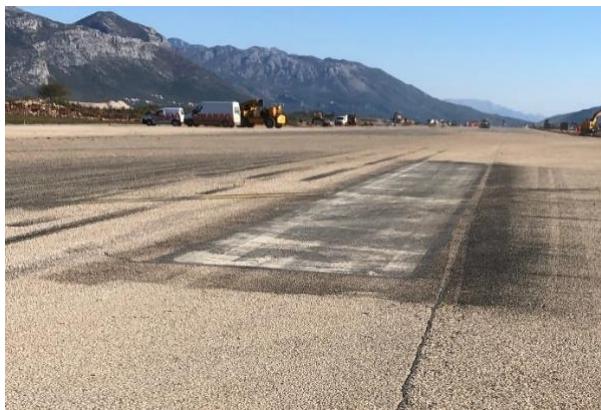
established that covering of markings on the portion of the operating area out of use was done by coating them with a black bituminous emulsion.

By inspecting of the performed works during the transitional night (between Phase I and Phase II of the construction works) it was established that the works of covering of the markings on the portion of the operating area which was out of use were performed in accordance with the requirement stated in the implementation document. Due to heavy rain during the transitional night and the following two days, the black colour of the bitumen emulsion faded to a lesser extent, resulting in the partial sighting of the covered markings (Figures 7 and 8).

Figure 7 – Runway markings on the day of the incident

- c) Analysis of compliance with the basic conditions, and adjustment of horizontal signalling with temporary solution for the manoeuvring areas.
- d) A working instruction on the obligation of use of aeronautical ground lighting at the highest intensity during each aircraft landing operation, to highlight the active portion of the runway and to increase the situational awareness of the flight crew on the position in space during landing operation.

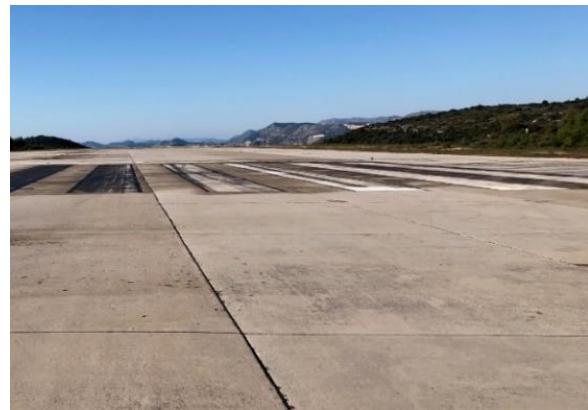
Figure 8 – Markings of the runway threshold on the day of the incident
