# Investigation Report

EX009-0/07  
February 2009

Type of Event: Serious Incident  
Date: 20 August 2007  
Location: Frankfurt  
Classification: Commercial Air Transport  
Manufacturer / Type: Boeing / B 767 - 300  
Injuries to Persons: None  
Damage to Aircraft: Minor Damage  
Third Party Damage: None  
Source of Information: Investigation by BFU

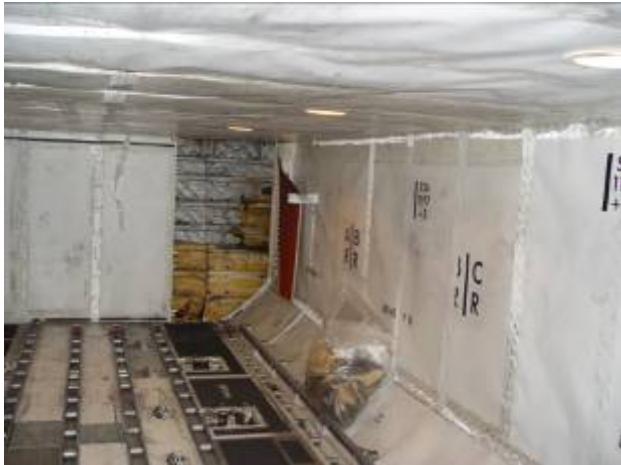
It was necessary to unload the rear freight hold to gain access to the void under seat row 26. A further search was then made for the cause with a thermal imaging camera. After several inner sidewall panels had been removed from the freight hold, investigation of the front bulkhead heat insulation located the site of a smouldering fire that had since gone out.

Photo above: Location of the fire in cargo hold

The smouldering fire in the insulation material was located below the defective strap and molten cables.

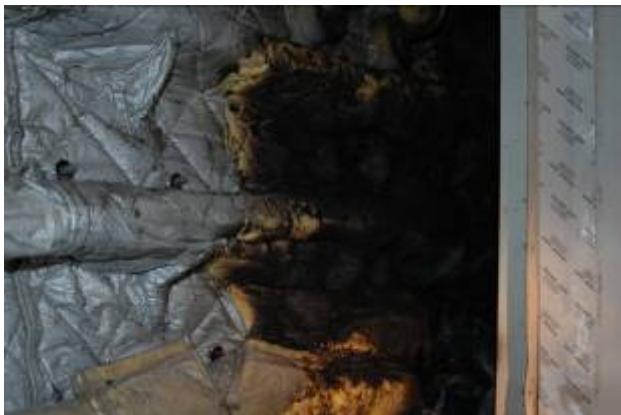
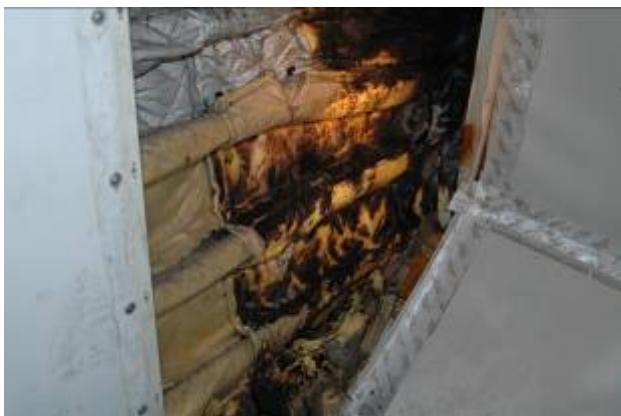
Photos above and below: The charred insulation mats

On the ground, further systems were activated – some of which demand much higher current – at which point the short circuit generated much bigger sparks. As a result, the insulation mats behind the freight hold wall panels broke into a bigger smouldering fire with much more smoke. The circuit breakers then tripped, terminating the emission of sparks. The smouldering fire was extinguished by lack of oxygen.

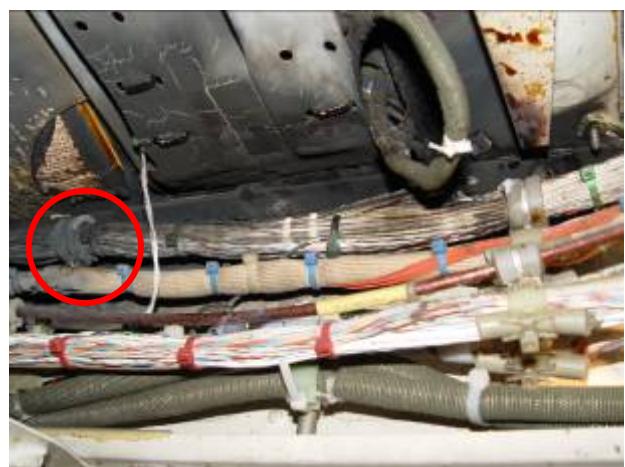
Because of the disruption to the power supply, it was not possible to use the rear cargo hold electrical loading/unloading system. After the freight container had been manually off-loaded and the site of the smouldering fire had been located in the heat insulation behind the cargo hold wall, further inspection located additional evidence of fire in a cable loom.

Photo above: Damage to the cable loom

On an insulated cable strap evidence was found of a short circuit between the cable strap and the current-carrying cable. The strap insulation had been abraded at two points, with evidence of fire at these points. Two cables in the loom had melted through, immediately alongside the strap.

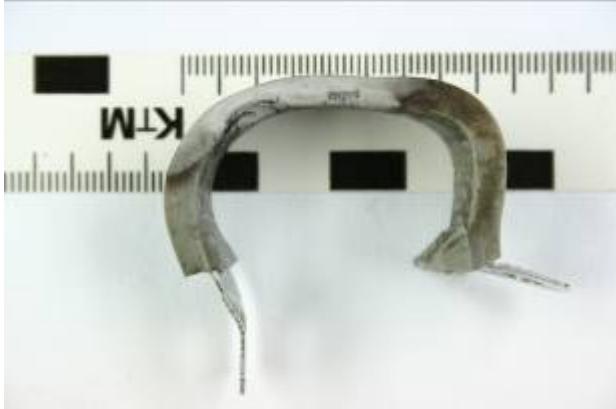
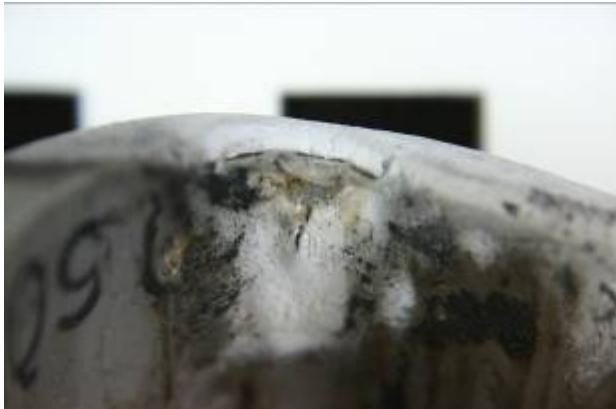
Photos above and below: The defective cable strap

The primary cause of this incident was motion between the wire loom and strap (relative motion), resulting in wear to the insulation material on both parts (electrical cable/strap). The abrasion, and the fact that this was a repeat incident, could be taken as an indication that the cable straps were unsuitable for the cable straps routing in this area.

The consequences arising from wear could be avoided by limiting strap service life, by periodic inspections, or fitting a plastic strap. The preferred solution would be a design change. In this aircraft, it would be sufficient to

replace the existing cable straps at this location with plastic fittings.

- Assess the protection of the electrical system (circuit breakers) which run through the area in front of the aft freight hold and make any necessary changes.
- Exchange the existing insulated cable straps with plastic straps in the area in front of the rear freight hold.
