**ACCIDENT**

<b>Aircraft Type and Registration:</b>	Boeing 737-33A, G-ZAPZ
<b>No &amp; Type of Engines:</b>	2 CFM56-3C1 turbofan engines
<b>Year of Manufacture:</b>	1991 (Serial no: 25401)
<b>Date &amp; Time (UTC):</b>	14 April 2012 at 1008 hrs
<b>Location:</b>	Chambery Airport, France
<b>Type of Flight:</b>	Commercial Air Transport (Passenger)
<b>Persons on Board:</b>	Crew - 5                      Passengers - 131
<b>Injuries:</b>	Crew - None                      Passengers - None
<b>Nature of Damage:</b>	Damage to rear fuselage skin, frames and drain mast
<b>Commander's Licence:</b>	Airline Transport Pilot's Licence
<b>Commander's Age:</b>	34 years
<b>Commander's Flying Experience:</b>	3,950 hours (of which 1,417 were on type) Last 90 days - 75 hours Last 28 days - 25 hours
<b>Information Source:</b>	AAIB Field Investigation

**Synopsis**

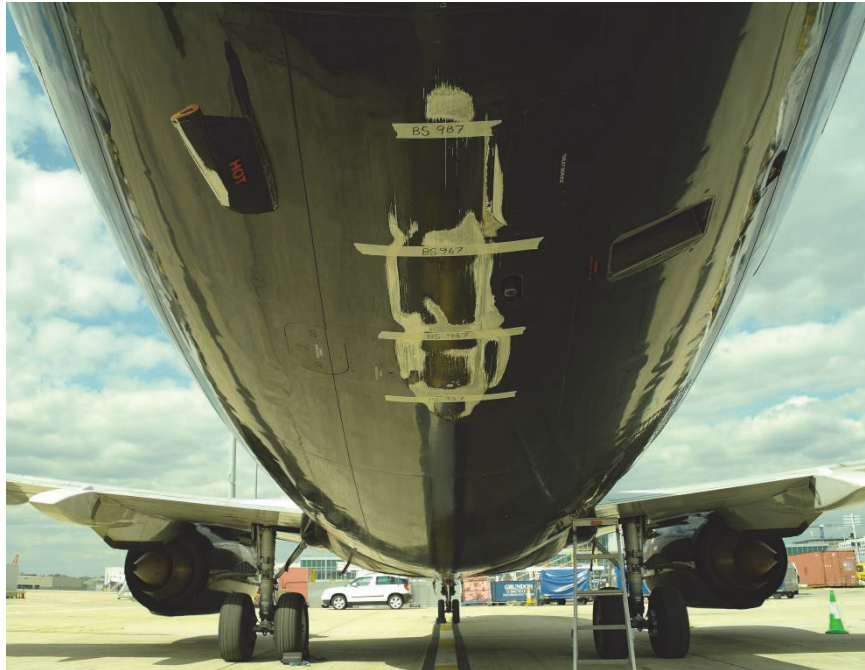
**Figure 1**

Damage to the aircraft was confined to deep longitudinal scoring of the rear fuselage skin, over a length of 1.9 m, from just forward of fuselage station BS927 to just aft of BS987 (Figure 1). The lateral extent of the damage was limited to the two lowermost fuselage stringers. The damaged area was within the pressurised section of the fuselage, beneath the aft end of the rear baggage hold. On the 737-300 variant of the aircraft this area is not protected by a tail bumper.

The fuselage skin had been fully abraded at stations BS927 and BS947, resulting in slight scoring of the supporting fuselage frames at these positions. This damage created a small leak path for pressurised cabin air to escape to atmosphere, although the rate of leakage was small and insufficient to affect cabin pressurisation during the flight to Gatwick.

Damage to the lower fuselage skin and drain mast

In addition to the fuselage skin damage, the rear heated drain mast had been abraded and bent outboard due to contact with the runway.

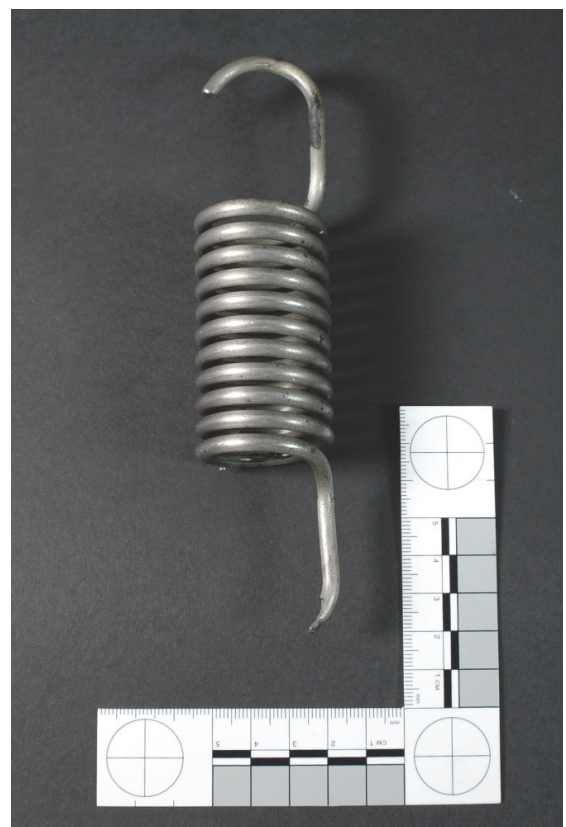
**Figure 2**

During the initial investigation it was reported to the AAIB that the pitch forces on G-ZAPZ were particularly light. No aircraft technical log entry regarding this had been made prior to the accident, but shortly after the aircraft was repaired and returned to service an entry was made by a flight crew member reporting that the elevator feel force was “light”. The operator carried out the ‘Low Control Forces’ troubleshooting actions from Chapter 27-31-00 of the aircraft maintenance manual, which revealed that a spring had broken within the aircraft’s elevator feel and centering unit. The unit was removed from the aircraft and sent to the AAIB for further investigation. During strip inspection, the outer main spring within the unit was found to have fractured (Figure 2). The

Broken outer main spring from the elevator feel and centering unit

elevator feel and centering unit was last inspected during the aircraft's 1C check, performed on 1 June 2011.

An analysis performed by the aircraft manufacturer showed that a broken outer main spring would reduce the control column pull force during aircraft rotation from approximately 30 lb.f, with intact springs, to approximately 20 lb.f.

It is considered that the reduction in pitch forces due to the broken outer main spring within the elevator feel and centering unit contributed to the excessive pitch attitude whilst attempting to get airborne.

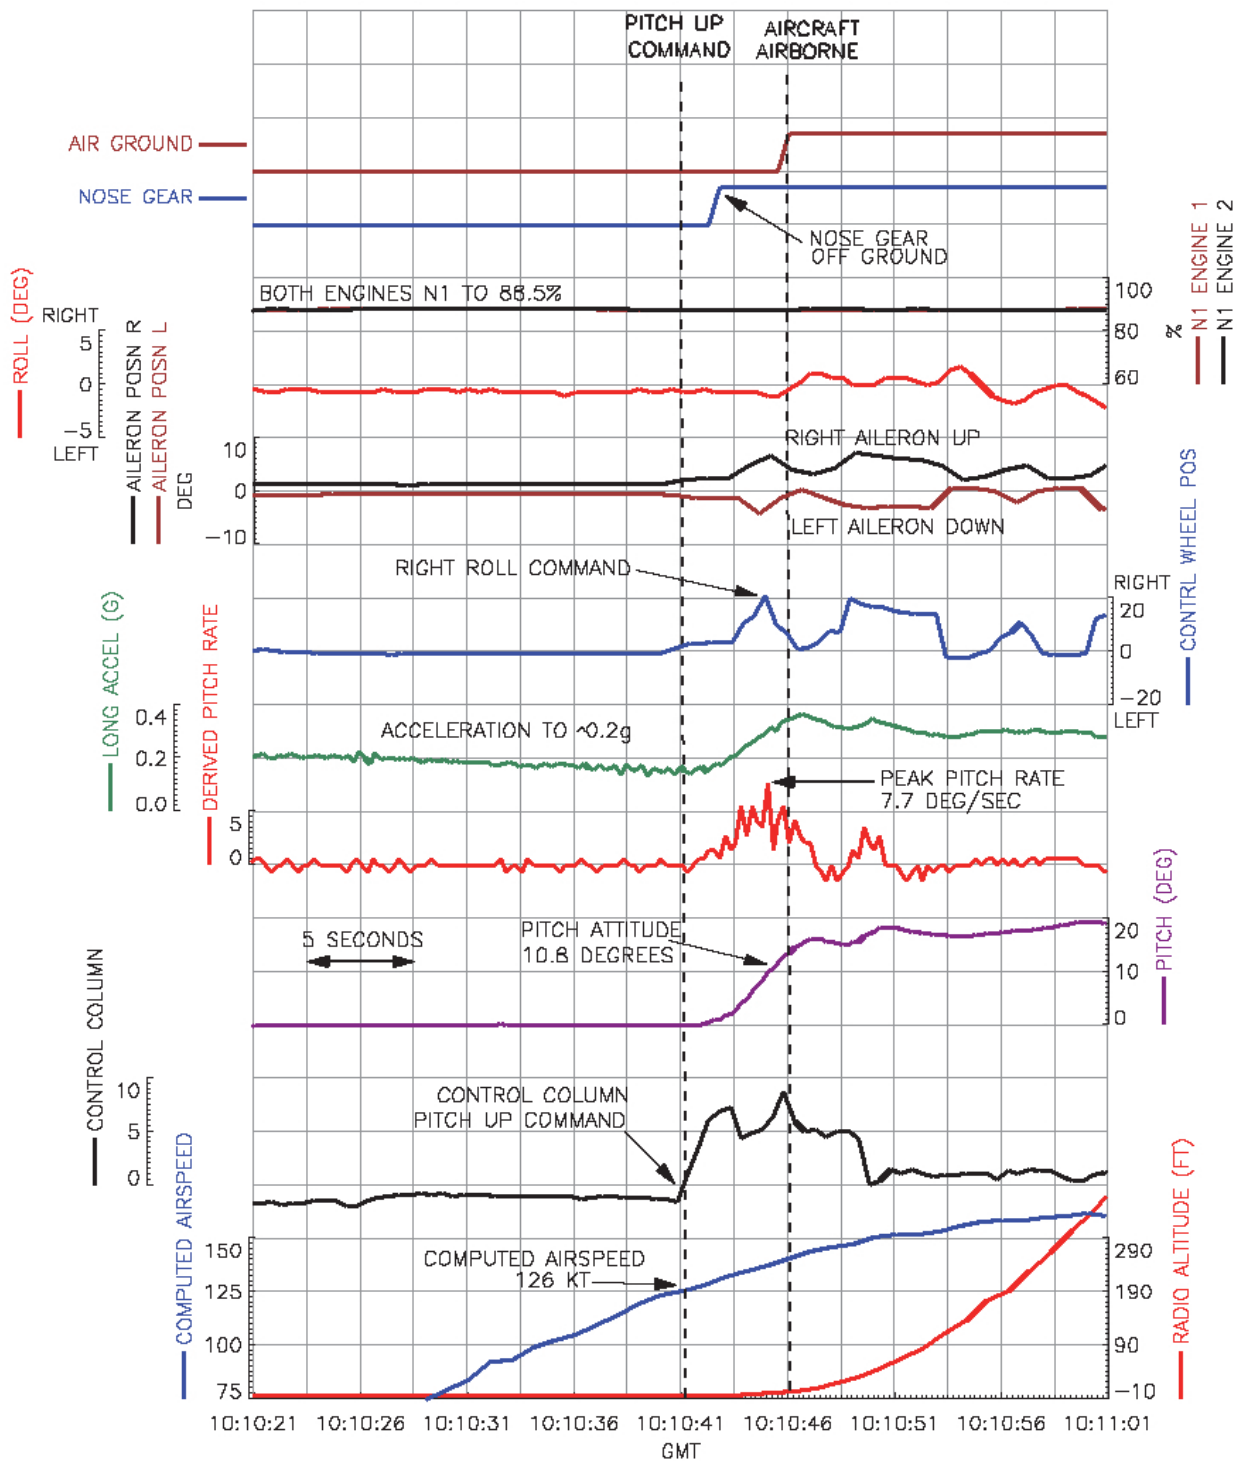
Just prior to takeoff, the recorded aircraft mass was 116,560 lb (52,870 kg). Takeoff commenced at 10:10:13 hrs with  $N_1$  on both engines increasing to 88.5% (Figure 3). At a computed airspeed (CAS) of 126 kt, the control column was pulled back to command a pitch-up attitude, the pitch attitude increased and the nosewheel left the ground. Approximately four seconds later, the pitch attitude increased through 10.8°, the threshold for a tailstrike with the landing gear compressed, and increased further as the mainwheels left the ground. The average pitch rate, calculated from the time of rotation to 10° pitch attitude, was 2.3° per second, within that recommended in the Flight Crew Training Manual.

At approximately the time the pitch attitude passed 10.8°, the recorded control wheel position increased to 21°, signifying a commanded right roll, which led to a corresponding aileron deflection. Spoiler positions

were not recorded, but assessment by the aircraft manufacturer was that this may have contributed to a loss of lift as this roll demand would have been sufficient to raise the roll spoilers on the right wing.

**Figure 3**  
G-ZAPZ Chambery Takeoff FDR Parameters

The aircraft rotation commenced at 126 kt, 13 kt below the required airspeed for the aircraft’s TOW. As a result of the early rotation, the aircraft pitched up but did not take off immediately and, with an increasing pitch attitude, the tail struck the runway. Despite the lower than required rotation speed and thrust derate, the aircraft continued to accelerate during the rotation and lift off, achieving  $V_2$  at a radio altitude of 30 ft.

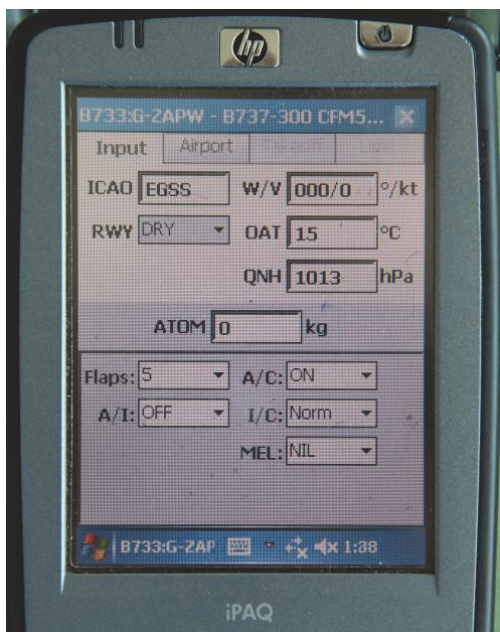
Figure 4

EFB takeoff input screen after software restart

Restarting the Guru program after shutdown takes approximately 36 seconds and results in the 'Input' data fields being reset to a standard data set (Figure 4). It also resets the 'Takeoff' and 'Limit' tabs to prevent data calculated (V speeds etc) from previous sectors being accessed.

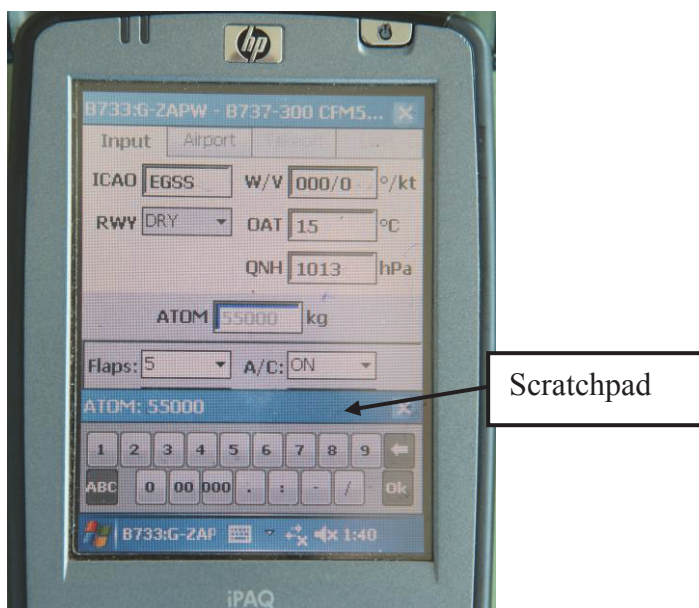
**Figure 6**

Both the EFB software supplier's keyboards have a 'scratchpad' which allows the user to see what is being entered even if the keyboard obscures the field being completed (Figure 6). To guard against data lying unknowingly hidden behind the open keyboard, their keyboards must be closed before different tabs can be accessed. If either of the EFB manufacturer's keyboards are selected, the device's intrinsic keyboard

EFB software supplier's keyboard

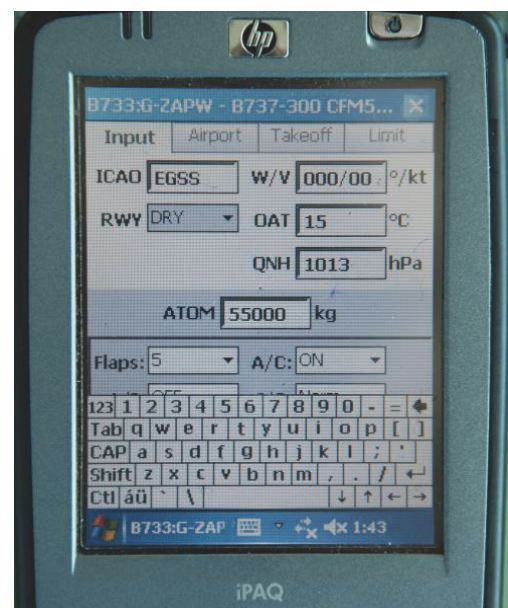
**Figure 7**

The device's intrinsic keyboard (Figure 7) has smaller key sizes (the number boxes are approximately 4 mm x 4 mm) than the EFB manufacturer's version. There is also no scratch pad facility, so should the keyboard cover the field being used, the numbers selected cannot be seen as they populate the field. In addition, the keyboard does not have to be hidden when moving between tabs, potentially allowing information to be hidden from view. For example, if the intrinsic keyboard was left open, the emergency turn information at the bottom of the screen shown in Figure 5 was hidden.

Device's intrinsic keyboard

At the time of the accident the operator was using a keyboard setting not intended for use by the EFB software supplier. An appropriate keyboard was available, but the software still allowed the use of the device's own intrinsic keyboard. Whilst it was not a factor in this accident, use of the intrinsic keyboard increased the potential for incorrect data being entered into the EFB and for information to be missed due to screen obscuration by the on-screen keyboard. The size of this keyboard was such that accurate use of the stylus was required to select the correct figures. This questions the use of the device whilst airborne in turbulent conditions for calculating data such as landing performance.
