Investigation report

L2012-02

Risk of an Airliner Colliding with Terrain in the Vicinity of Mariehamn Airport on 14 February 2012

YL-RAG

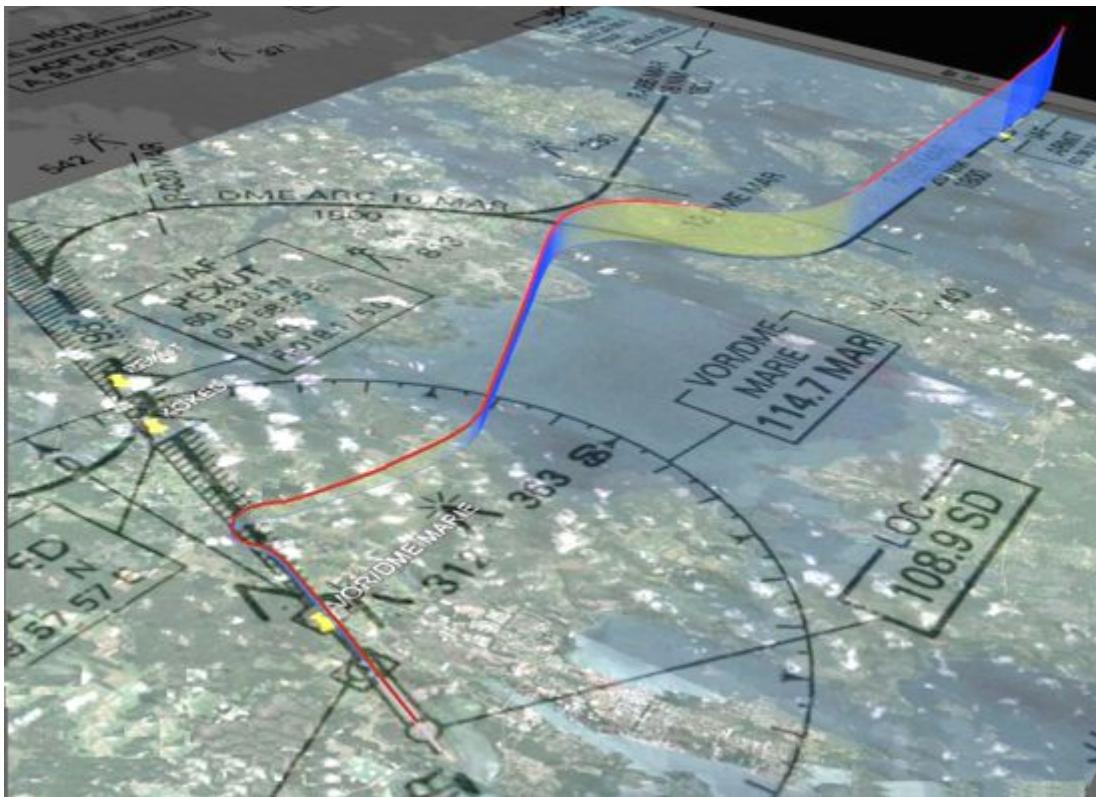
Figure 1. The flight track of NEF021 © Finavia, permission 4/590/2007.

At 6:41, contrary to the approach procedure and the ATC clearance, NEF021 turned left, away from the DME arc. NEF021 continued to fly towards the runway threshold with the approximate heading of 240 degrees, which is approximately 40 degrees off of the final approach track prescribed for the approach.

From the ATS monitor the air traffic controller noticed that NEF021 had turned left. The controller asked the flight crew to confirm that they were following the initial approach route. The crew replied that they were on the initial approach route. Following this the symbol of the aircraft on the monitor faded below the radar horizon.

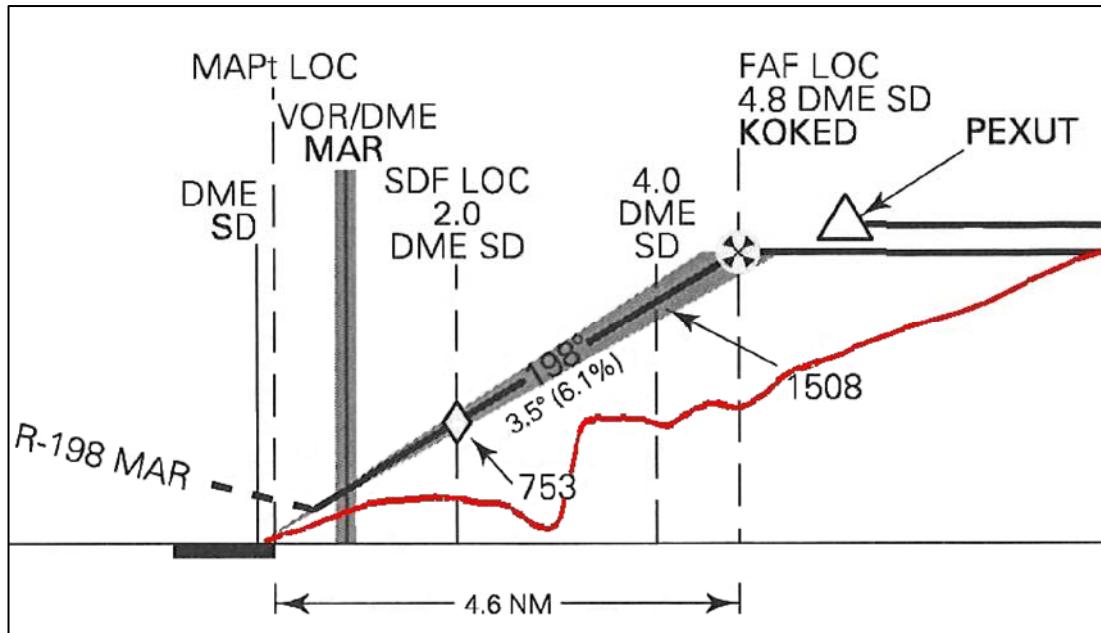
Figure 2. The flight path of NEF021 in relation to the ILS approach.

At 6:45, after crossing the final approach track, the co-pilot noticed from the instruments that they were within the ILS LOC beam, and advised the captain to turn to the left. The captain made a rapid deflection with the aileron and the rudder to the left, in addition to which the captain deflected the elevator down. NEF021 ended up in an unusual flight attitude in which the maximum bank angle was 50 degrees to the left and the maximum pitch angle was 19 degrees, nose down. The aircraft went into a sideslip with a rapidly accelerating sink rate. The Ground Proximity Warning System (GPWS) activated, warning the crew of an excessively steep bank angle, excessive deviation below the ILS glide slope and an excessive terrain closure rate. The sink rate of NEF021 peaked at approximately 5000 FT/min (25 m/s) at the height of 300 FT (90 m).

In the aircraft the “WHOOP, WHOOP, PULL UP” warning, the mode alerting of excessive terrain closure rate, was repeated eight times, but the crew did not react to this. The captain managed to recover the aircraft about two seconds before they would have collided with the ground, at approximately 150 FT (46 m) AGL. During the recovery the co-pilot saw treetops that were illuminated by the aircraft’s landing lights.

Following the recovery the captain increased the altitude only a little and continued the approach below the ILS glide path. Due to the low altitude the “TERRAIN, TERRAIN WHOOP WHOOP, PULL UP” warning of the GPWS activated, but the flight crew did not react to this. The captain of NEF021 did not have the runway in sight. Rather, the captain flew the aircraft by following the co-pilot’s guidance.
