**Emergency landing Bristow AS332L2
search and rescue helicopter**

North Sea, near Den Helder, 21 November 2006

The Hague, (project number M2006LV1121-07)

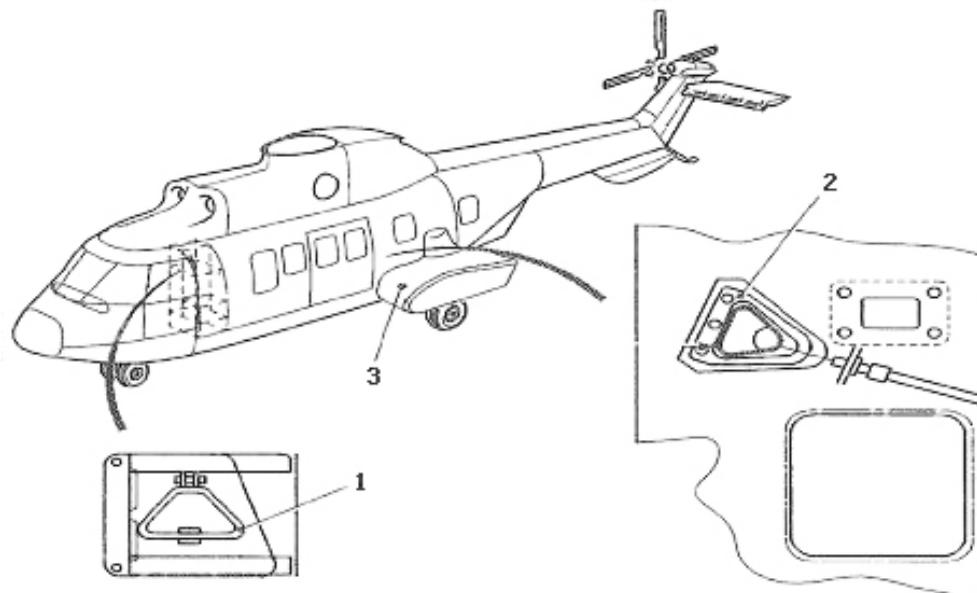
eventually gave up. The winch operator, observing the winchman's predicament and assuming that he had already attempted to use the right-hand external life raft deployment handle, decided to swim around the helicopter to inflate the left-hand sponson life raft. This proved to be problematic, however, due to the high sea conditions with wave heights between 2-3 metres, so he returned to the right-hand cabin door area.

Illustration 5: for each life raft, 3 inflation systems/release handles are in operation. One is installed in the cockpit (1), one is installed externally on the fuselage aft of the main door (2), the third handle is installed in the sponson stowage (3).

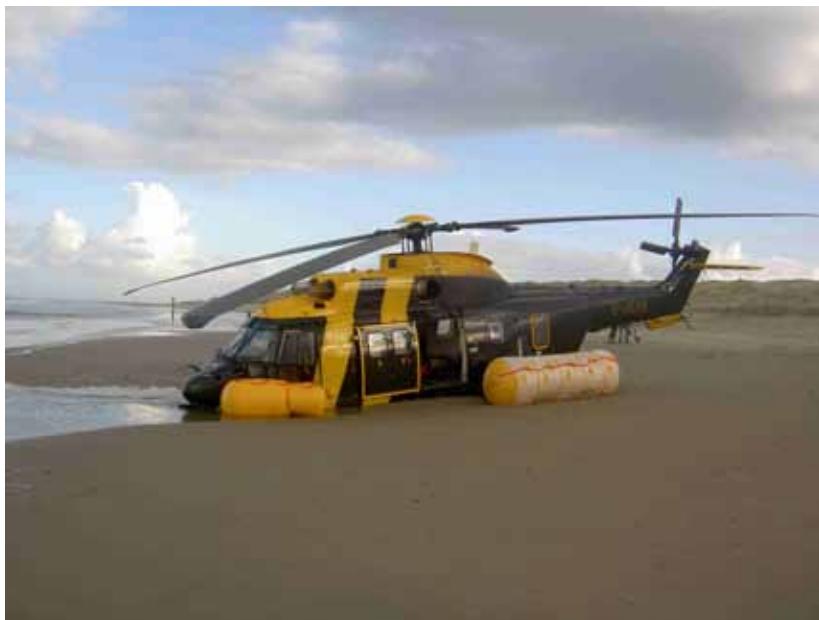
Illustration 7: G-JSAR washed ashore the day after the incident.

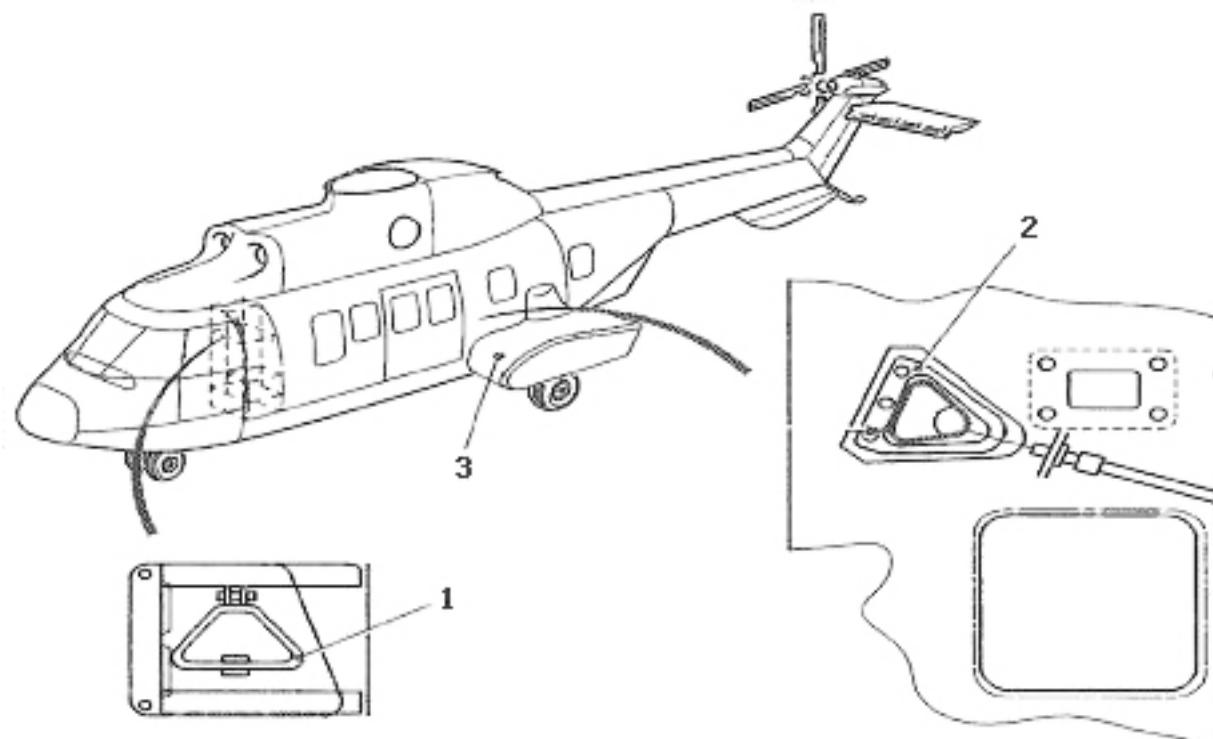
Illustration 5: for each life raft there are three inflation system operating/release handles. One is installed in the cockpit (1), one is installed externally on the fuselage aft of the main door (2), the third handle is installed in the sponson stowage (3).

When carrying out the life raft release test on the left-hand side, it was found that the life raft could not be released using the exterior (2) and interior (1) release handles. The third possibility, release after removing the cover of the sponson, was abandoned. The possibility existed that the previous

release attempts had armed the release mechanism and this would endanger the person removing the cover of the sponson. Eventually the life raft was released by turning the control lever inside the cabin beyond its normal operating range. After the release it was established that the activating mechanism inside the left-hand sponson (the third release possibility) functioned normally.

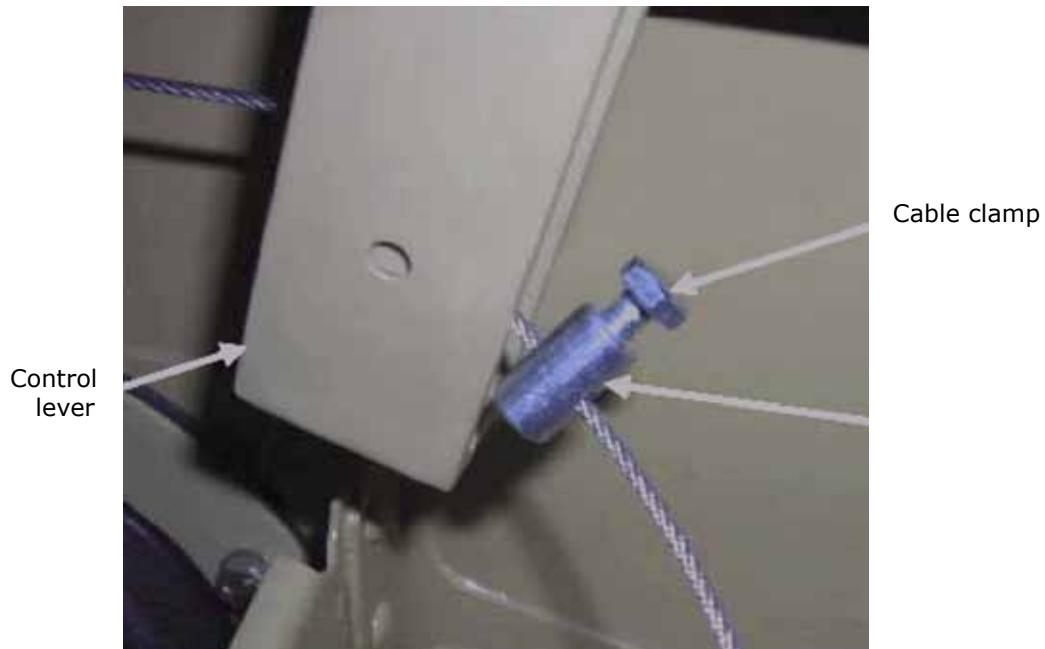
Illustration 6: lower side of the control lever [source Eurocopter].

Maintenance logbook entries indicated that life raft due bay (sponson) services were carried out in accordance with maintenance procedures. Initially, the cable grip of the release control cable (illustration 6) was suspected to have slipped, but a detailed investigation of the cable proved that this was not the case. It turned out that the control lever angle was too large in relation to its horizontal axis and prevented the control lever from functioning within its normal operating range.
