ATSB TRANSPORT SAFETY INVESTIGATION REPORT

Aviation Occurrence Report – 200602099

**Runway incursion
Brisbane Airport, Qld – 21 April 2006
VH-VXS
Boeing Company 737-838
Tug 92
Aircraft tow vehicle**

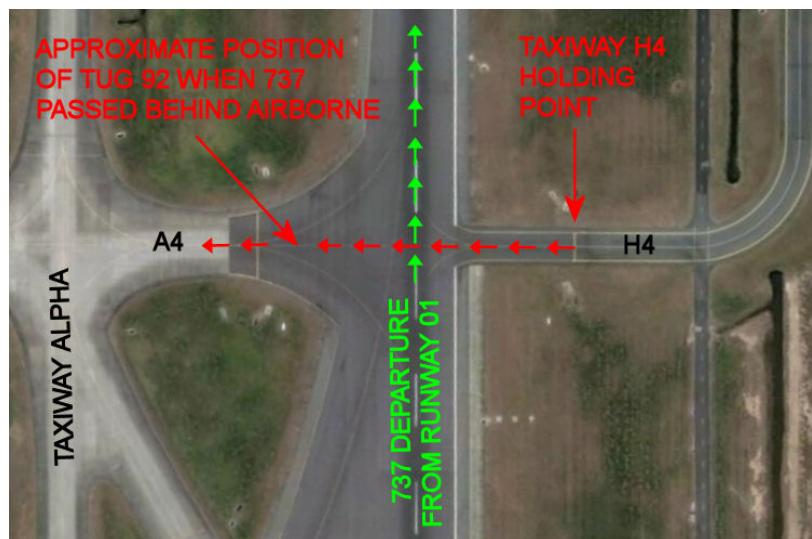
Figure 2: Intersection of Runway 01 with Taxiway H4

The driver of Tug 92 later reported to his company that the vehicle was 'still within the runway strip, short of the Alpha 4 holding point, when the 737 passed behind them airborne' (Figure 2).

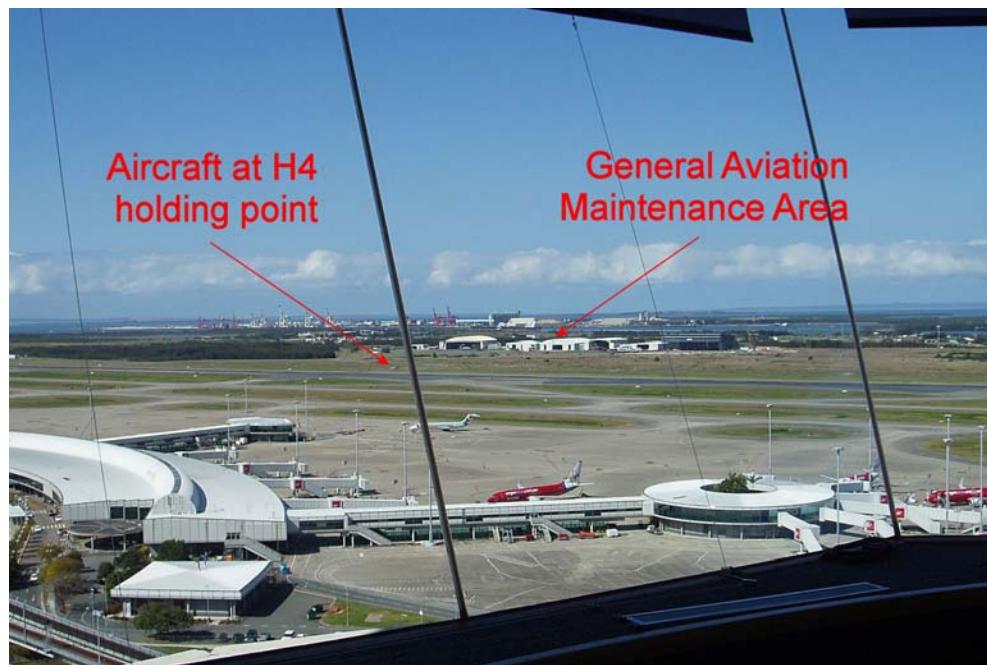
Figure 3: View from Brisbane Tower towards the Runway 01 / H4 intersection.

small vehicles such as Tug 92 can be difficult to see particularly when environmental factors such as glare, background colouring and weather are taken into consideration. Additionally the tower has concrete support pillars that obscure the view of certain parts of the airfield from various positions within the tower. One such concrete support pillar obscures the view of the area in the vicinity of [runway 01 and taxiway H4 and A4] from the [ADC] position.

Figure 3 shows a view from the Brisbane Tower looking towards the runway 01 and H4 intersection, with the general aviation maintenance buildings visible in the centre of the photograph. Also shown is an aircraft holding at the H4 intersection waiting to cross the runway. This photograph was taken from the far left of the tower cabin and the concrete pillar and ADC position are located out-of-shot to the right of the photograph.

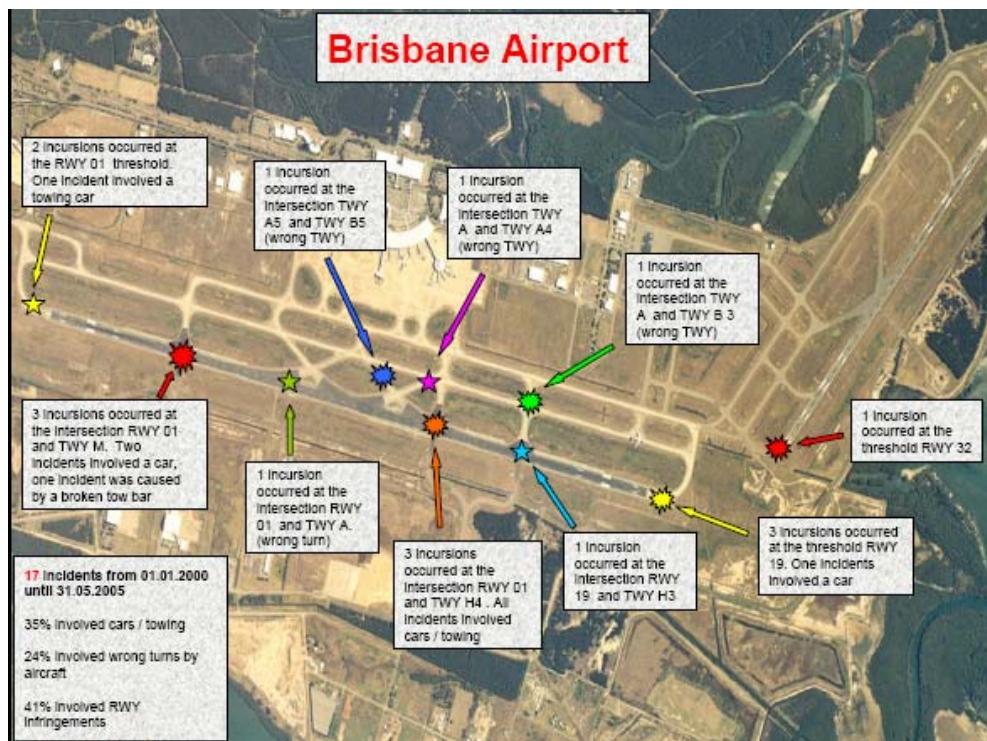
Figure 4: Brisbane Airport Runway Incursion Incidents

The Airservices website⁹ contained information relating to runway safety initiatives and the activities of the RIG. Also available was a pictorial representation of runway incursions at various locations within Australia, including Brisbane Airport (Figure 4). This information showed that between 1 January 2000 and 31 May 2005, there were 17 reported runway incursions at Brisbane Airport, with 35% of those incidents involving cars/towing. Three incursions were reported as occurring at the runway 01 and taxiway H4 intersection, all of which involved cars/towing.
