**NATIONAL TRANSPORTATION SAFETY BOARD**  
**Office of Aviation Safety**  
**Washington, D.C. 20594**

**POWERPLANT GROUP CHAIRMAN'S FACTUAL REPORT**

**NTSB No: ENG13IA033**

Aircraft: Korean Airlines Boeing B777-300ER, registration HL8275

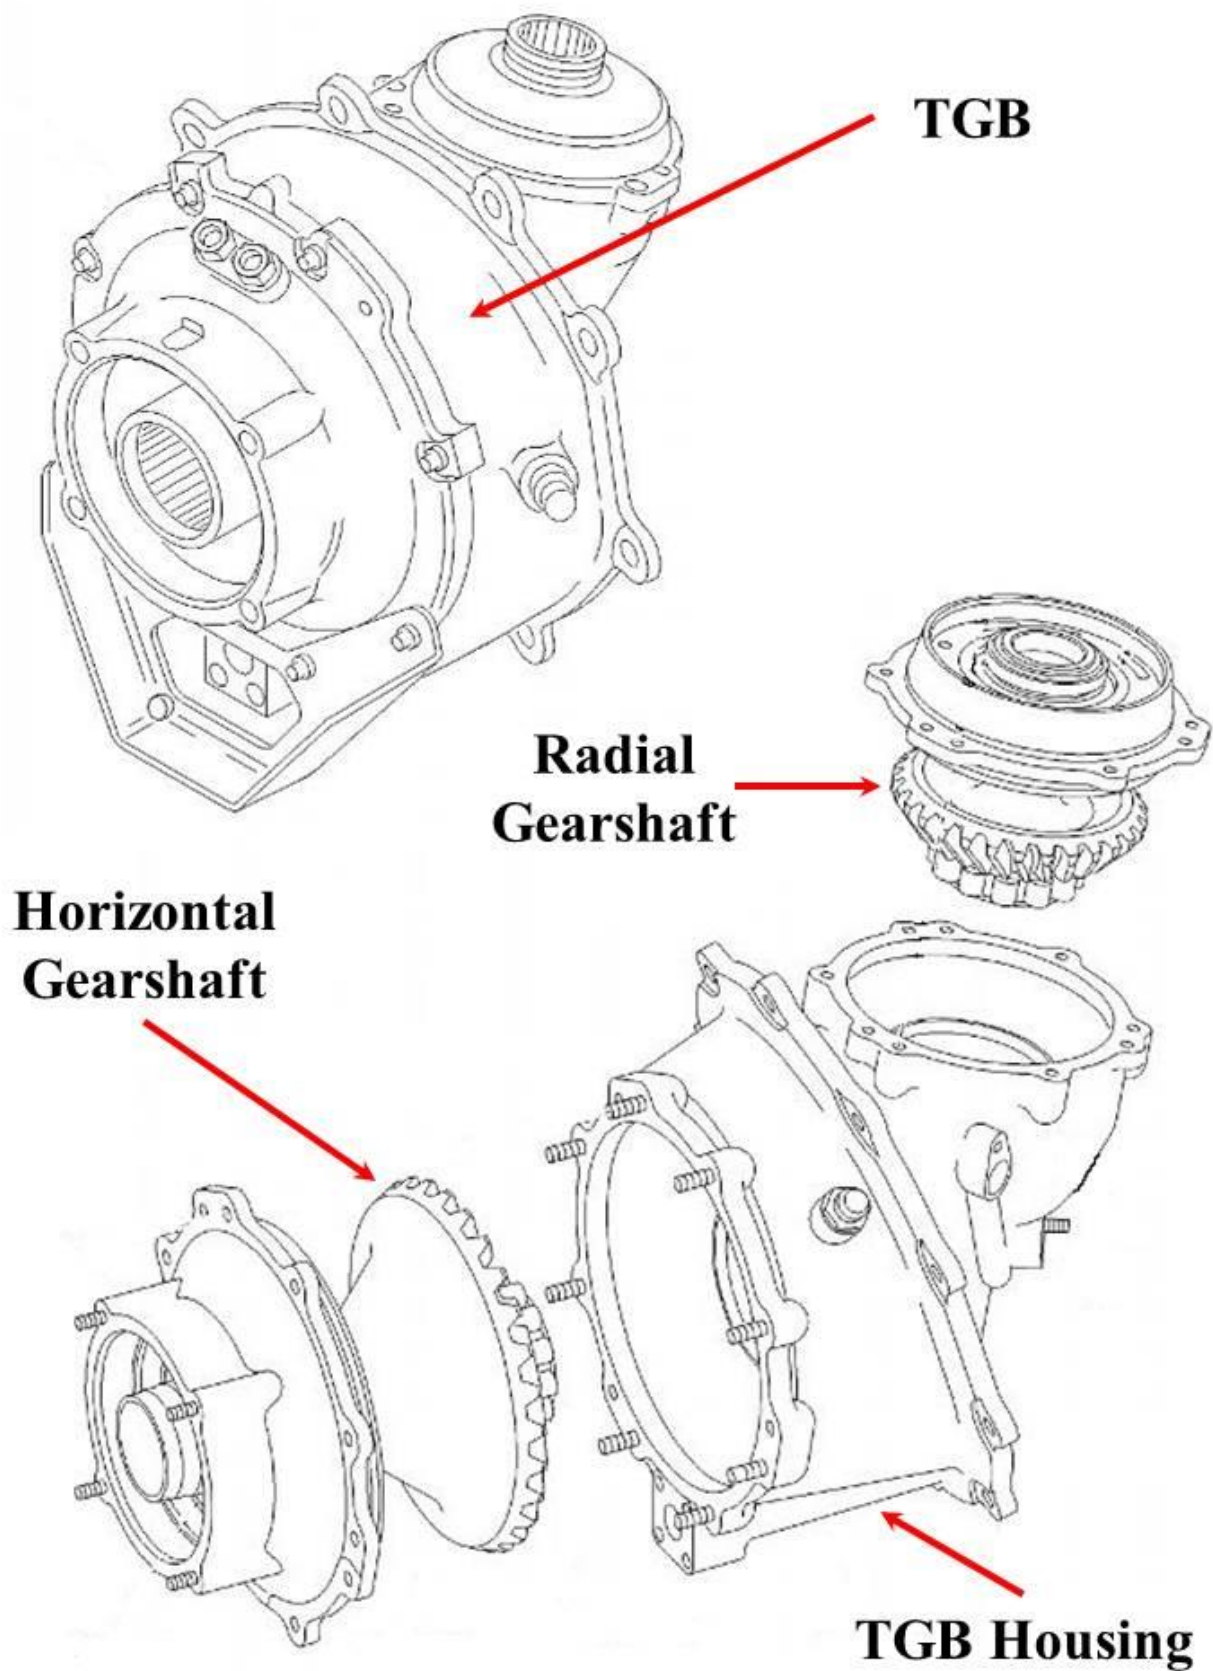
**FIGURE 1: TRANSFER GEARBOX EXPLODED VIEW OF INTERNAL PARTS**

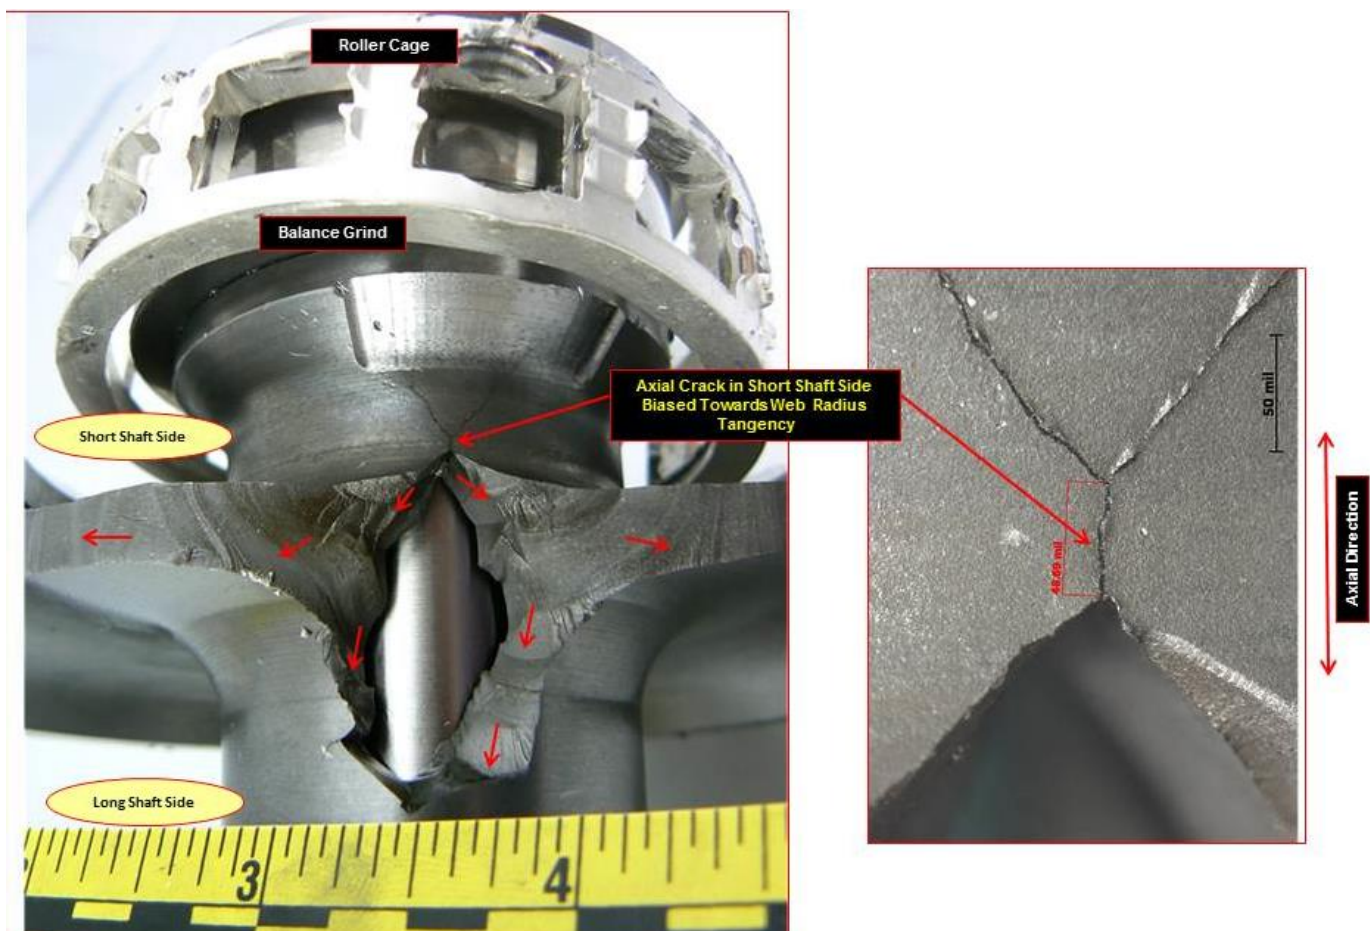
Initial visual examination revealed that the gear teeth contact surfaces revealed no evidence of fatigue spalling damage or unusual contact wear patterns. An X-shaped crack was observed in the short shaft side outer diameter at the shaft-to-web transition radius where part of the bevel gear and long shaft material was missing (**PHOTO 4**). In this area, an axial crack that measured about 0.049-inches (49 mils) in length was also noted. Fluorescent penetrant inspection (FPI) of the rest of the radial gearshaft revealed two additional X-shaped cracks in the short shaft side of the shaft-to-web transition radius region. According to GE, the X-shaped nature of cracking supported at least some torsional or biaxial stress influence during initial cracking. Published literature for fatigue cracking under torsional and/or biaxial loading conditions was consistent with the X-shaped cracking observed on the fractured radial gearshaft. GE subjected several AISI 9310 steel test bars to various biaxial fatigue loading conditions in an attempt to reproduce fracture features observed within the axial fracture. The results of the testing indicated biaxial loading conditions could reproduce features observed in the axial fracture.

**PHOTO 4: X-SHAPED AND AXIAL CRACK RADIAL GEARSHAFT SHORT SHAFT SIDE**

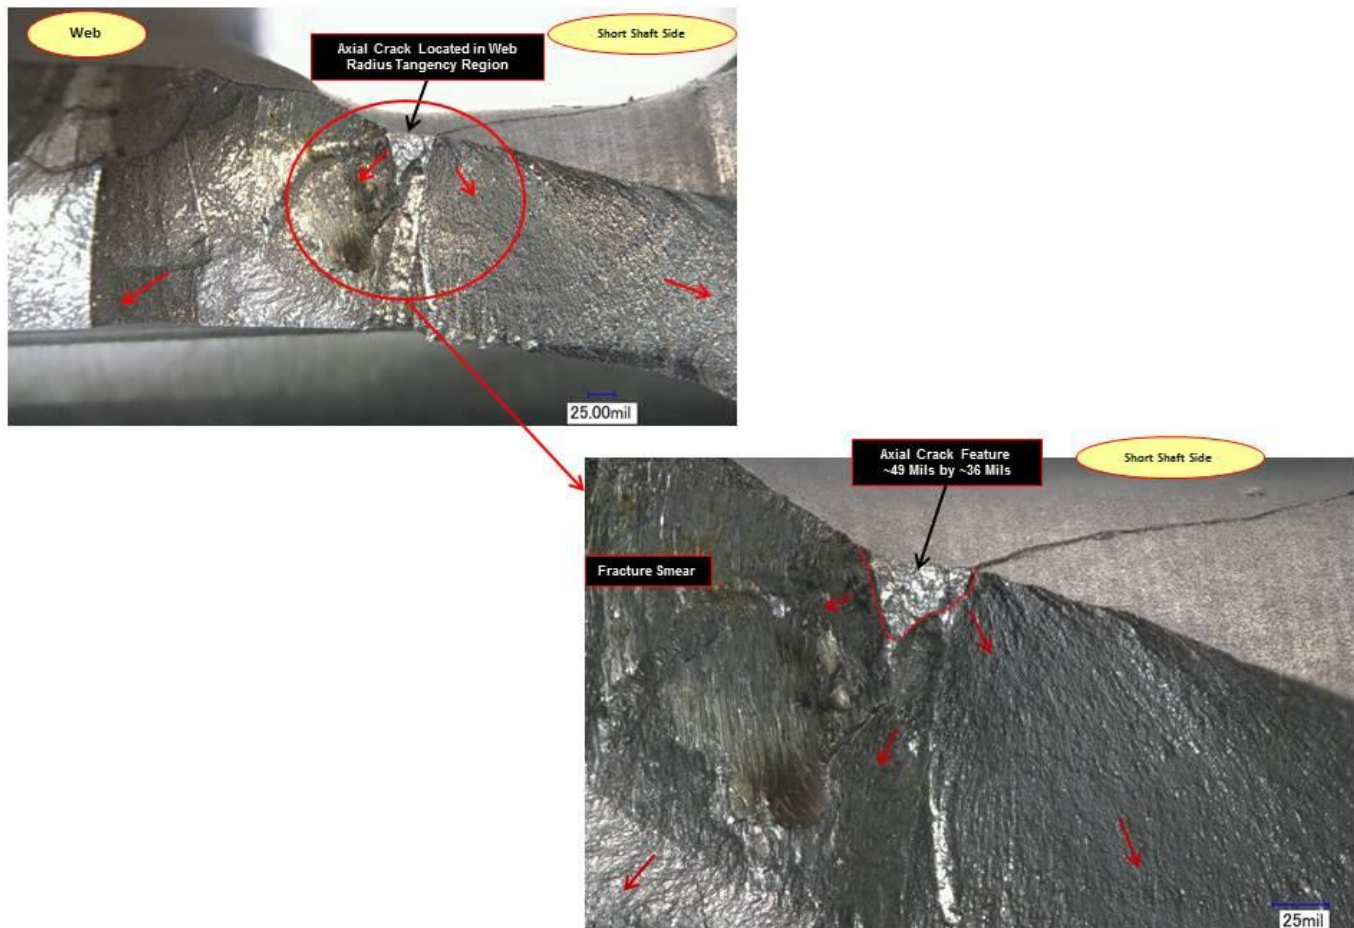
Scanning Electron Microscope (SEM) inspection of the axial fracture region revealed: 1) striation features indicative of fatigue propagation, 2) no evidence of any unusual surface anomalies such as impact or heavy scoring was associated with the axial fracture, 3) no appreciable oxidation was observed on the axial fracture region indicating fracture was not exposed to elevated temperatures such as from forging or heat treatment, 4) did not exhibit morphology typical of axial-axial induced fatigue fracture surfaces, such as interpretable flow lines pointing back to a single origin location, but instead

was more consistent with initial fatigue initiation occurring under a torsional and/or biaxial stress condition, 5) fracture morphology exhibited features consistent with tensile shear dimples indicating exposure to high shear stresses, and 6) no additional secondary cracks were observed adjacent to the primary axial fracture (**PHOTO 5**). According to GE, the axial crack was considered the primary crack initiation site for the fractured radial gearshaft with the crack continuing to propagate leading to the X-shaped crack. The axial and X-shaped cracks were consistent with torsional and/or biaxial fatigue mechanism. The fracture morphology outside of the axial fracture region exhibiting a “feathery” appearance and according to GE is more consistent with axial-axial fatigue, typical of lower alternating stress fatigue (high cycle fatigue) mechanisms attributed to the gear meshing stresses experienced by the gearshaft during engine operation.

**PHOTO 5: FATIGUE PROPAGATION FROM AXIAL CRACK**

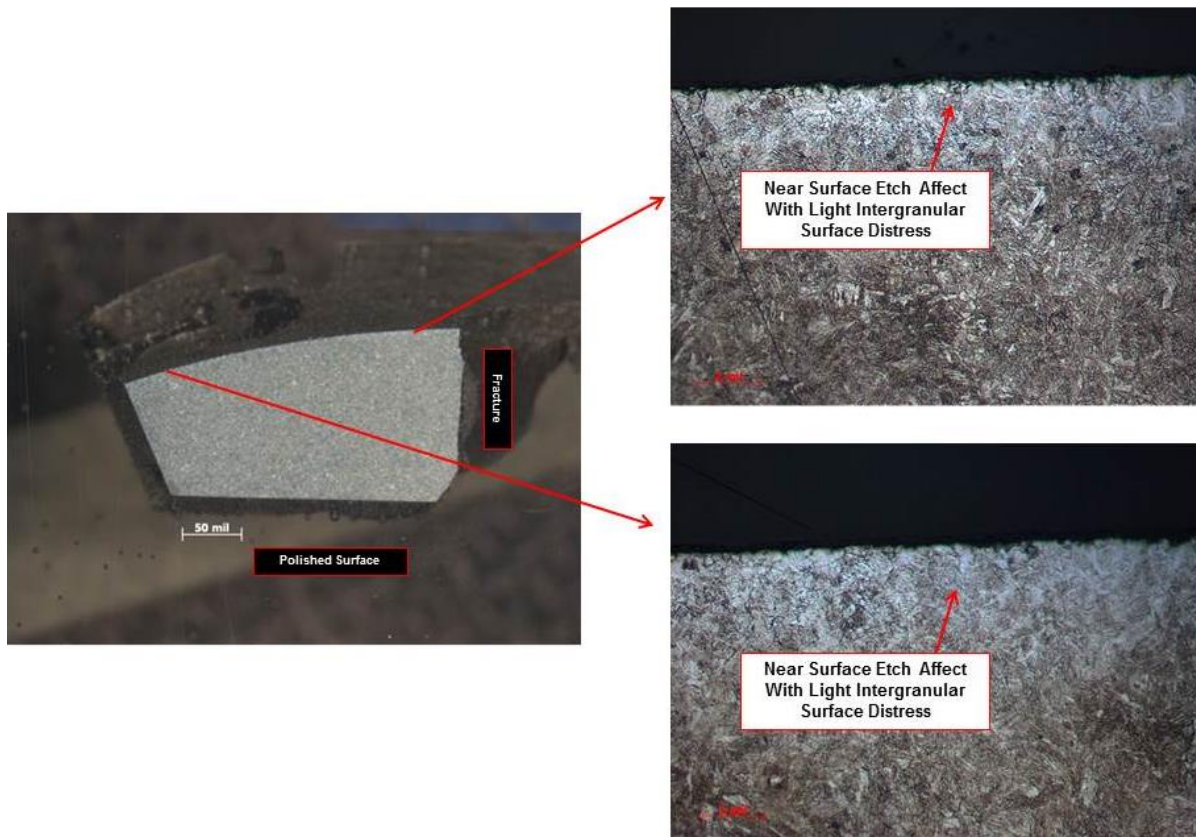
Etching<sup>3</sup> of a cross-section through the short shaft side revealed a near surface etch affect (lighter shading) on the outer diameter surface both at and away from the axial fracture location (**PHOTO 6**). Microhardness tests were performed on the radial gearshaft and a corresponding reduction in near surface hardness was measured within the lighter etching region with near surface hardness loss beginning at about 4 mils (**FIGURE 2**)<sup>4</sup>. The core hardness averaged HRC 40.4 (Rockwell Hardness on the C Scale) which met the part drawing requirement of HRC 32-44.

**PHOTO 6: ETCHING OF SHORT SHAFT SHOWING NEAR SURFACE LIGHT INTERGRANULAR DISTRESS**  
(Pictures Courtesy of GE-Aviation)

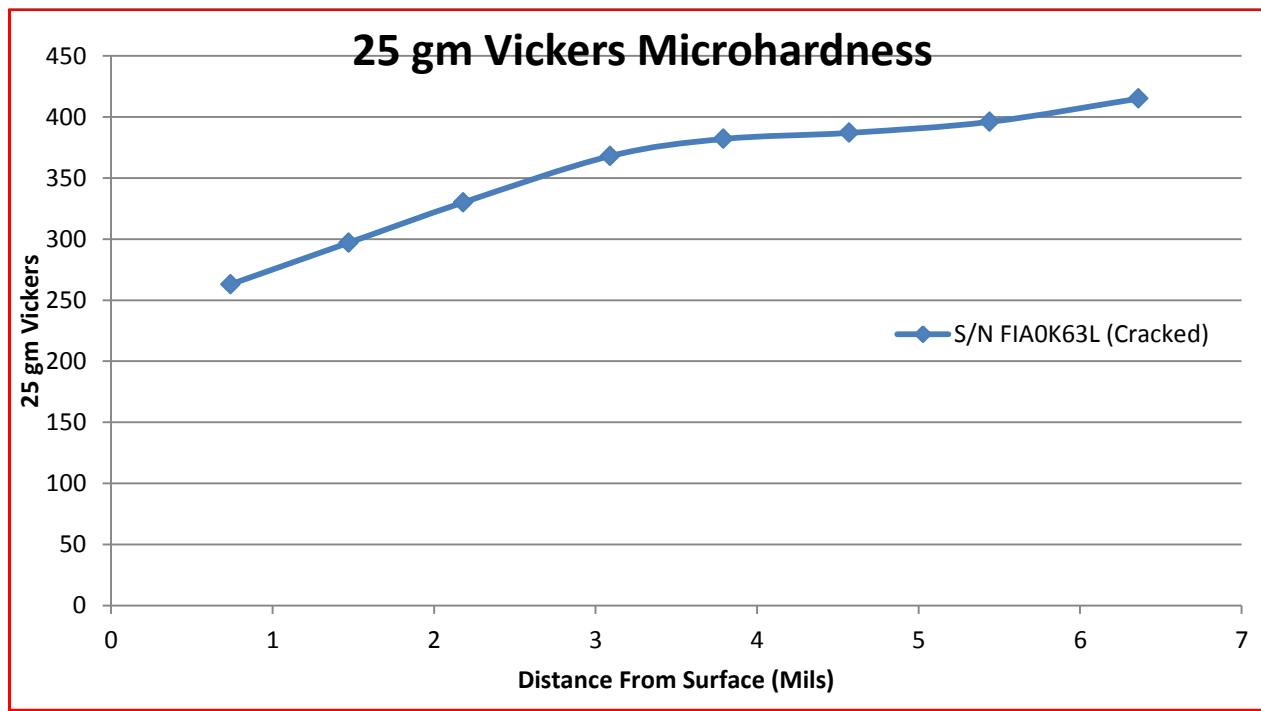
**FIGURE 2: NEAR SURFACE MICROHARDNESS MEASUREMENTS NEAR AXIAL CRACK LOCATION**  
(Graph Courtesy of GE-Aviation)
