Flight path management occurrence involving Boeing 737-838, VH-VYE

213 km SSE of Brisbane Airport, Queensland | 25 February 2013

ATSB Transport Safety Report
Aviation Occurrence Investigation
AO-2013-049
Final – 27 April 2015

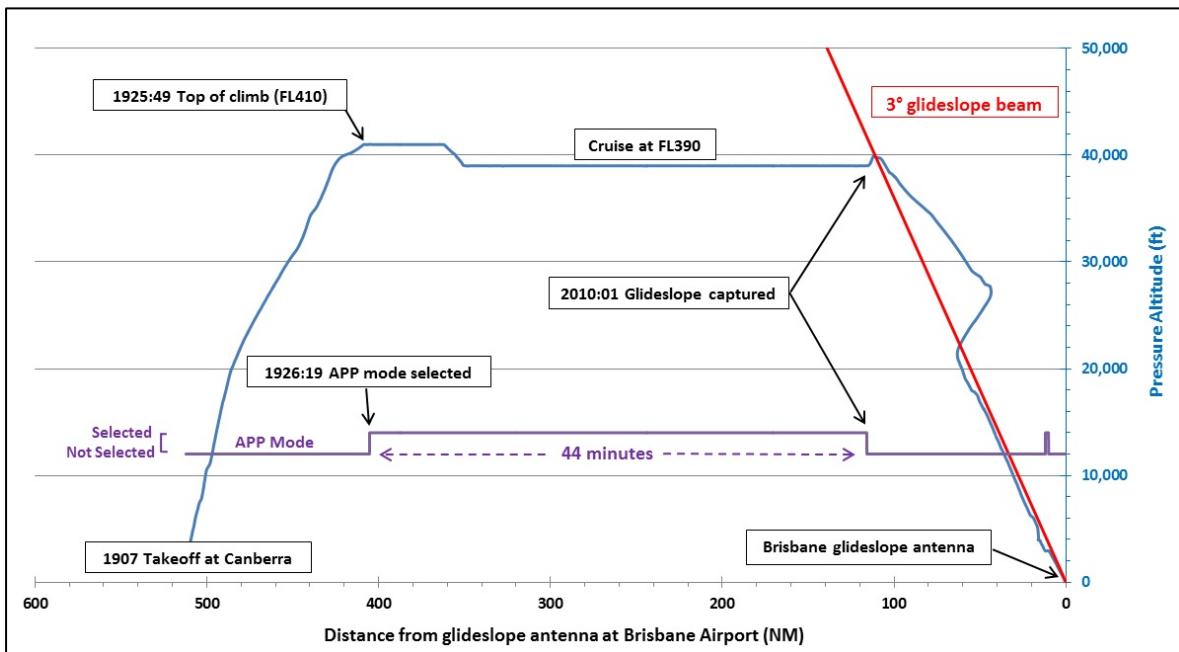
Figure 1: Aircraft's recorded vertical flight path and key events

At 2109:22, ATC advised the crew that 'when ready' they could descend to the cleared altitude of FL 300. The crew changed the MCP-assigned altitude indicator to the assigned altitude of FL 300. At this stage the captain was still completing their meal and the FO was the pilot flying. At 2110:01, which was about 44 minutes after the APP P/B was inadvertently selected and before the crew initiated their descent from FL 390, the aircraft's navigation system captured the glideslope signal (Figure 1). The signal caused the aircraft's auto-flight system to climb the aircraft in an attempt to intercept and track the glideslope beam, and the aircraft started climbing at 2110:07.

At the time of the glideslope capture, the aircraft was about 115 NM (213 km) south of the Brisbane glideslope transmitter and 29 NM (54 km) to the right of the localiser beam⁵ (runway centre-line). The localiser signal was sensed but the aircraft was outside the localiser capture criteria and it was not captured. The calculated altitude for an aircraft to be considered 'on slope' at that distance from Brisbane was about FL 488. Due to atmospheric refraction of the glideslope beam the actual 'on slope' altitude was FL 398 (Figure 1).

The flight crew were surprised by the aircraft's climb. The FO reported that they initially looked at the MCP and attempted to change the vertical mode. At 2110:33, 26 seconds after the climb commenced, the FO disengaged the autopilot to control the climb and soon after started manually descending the aircraft to the cleared altitude of FL 300.

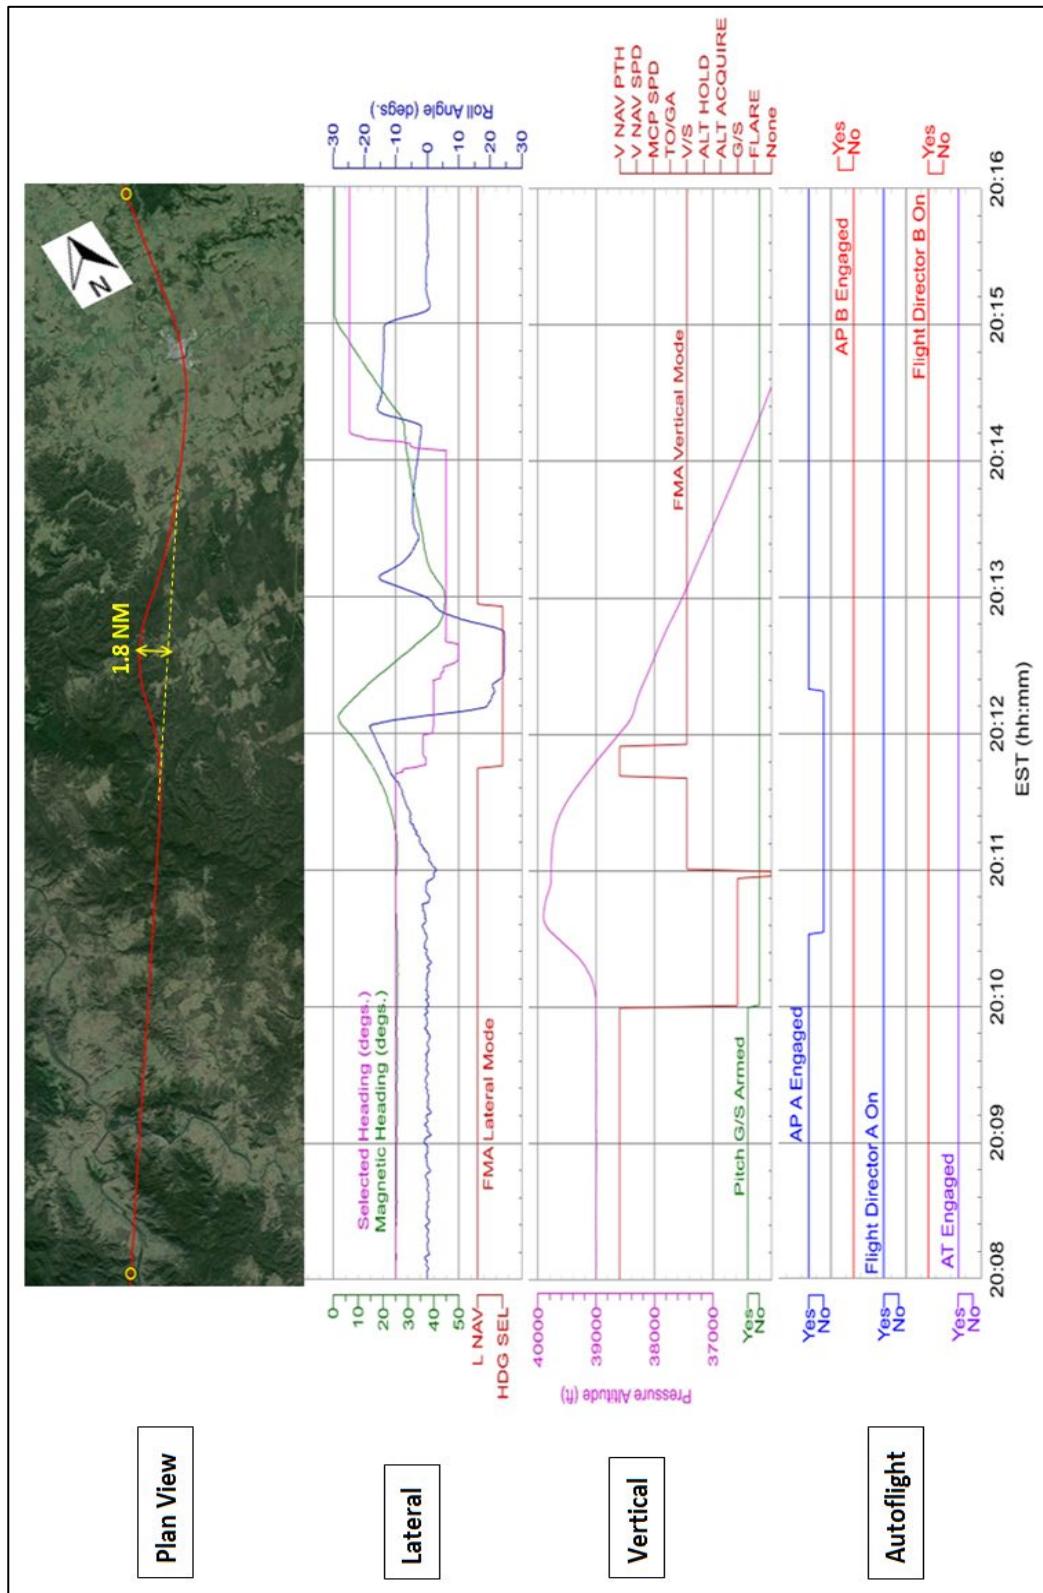
Figure 2: Recorded aircraft track and vertical and lateral data

The crew later reported that they thought they had re-engaged the autopilot during the descent to FL 390, but recorded data showed that was not the case. At about 2111:10, when approaching FL 397, the aircraft gradually banked left due to a small residual left rudder deflection, which was previously compensated for by the autopilot following the completion of the climb from Canberra.

The crew identified that the aircraft was deviating left of the intended track displayed on the aircraft's navigation display and at 2111:46 the FO changed the lateral mode to heading select (HDG SEL) and changed the selected heading to 036°. However, the aircraft continued to roll left as the autopilot had (unknowingly) not been re-engaged. At 2111:56 the captain advised ATC that they were leaving FL 390 but that they now had a lateral navigation problem.

At 2112:01 the selected heading was changed to 040°. At about this time the crew realised that the autopilot was not engaged and at 2112:03 the first officer manually commenced a right turn back towards the flight-planned track. The maximum deviation from the flight plan track was about 1.8 NM (3 km). The recorded aircraft track and vertical and lateral data is shown at Figure 2.

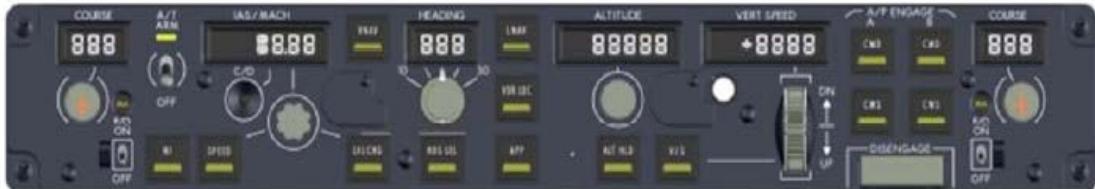
Figure 3 – Rockwell Collins MCP as installed in VH-VYE

The MCP's fitted to the Qantas B737 fleet were manufactured by Honeywell or Rockwell Collins. The MCP fitted to VH-VYE was manufactured by Rockwell Collins (Figure 3). Although similar in layout to the Honeywell unit, there are some differences in the Rockwell Collins unit in the way information is displayed to the flight crew, the push-button design and the illumination of the selected push-button.

The selection of the APP push-button required a distinct application of force. Inadvertent activation of push-buttons can be minimised through increasing the force required to activate them, increasing separation from other controls, introducing protective covers or requiring multiple actions for activation. However, given that this type of occurrence has not been reported before, and was considered unlikely to lead to a hazardous situation, changes to the MCP design were not required.
