Air Accident Investigation Sector

- Final Report -

AAIS Case N° AIFN/0014/2013

Carriage of Cargo on an Aircraft (Dangerous Goods Onboard Passenger Aircraft)

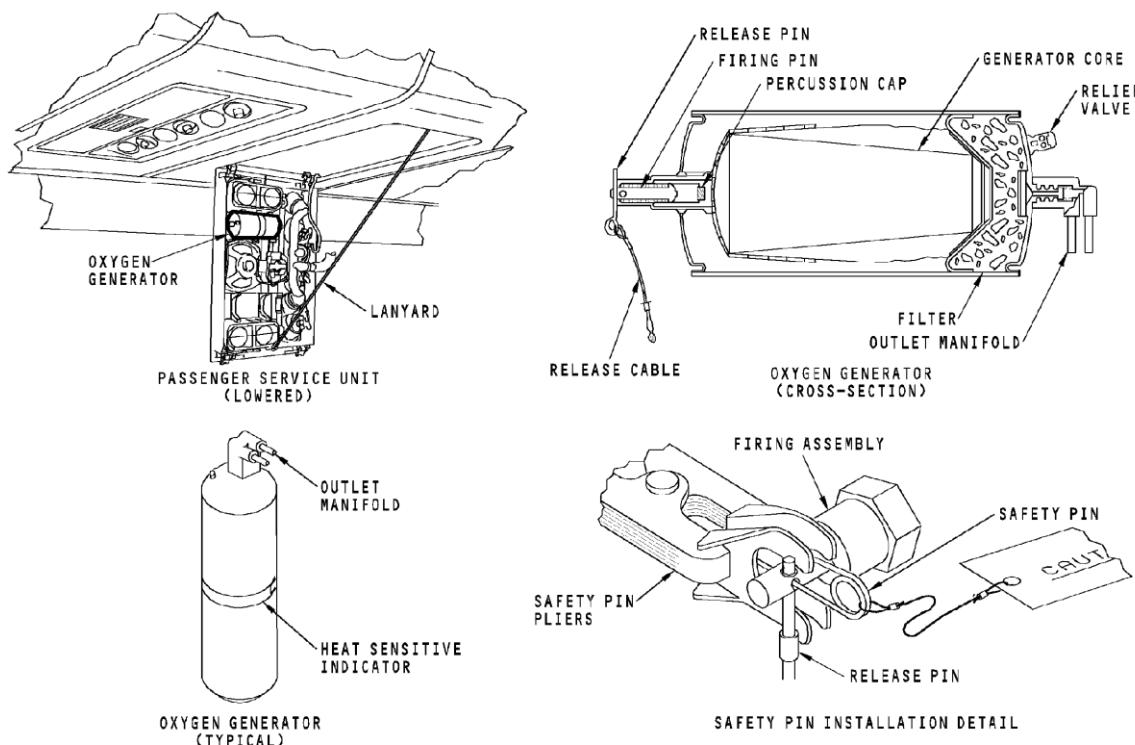
Figure 1. General arrangement of oxygen generator

When a passenger pulls the mask down, this action causes a pin to be released from the firing mechanism of the oxygen generator, resulting in ignition of an explosive charge, which activates chemicals contained in the generator causing oxygen to be produced. The resultant exothermic reaction produces heat as a byproduct, and the outside temperature of the oxygen generator canister can reach 450 degrees Fahrenheit (232 degrees Centigrade). In addition to activation by release of the generator firing pin, the reaction may commence due to exposure of the generator to high temperatures. Once the oxygen producing chemical reaction commences it cannot be stopped.

The oxygen generators installed in the PSU assemblies were designed to produce oxygen for at least 12 minutes. The gaseous oxygen passes through a filter medium and then flows out of the output manifold. The output manifold ports are connected to the passenger oxygen masks by flexible tubing. A pressure relief valve prevents over-pressurization of the generator.
