Serious incident to the drone⁽¹⁾ DJI - Inspire 2 on 14 July 2019 at Barcarès (Pyrénées-Orientales)

Time	Around 00:40 ⁽²⁾
Operator	Fly Art Prod
Type of flight	Aerial photography
Persons on board	0
Consequences and damage	3 people on ground injured, drone damaged

Collision with an obstacle, uncontrolled descent, collision with people on the ground, during an aerial photography flight

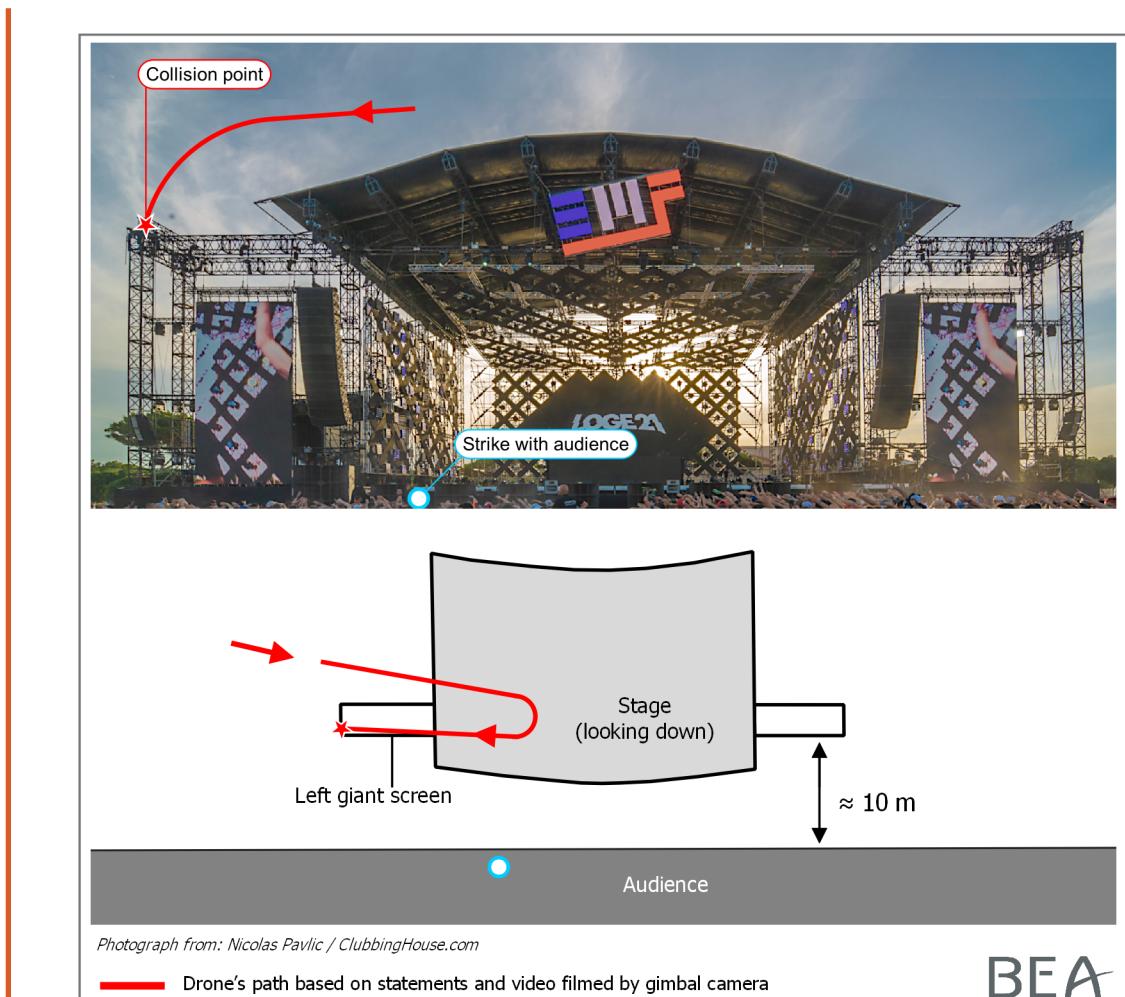
Figure 1: Drone's path

The drone carried out to-and-fro movements between the left side and overhead the stage. During the fourth to-and-fro movement, on flying back towards the drone pilot, the drone quickly lost altitude and collided with a vertical structure on the left side of the stage (see [Figure 1](#)). It then progressively descended towards the festival-goers in front of the stage, before striking several people and creating panic in the crowd. A festival-goer then threw it onto the ground which brought the drone to a halt.

Travel stops at 0:28⁽⁴⁾ when the drone had flown over around one third of the stage. From 0:28 to 0:32, the drone starts returning to the left side of the stage without changing altitude. From 0:32, it continues its return, descending quickly. At 00:43, the drone strikes the top of a vertical structure on the left side of the stage.

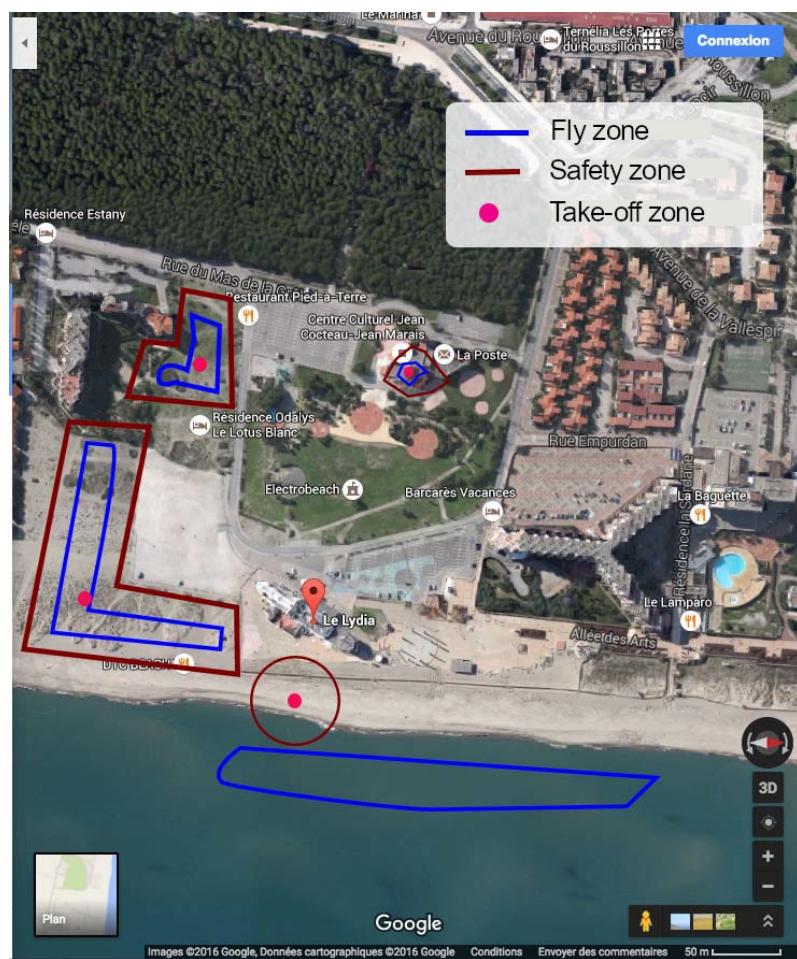
Figure 2: Map sent to prefecture

The manager of Fly Art Prod had sent a flight request file (flights not limited in number) to the Pyrénées-Orientales prefecture which had approved it. The file included a map on which four flight sites were shown (see [Figure 2](#)).

⁽⁷⁾ The map, produced using a Google Maps satellite view indicated the date 2016. However, it was inexact as the holiday residence was already being built and was visible on photos taken in 2014.

This map did not show the position of the stages and the various areas assigned to the festival's audience.

Neither did it show the holiday residence on the site shown with a reverse letter L⁽⁷⁾. On arriving at Barcarès, the company manager and the drone pilot decided to carry out certain flights from a children's playground, situated close to the holiday residence (see [Figure 3](#)). The playground was closed to the public.

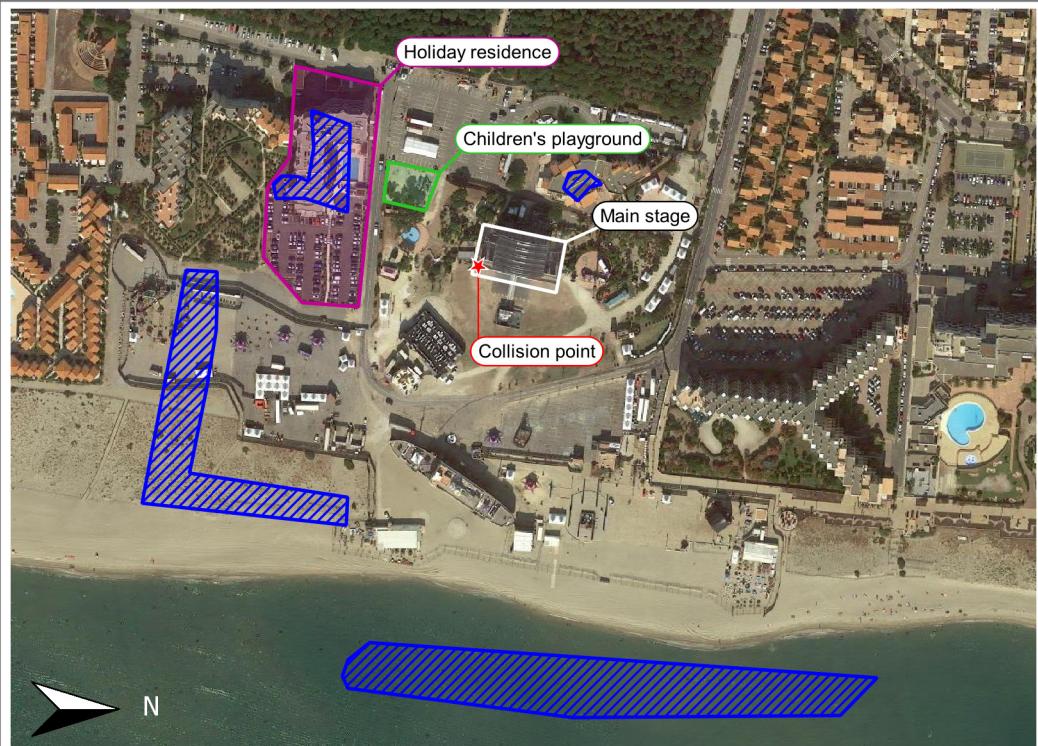
Figure 3: Position of zones, stage and children's playground

No flight site over the children's playground or main stage had therefore been declared.

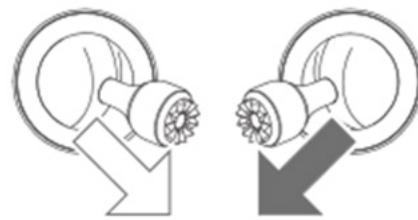
After the drone struck the top of a vertical structure on the left side of the stage, the cameraman asked the drone pilot to shut down the motors. The latter then pushed the two joysticks of his remote controller as shown below:

According to the user manual, this action corresponds to starting the motors. The motors were not therefore shut down.

If the drone was controllable, the drone pilot's action to cut off the motors would have resulted in:

- making the drone descend;
- the drone yawing to the right (clockwise direction);
- making it back up leftwards.

To shut down the motors in flight, the drone pilot had two possibilities:

- use his remote controller to carry out the procedure described in the user manual: *"Pull the left stick to the bottom inside corners and press the RTH button at the same time."*
- use his separate control to activate the system associating the power cut-off and twin parachute.
