Abnormal Runway Contact (ARC)

Serious Incident Investigation Final Report

**Boeing 747-47UF
Hong Kong International Airport
Hong Kong
30 August 2018**

03-2020

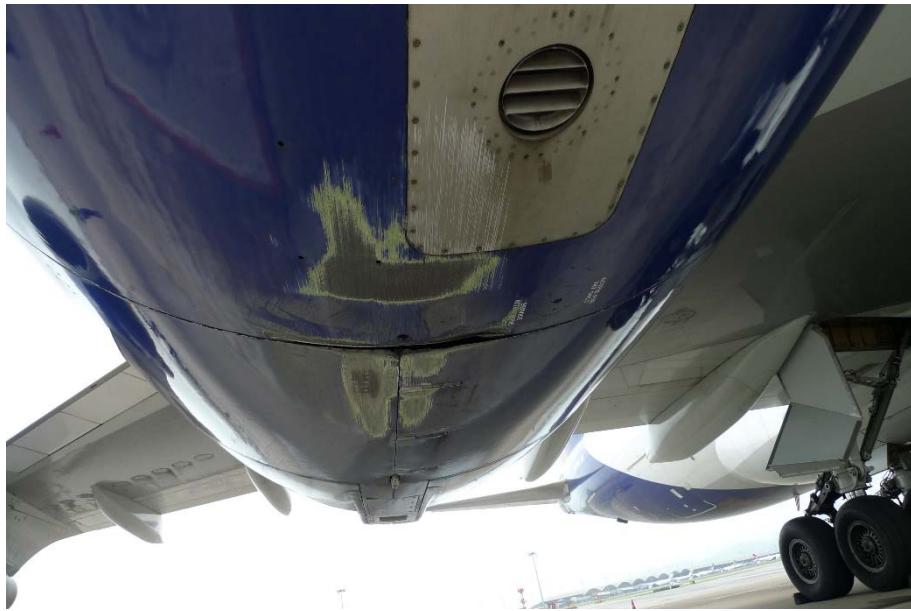
Photo 1: Damage at the Underside of No.3 Engine

The underside of the inlet cow, fan cowl, and reverser translating cowl of No.3 and No.4 engines sustained scrapping and abrasion damage. The drain masts of both engines suffered heavy abrasion damage. The damaged parts on No.3 engine and No.4 engine were replaced.

The damage to the underside of the inlet cowl, fan cowl and translating cowl of No.3 and No.4 engines was due to the combined effects of a sharp right yaw and significant right roll corresponding to the exaggerated inputs made by the PF.

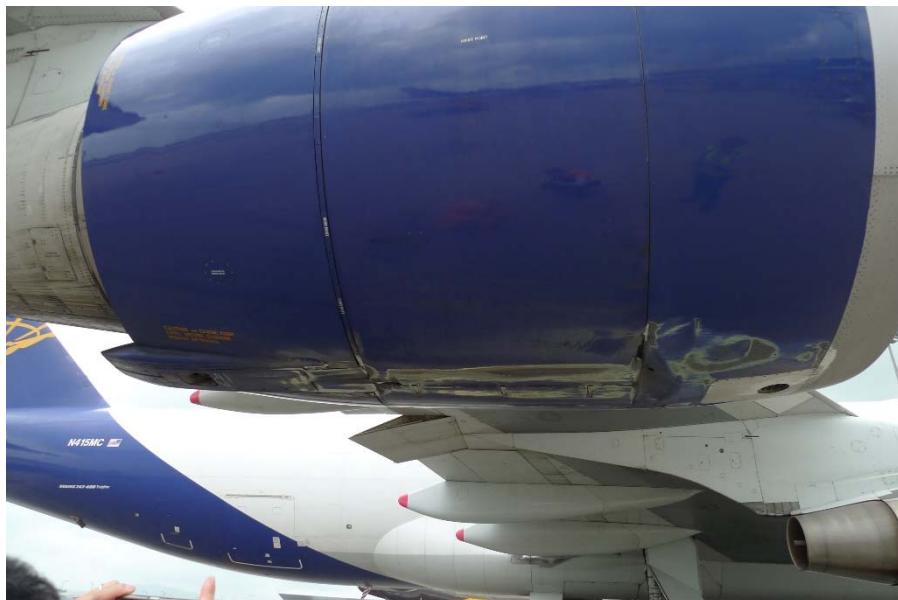
Photo 2: Damage at the Underside of No.4 Engine

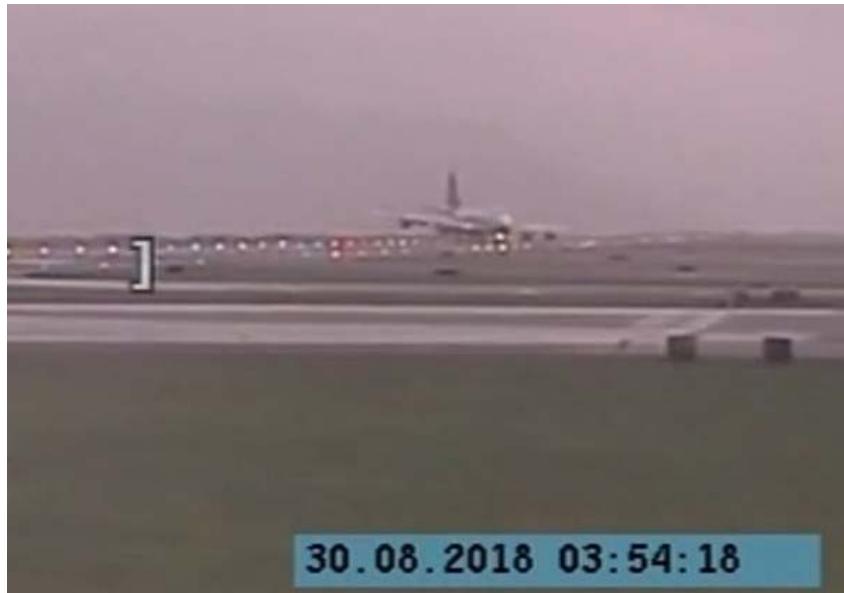
Photo 3: Aircraft Banking to the Left (Looking from 07L Direction)

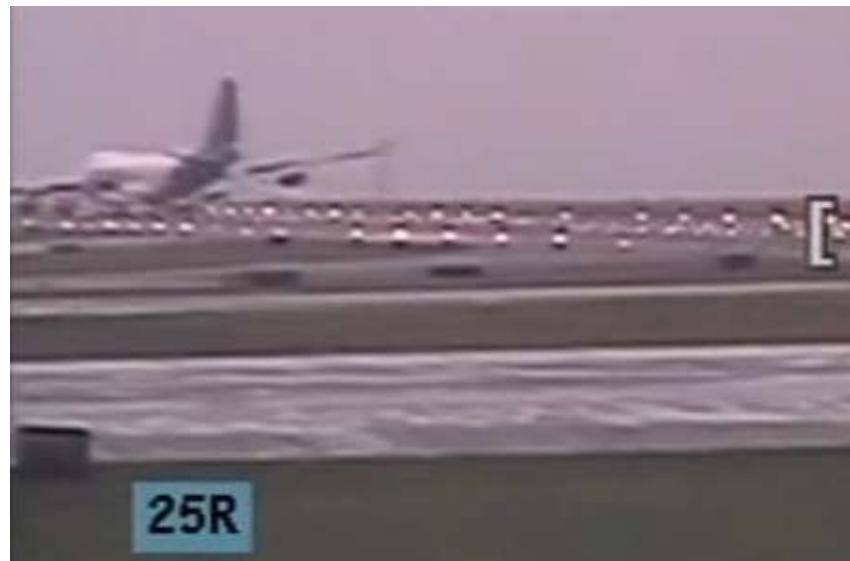
Photo 4: Aircraft Banking to the Left (Looking from 25R Direction)

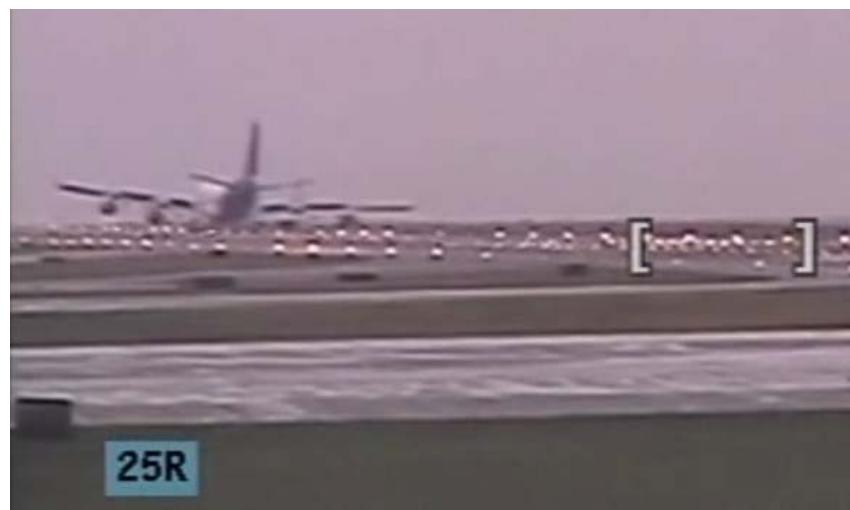
Photo 5: Aircraft Banking to the Right (Looking from 25R Direction)

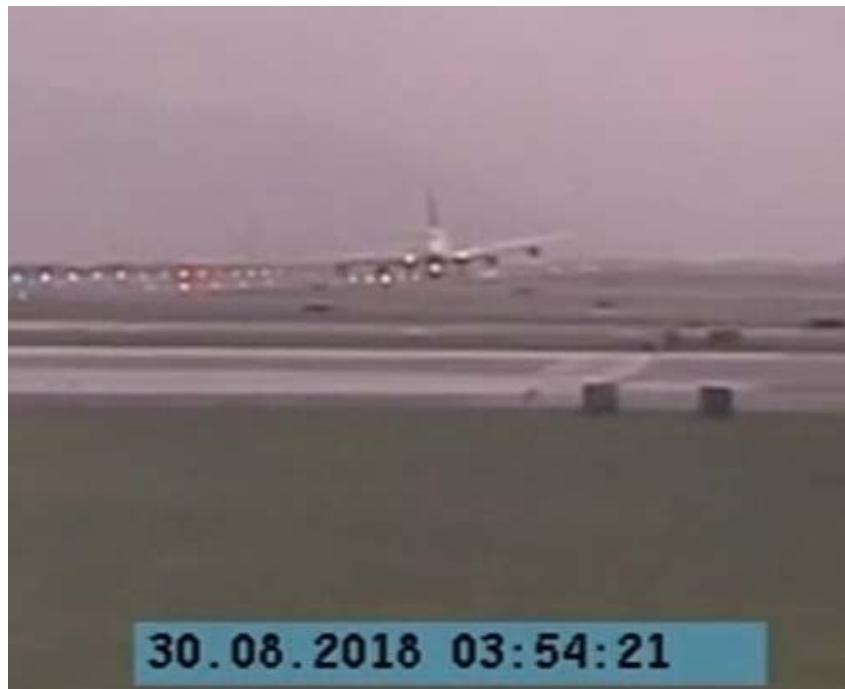
Photo 6: Aircraft Banking to the Right (Looking from 07L Direction)

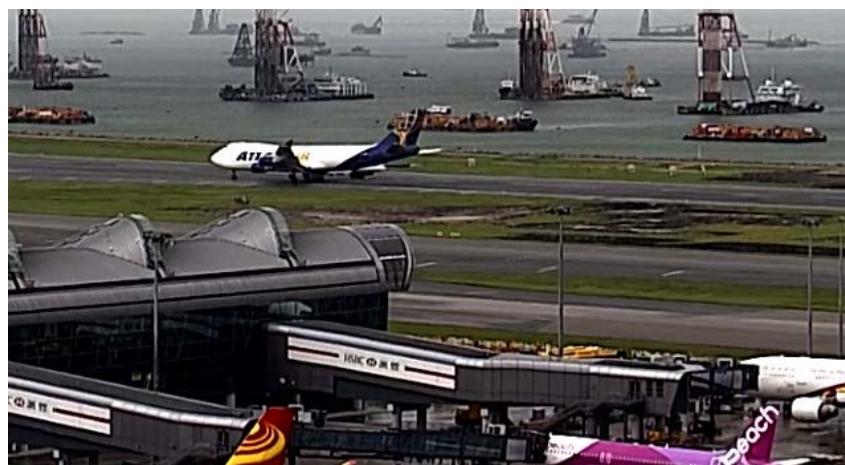
Photo 7: Veering to the Right, Left Wing High (Looking from 25R Direction)

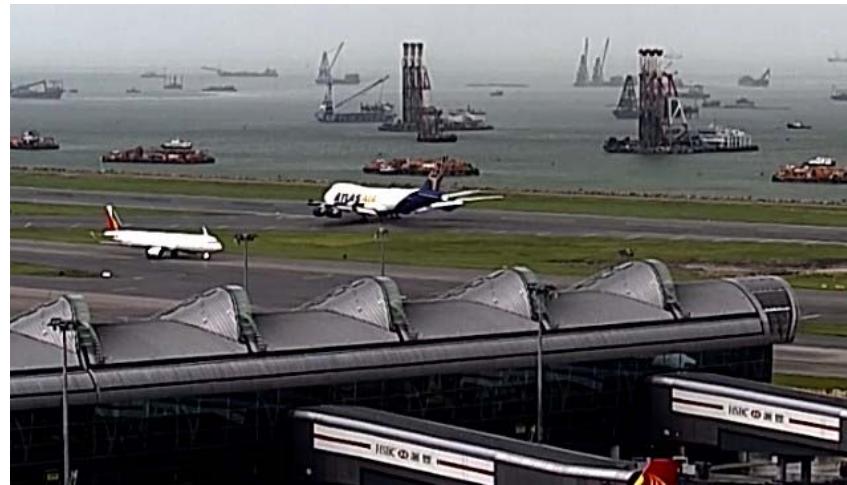
Photo 8: Aircraft Returning to Normal Attitude (Looking from 25R Direction)

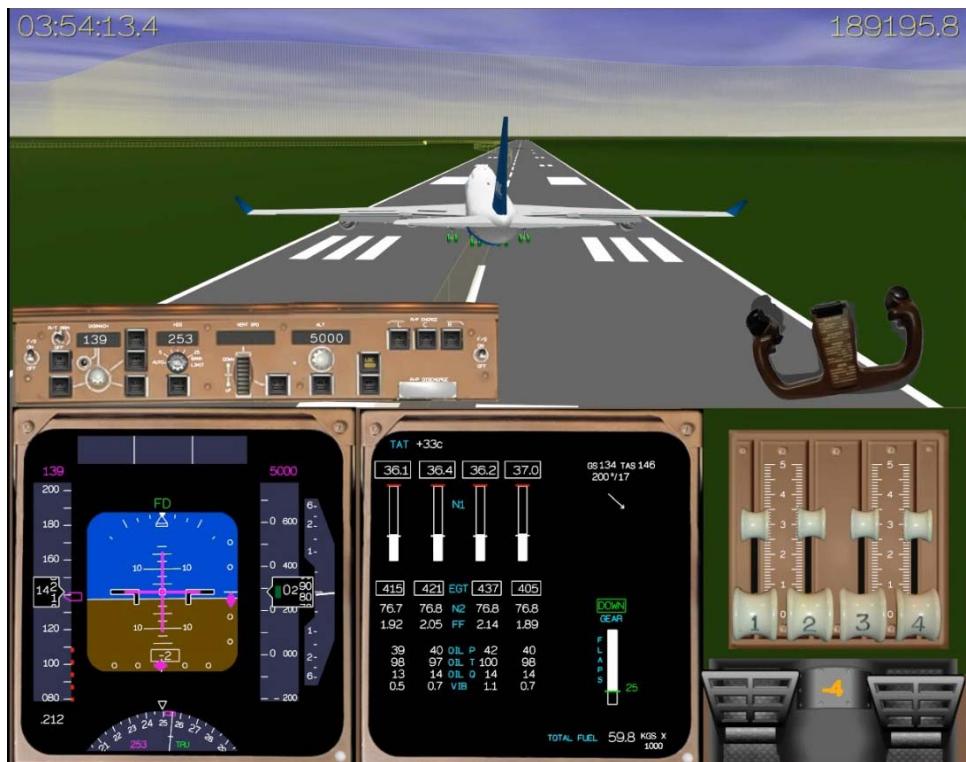
Figure 1: Aircraft in a Crab at Touchdown

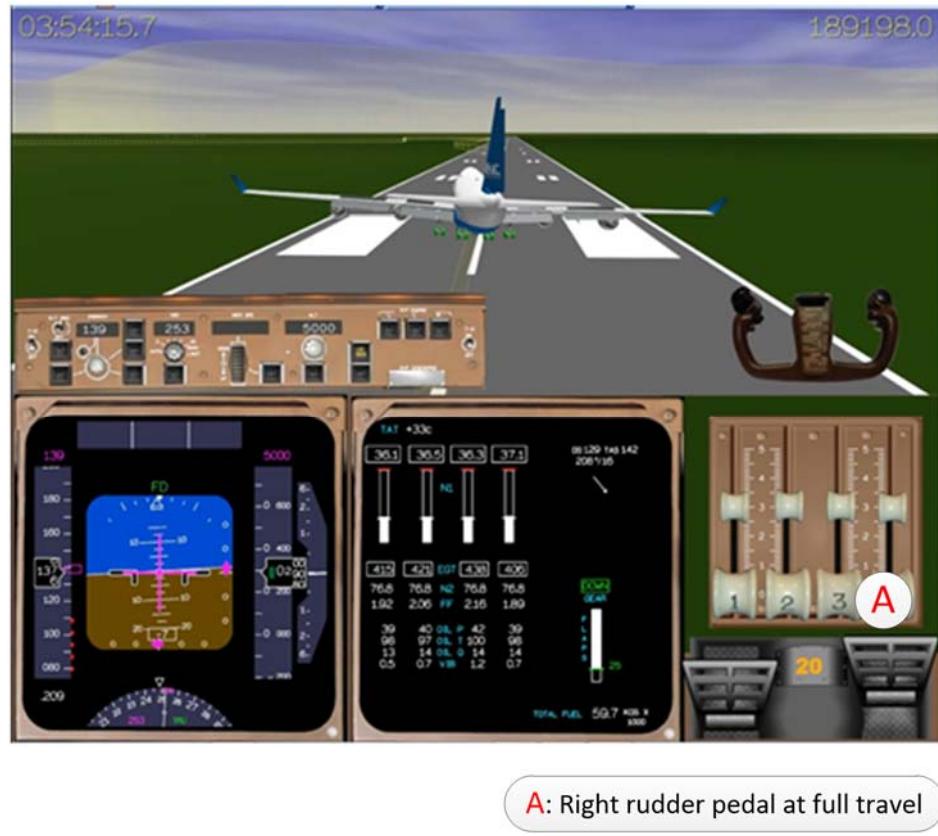
A: Right rudder pedal at full travel

Figure 2: Full Right Rudder Applied

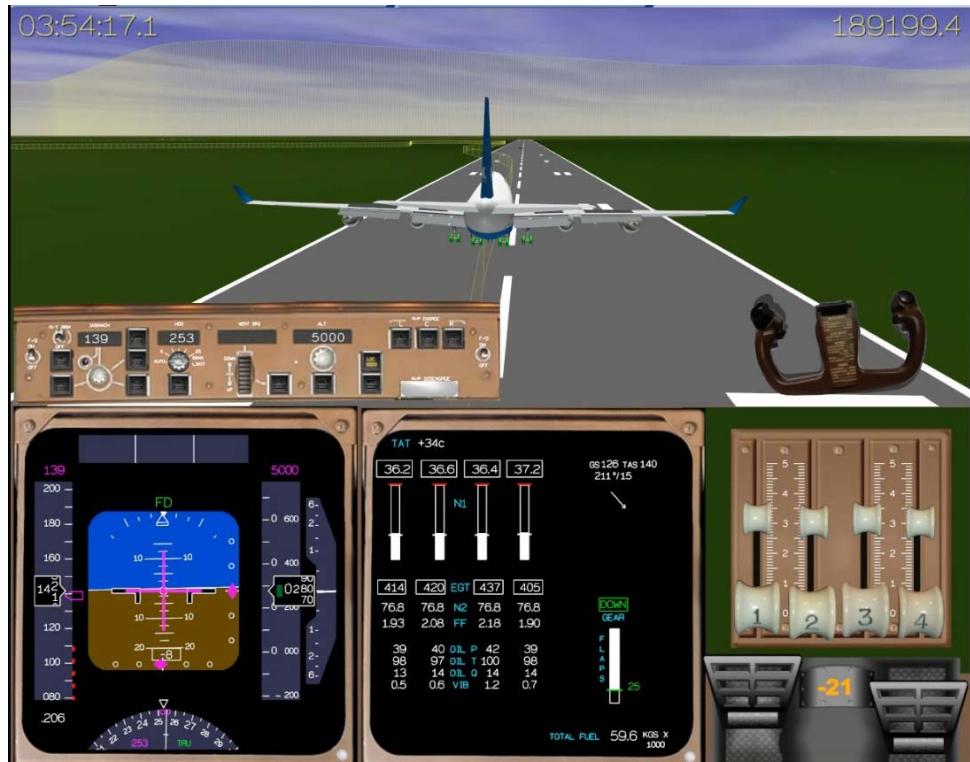
Figure 3: Full Left Rudder Applied

Figure 3 showed that the aircraft was on the centreline with ailerons neutral and full left rudder applied.

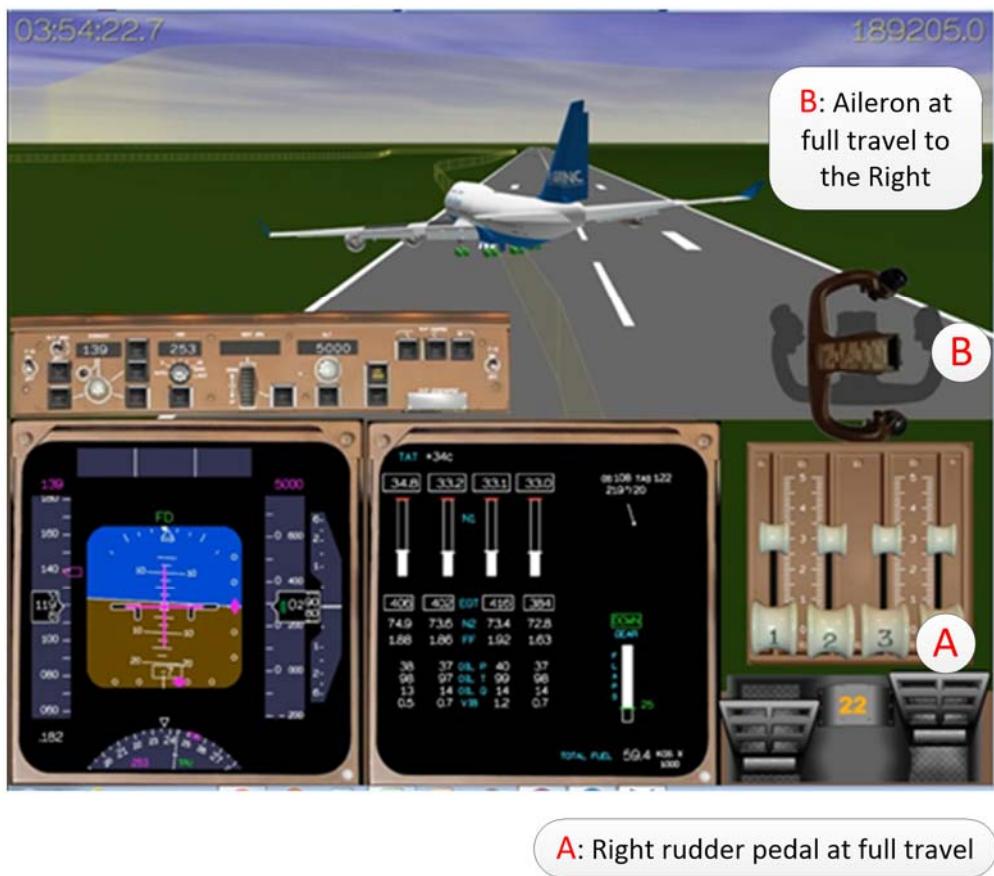
Figure 4: Full Right Aileron Applied

The aircraft was at approximately 30 degrees to the left of the centreline with the control column at full right deflection and full right rudder applied.

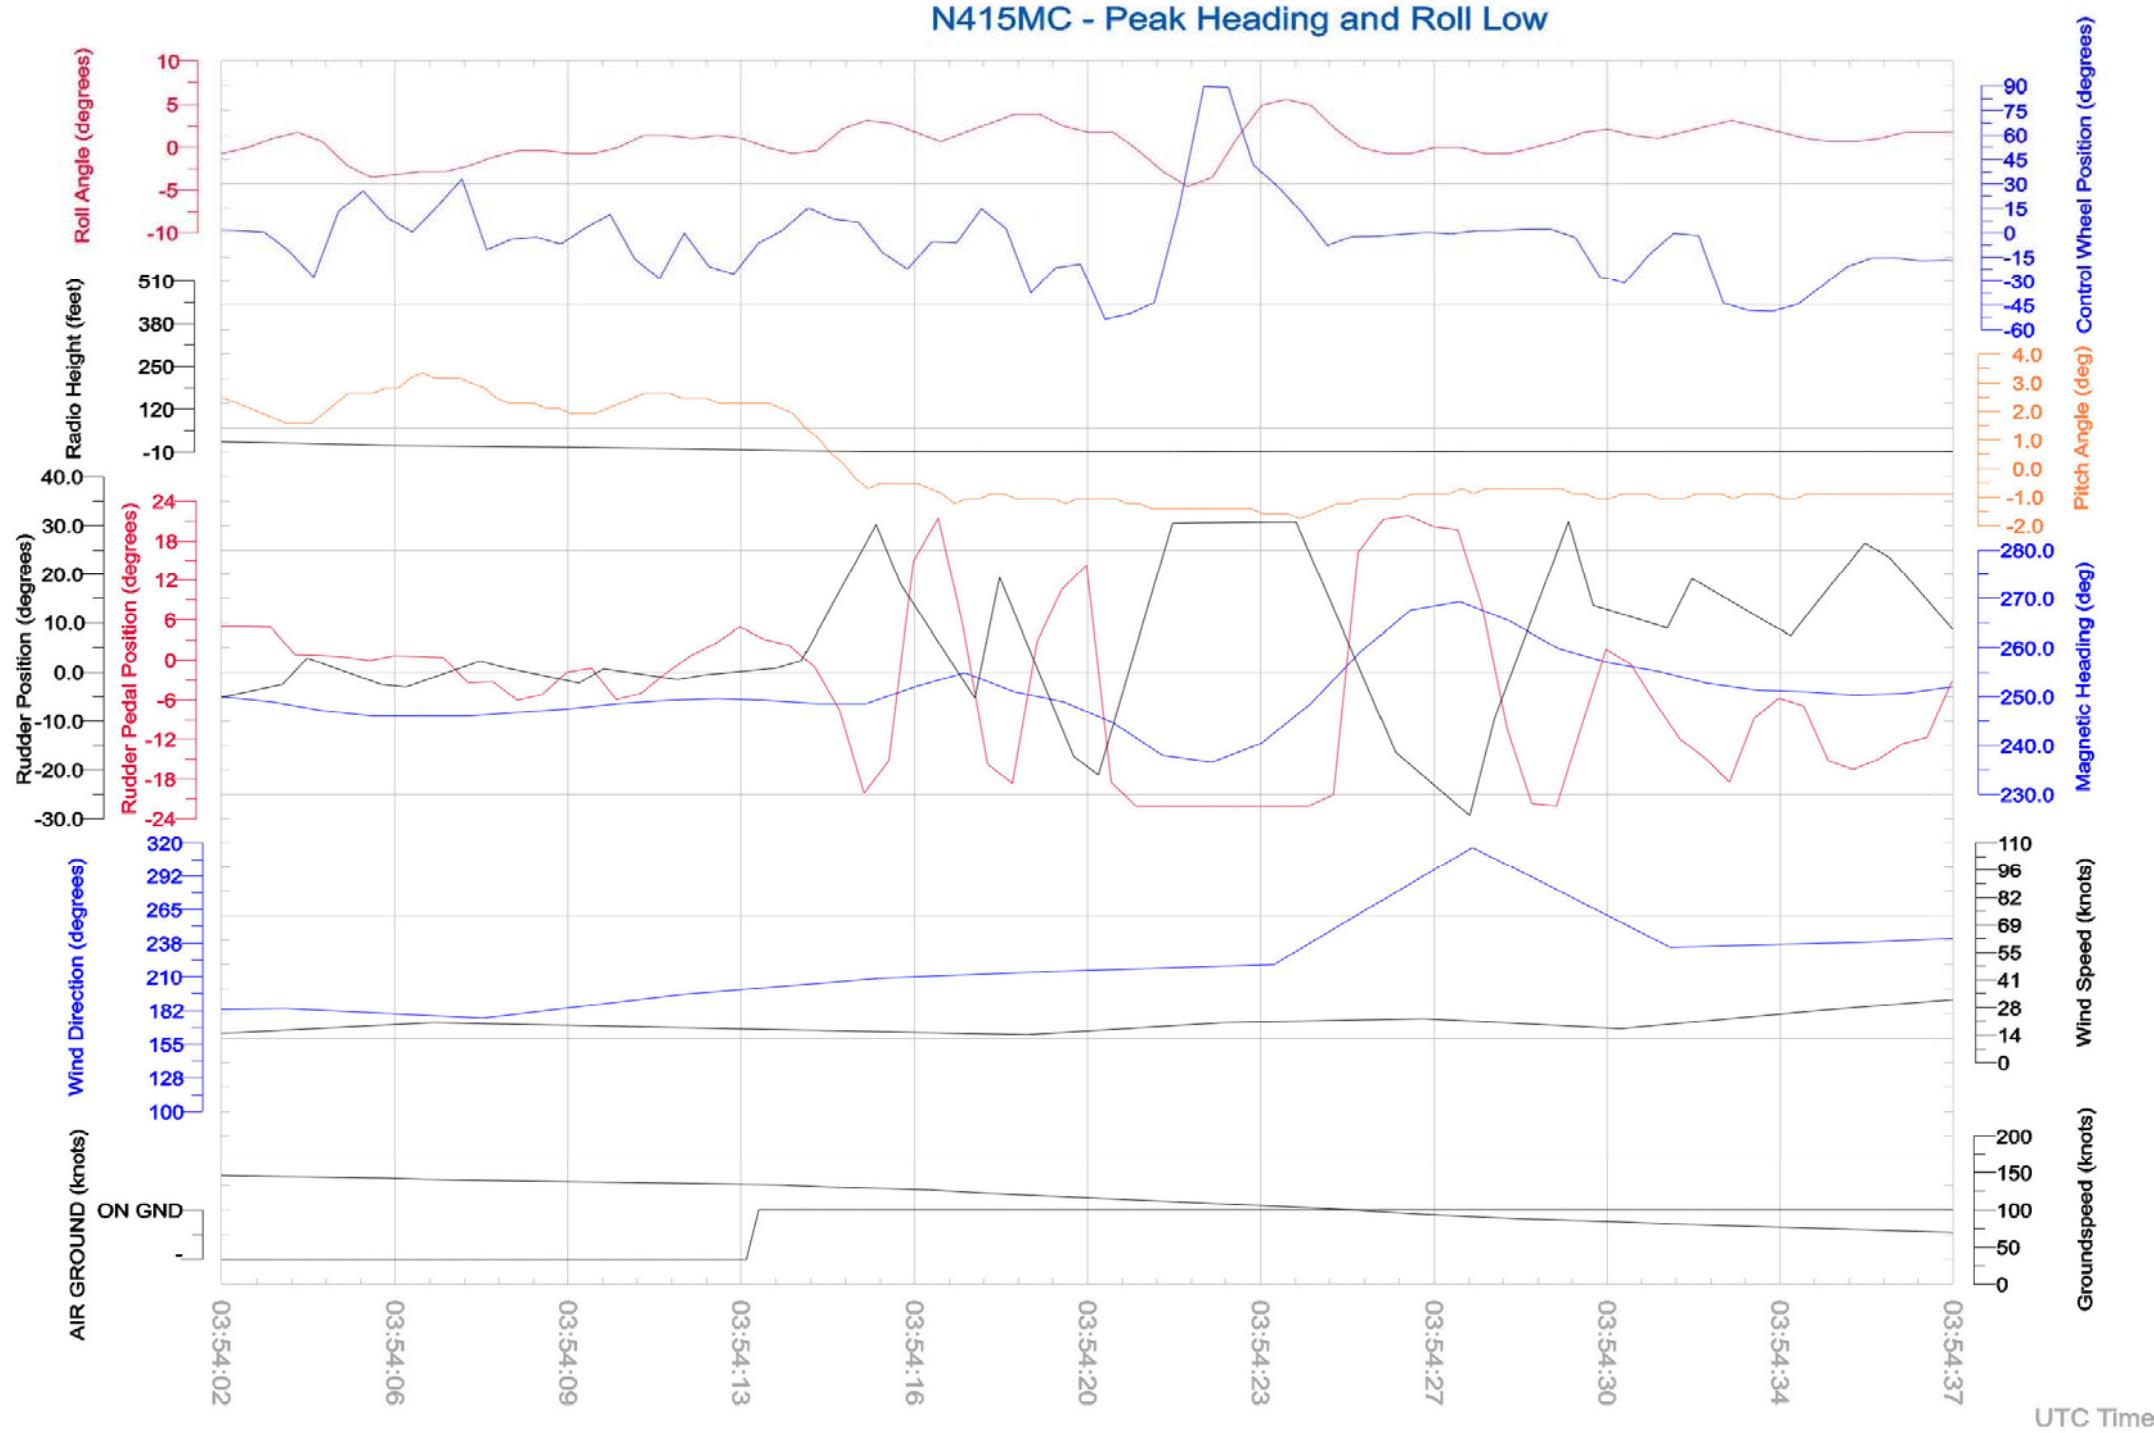
A time history of relevant FDR parameters for the final approach and landing roll is shown in Appendix 9.1. It can be seen that, up to about 10 seconds before touchdown, the recorded

wind direction was generally from the south (actual direction about 200°), with a wind speed that varied from about 17 to 20 knots.

The descent rate was maintained primarily at an average of around 900 feet/minute (fpm) until just prior to flare initiation, with a momentary excursion to 330 fpm and 1320 fpm at 450 feet radio altitude. The aircraft was crabbed (negative drift) into the left crosswind with an angle of about 7 degrees during the approach.

Figure 5: Flight Data Plot of Selected Parameters
