**Republika e Kosovës
Republika Kosova-Republic of Kosovo
Qeveria – Vlada-Government
Zyra e Kryeministrit – Ured Premijera –Office of the Prime Minister**

**Komisioni për Hetimin e Aksidenteve dhe Incidenteve Aeronautike
/Vazduhoplovna Komisija za Istraživanje Nesreća i
Incidenata/Aeronautical Accidents and Incidents Investigation
Commission**

**Report on Serious Incident of aircraft Boeing B737-800, TC-JFY at
the International Airport of Pristina “Adem Jashari”, on 2 May 2016**

Investigation Report no:	ZKM KHAIA 001 / R
Type of Occurrence:	Serious Incident
Date:	2 May 2016
Location:	Pristina International Airport Adem Jashari
Aircraft:	Fixed Wing
Manufacturer / Model:	The Boeing Company/B737 - 800
Registration:	TC-JFY
Injuries to Persons:	No injuries
Damage:	Minor damage to Aircraft
Other Damage:	None

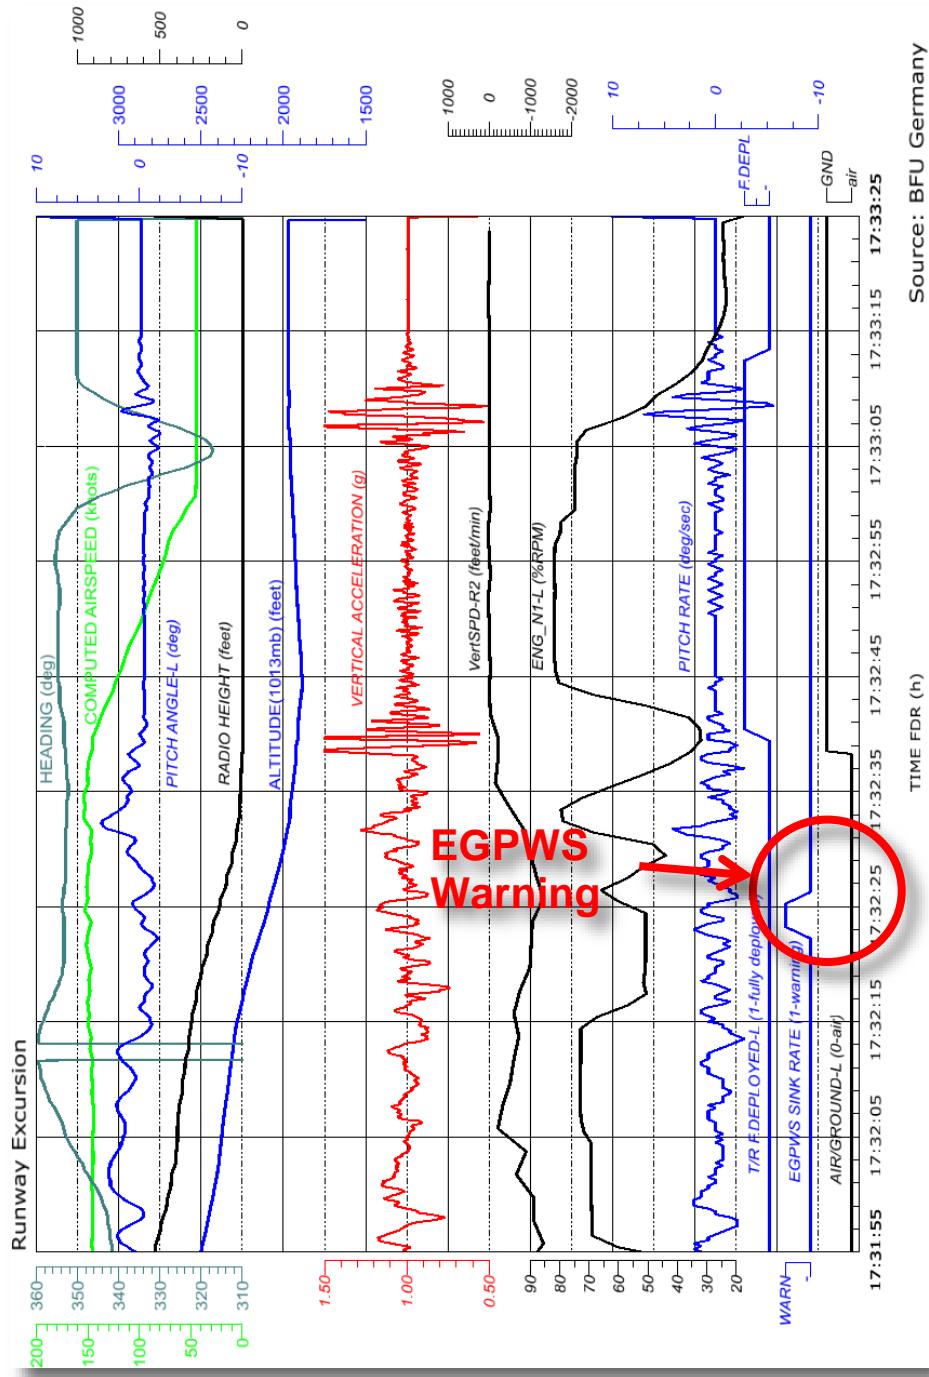
This image shows the approach phase where the EGPWS Sink Rate Warning was activated. The vertical speed and pitch attitude was thereafter significantly reduced.

Image 3: FDR parameters of the approach phase

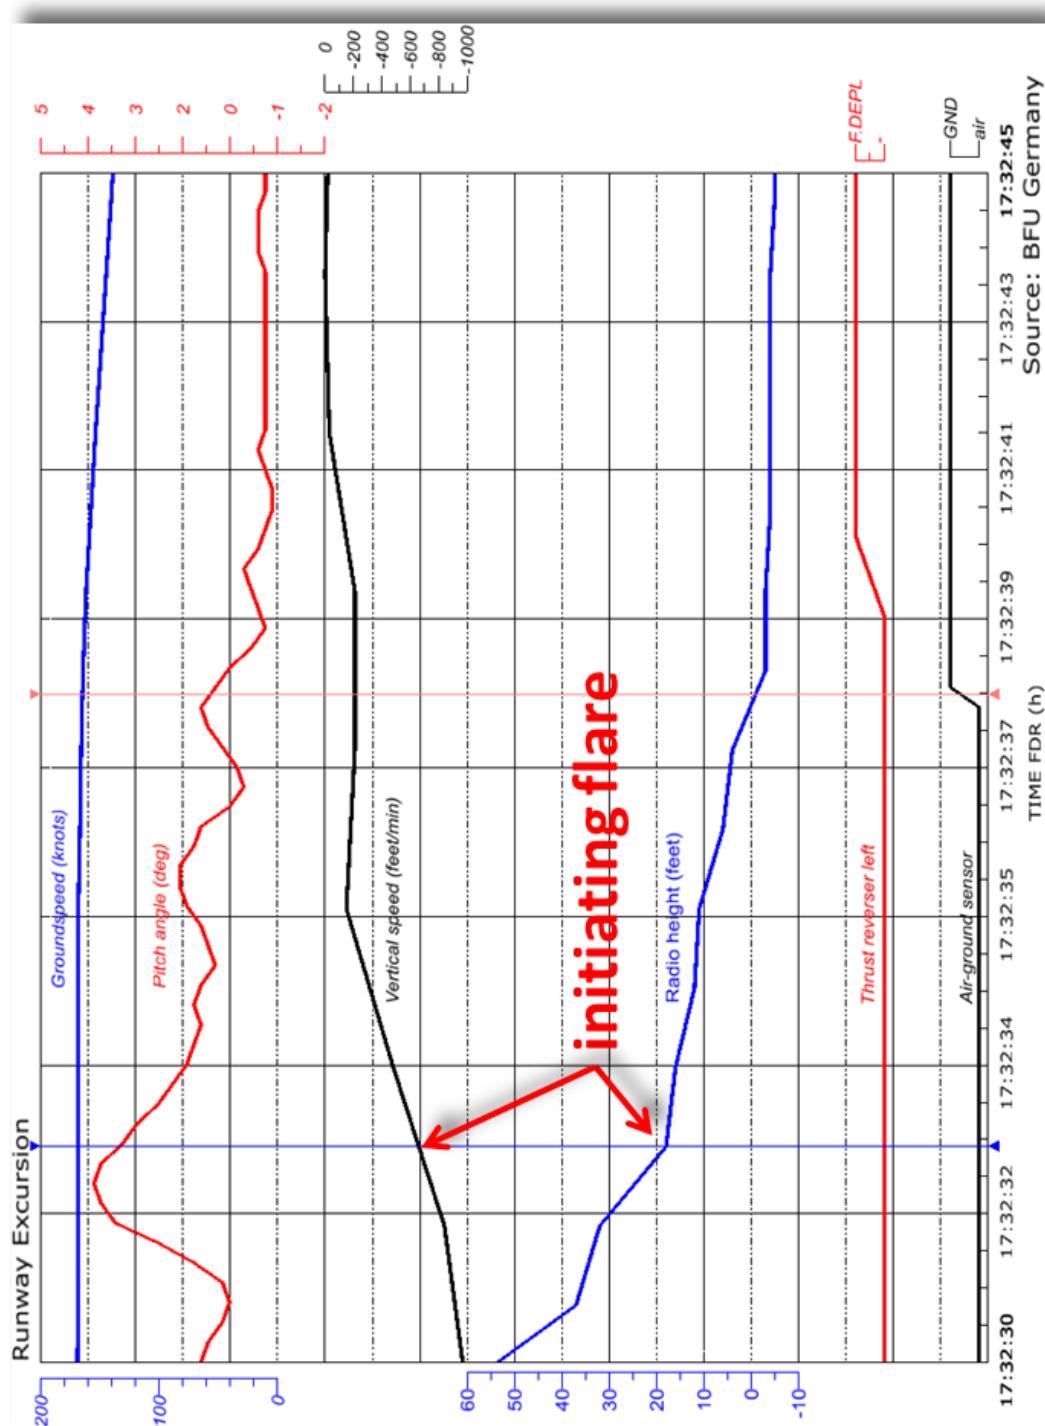
The Image shows the initiated landing flare. Parameters such as Radio Height, Vertical Speed and Pitch angle were analyzed the landing flare.

Image 6: FDR parameters of the landing flare

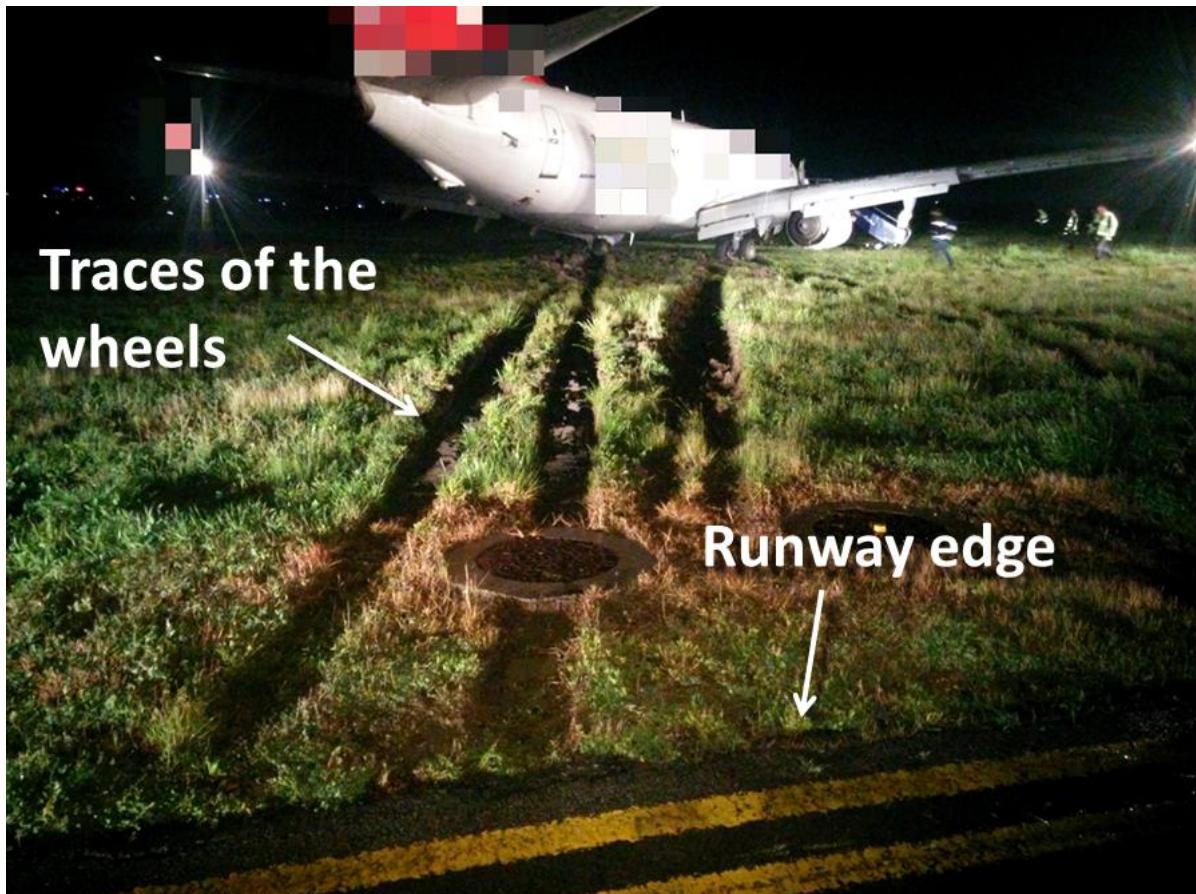
The aircraft veered left off the runway between the end of the runway and taxiway C and came to a full stop in the adjoining grass approximately 36 m left of the runway.

Image 7: Overview where the aircraft had veered off the runway

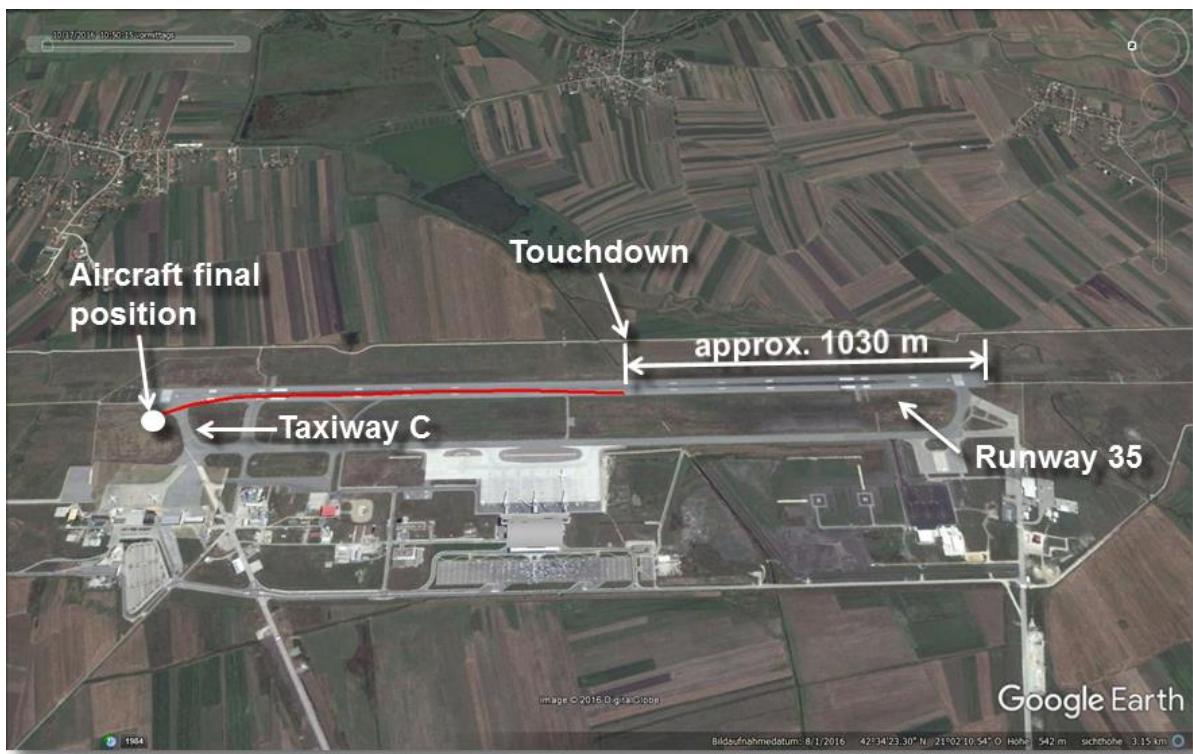
- Thrust-Reverse was canceled as the aircraft left the paved runway surface
- At the point when the aircraft left the runway, the taxi speed was approx. 50 kt

Image 8: Overview of the ground roll path

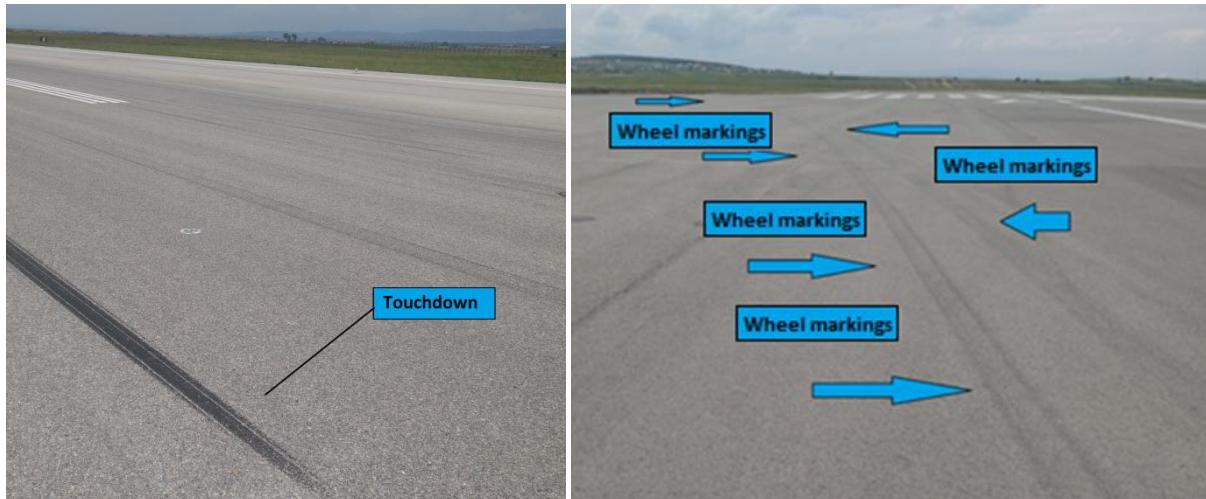
Approximately 1 030 m beyond the threshold of runway 35 wheel markings of the right main landing gear were found on the middle runway edge marking. Wheel markings were also found on taxiway C before the aircraft veered off.

Image 9 & 10: Wheel markings on the runway

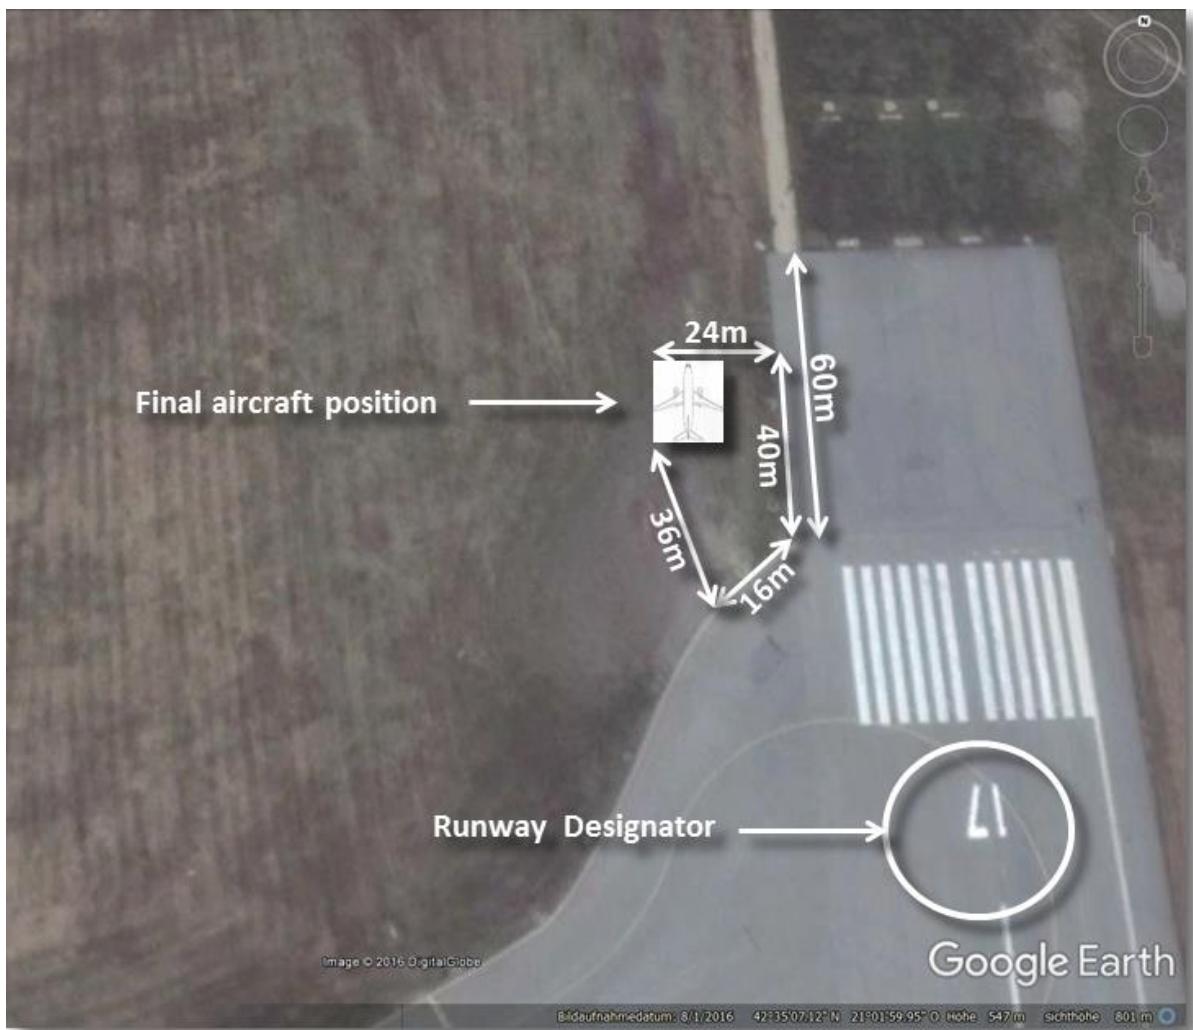
Image 11: Sketch of the final aircraft position

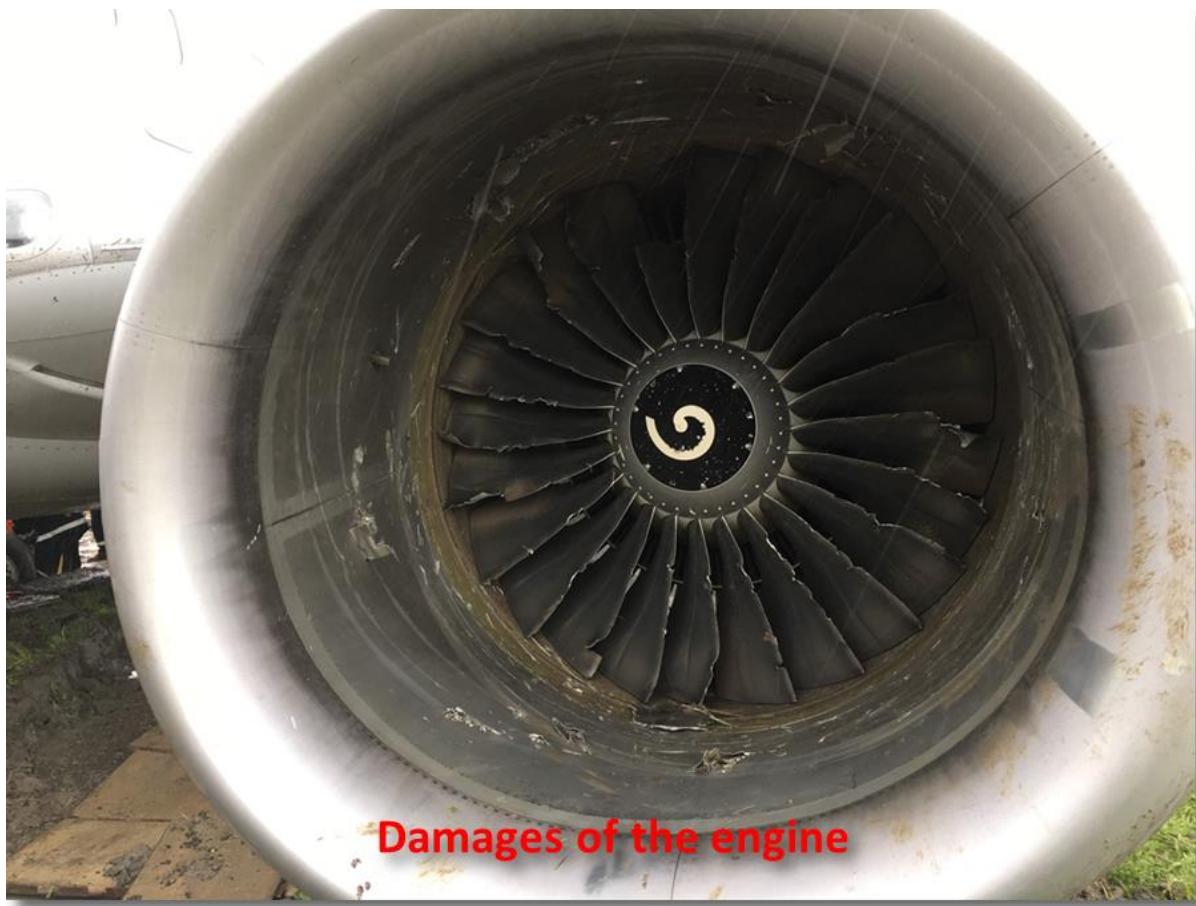
Image 12: Damages on engine no.1

The airplane's left engine was slightly damaged. Due to the runway excursion, the wheels sank into the mud and wet grass beside the taxiway. The left engine had ground contact and was damaged.

Engine No.1:	damages at the Nacelles
	damages of the LH & RH Thrust Reverser
	damages of the LH & RH Fan Cowl and the inlet cowling
	damages of the Bleed Air Cooler

Because of the damage, the engine was replaced by the maintenance organization.

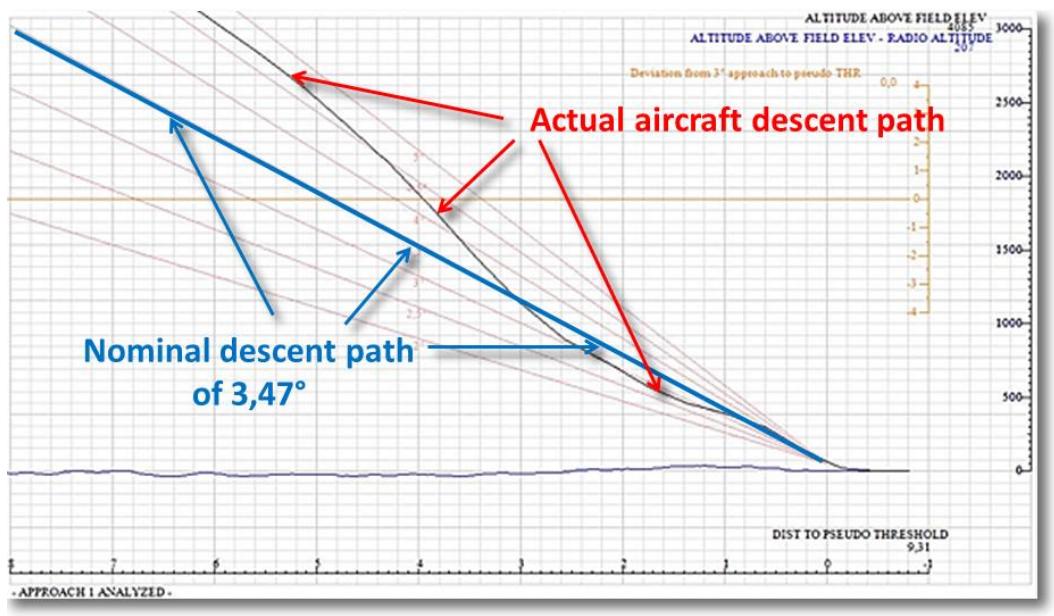
This graph shows the actual flight path flown in accordance to the assigned 3.47° flight path for the VOR / DME P runway 35 approach.

Image 15: Approach path runway 35

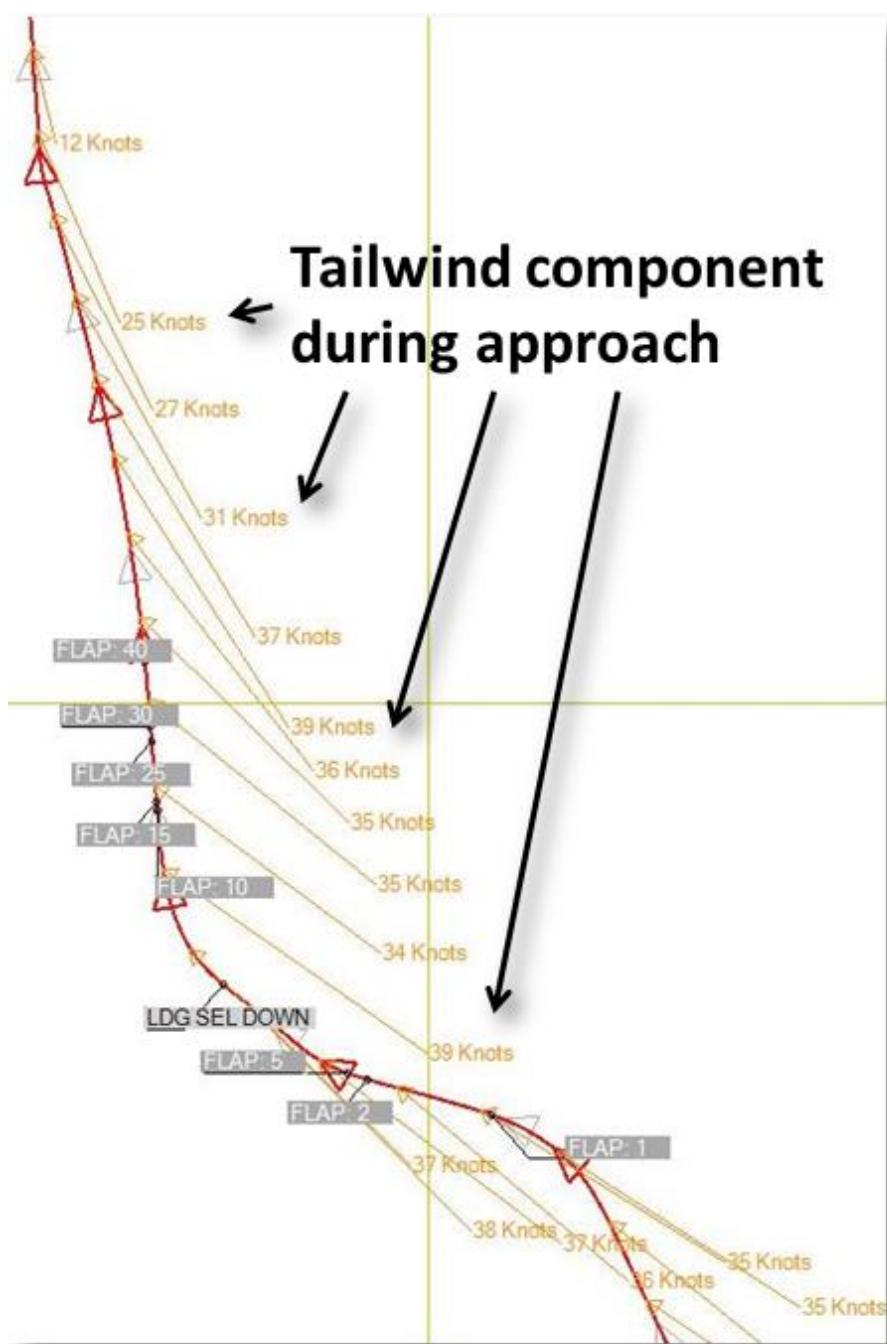
The airline operator provided a wind chart for the time of the approach. The starting point correlates with the time the Flaps were put in position 1 and ends at the time the aircraft touched down. The crew had planned a Flaps 40 landing. According to the chart a constant tailwind prevailed during the approach of the aircraft.

Image 16: Wind analysis during the approach

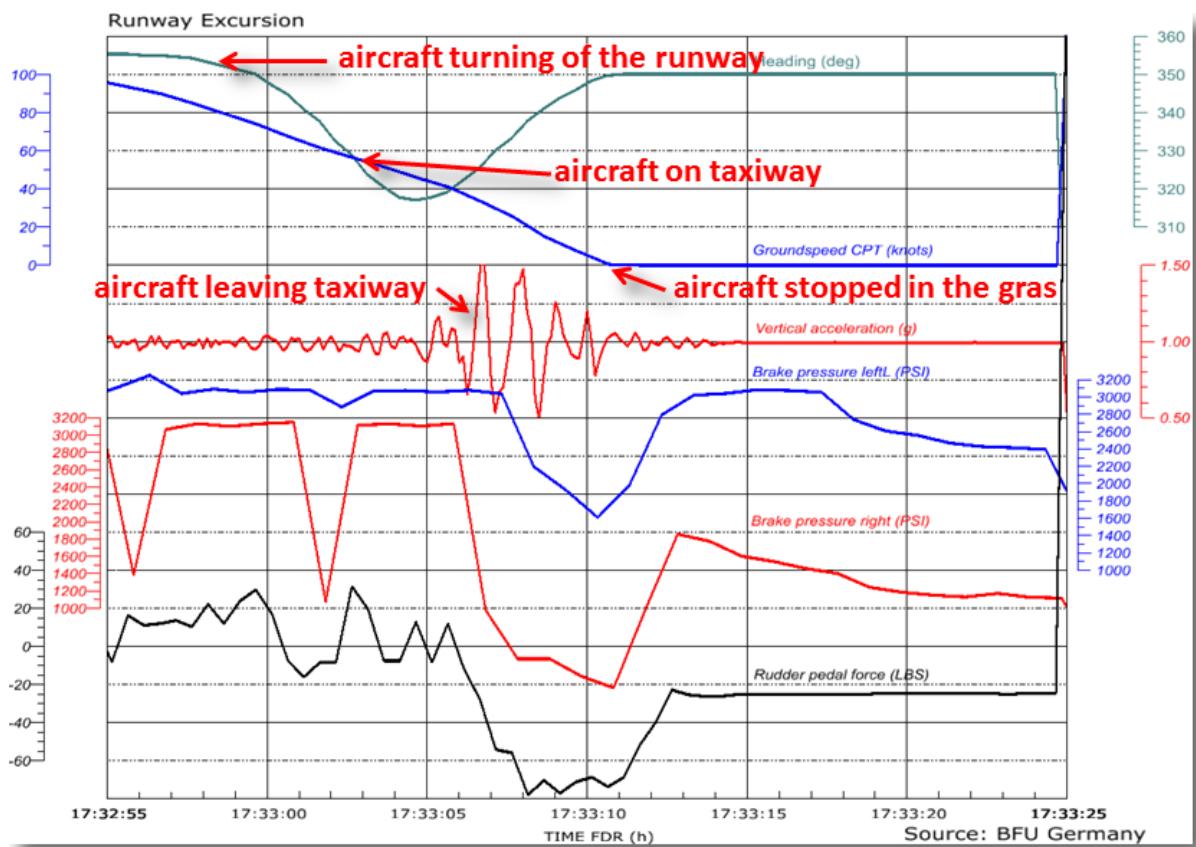
The taxi speed was according to FDR data around 50 kt when the aircraft began deviating from centerline and departed to the left edge of the runway to the taxiway C. The airline operator defined in the Operational Manual OM-B Vol.2, chapter 2.14.1 stipulates the following:

Image 19: Taxi speed during veering off runway
