Technical report

IN-049/2019

Incident involving two Boeing 737-8AS aircraft, registrations EI-ENH and EI-DYR, on 11 September 2019 at Málaga Airport

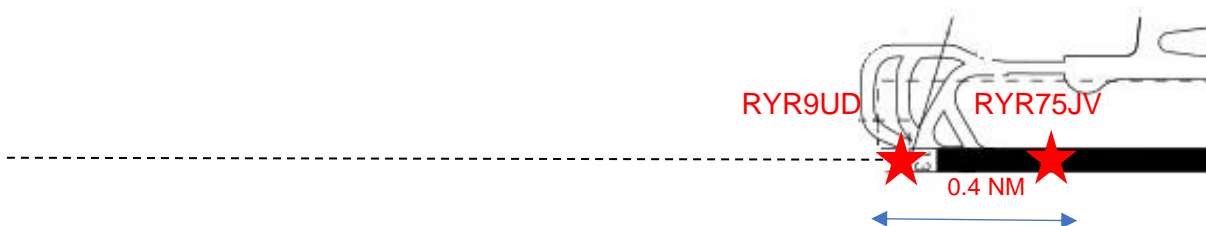
Illustration 7 Position of aircraft at 19:53:59 UTC

At 19:53:59 UTC, the trace shows aircraft RYR9UD established on short final at an altitude of 200 ft AMSL, and aircraft RYR75JV on its take-off run on RWY 13 at a speed of 94 kt (GS). The distance between the two aircraft was 0.4 NM.

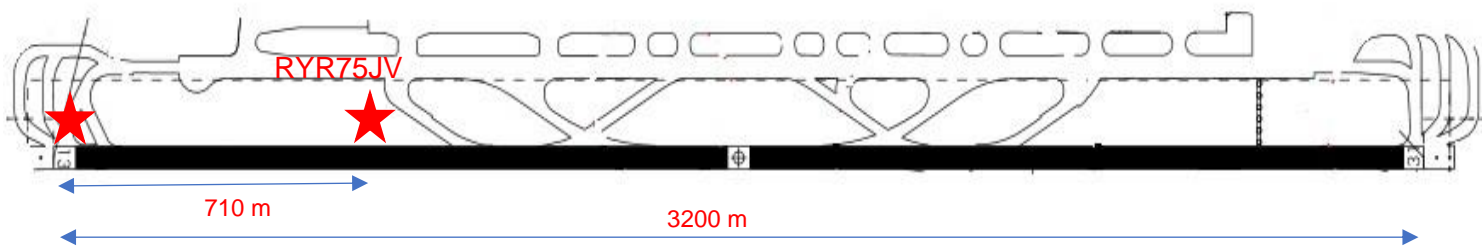
Illustration 8 Position of aircraft at 19:54:03 UTC

At 19:54:03 UTC, the trace shows aircraft RYR9UD over the threshold of RWY 13, travelling at an altitude of 100 ft AMSL and a speed of 150 kt (GS), and aircraft RYR75JV on its take-off run from the same runway at a speed of 111 kt (GS). The distance between the two aircraft was 710 m (0.38 NM)

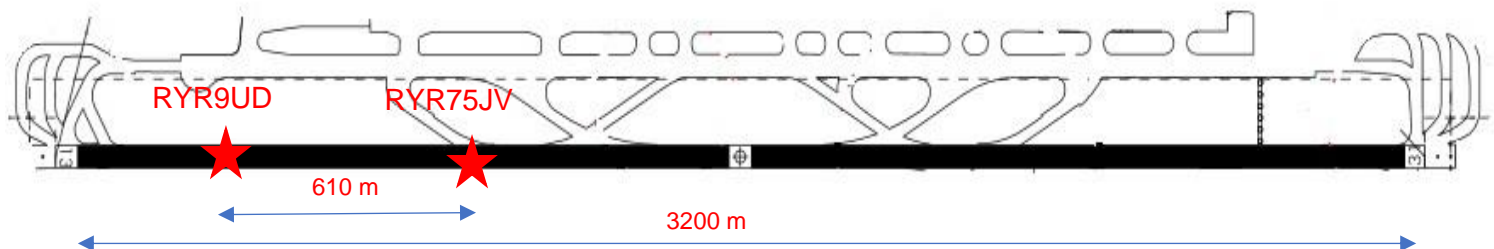
Illustration 9 Position of aircraft at 19:54:08 UTC

At 19:54:08 UTC, the trace shows aircraft RYP9UD over RWY 13 with its main landing gear not yet having made contact with the runway, and aircraft RYP75JV on its take-off run from the same runway, not yet having commenced rotation. The distance between the two aircraft was 610 m (0.33 NM)

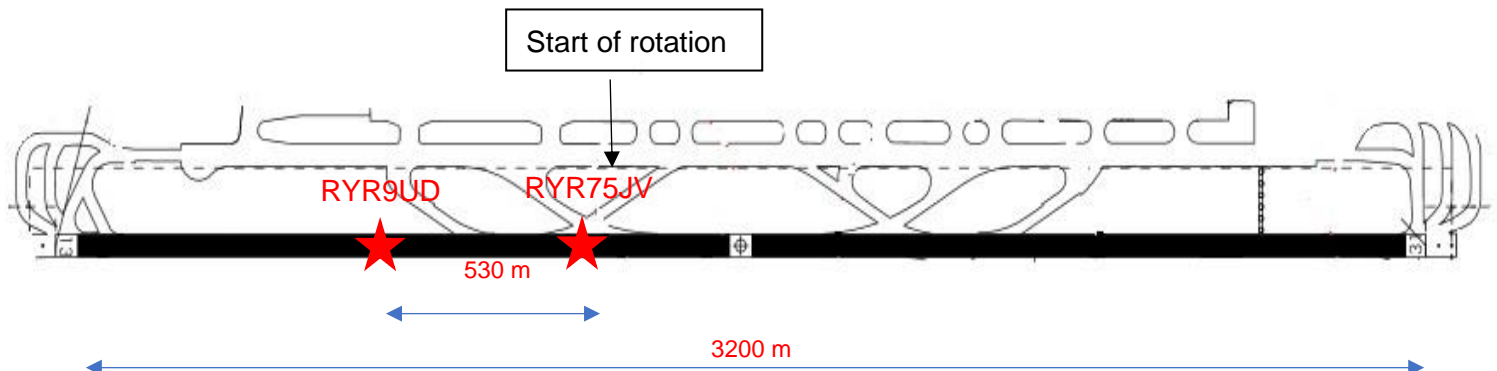
Illustration 10 Position of aircraft at 19:54:11 UTC

At 19:54:11 UTC, the trace shows aircraft RYP9UD over RWY 13 with its main landing gear not yet having made contact with the runway, and aircraft RYP75JV on its take-off run initiating the rotation manoeuvre (forward landing gear in the air and main landing gear on the ground). The distance between the two aircraft was 530 m (0.29 NM)

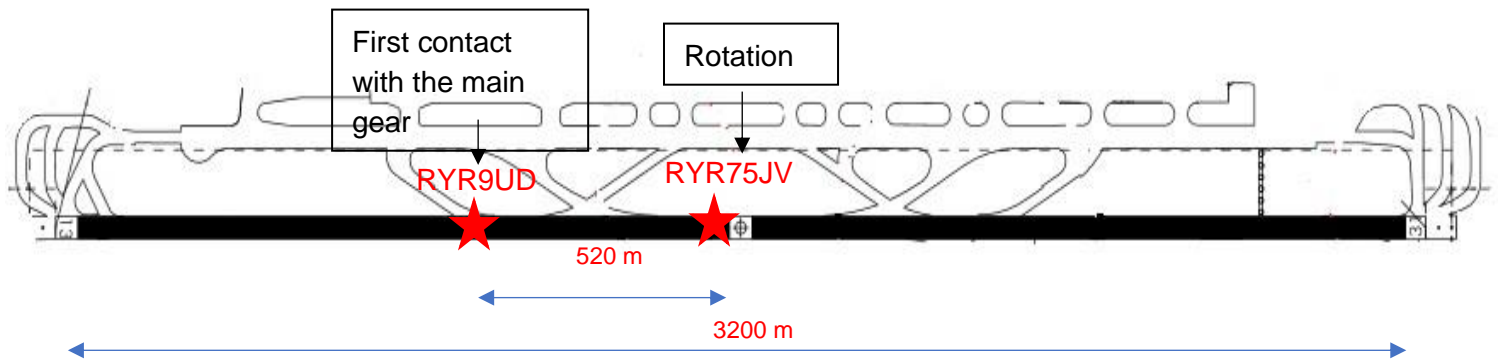
Illustration 11 Position of aircraft at 19:54:15 UTC

At 19:54:15 UTC, the trace shows aircraft RYR9UD over RWY13 with its main landing gear on the runway, and aircraft RYR75JV finishing the rotation manoeuvre on its take-off run (forward landing gear in the air and main landing gear on the ground). The distance between the two aircraft was 520 m (0.28 NM), the shortest separation recorded between them.

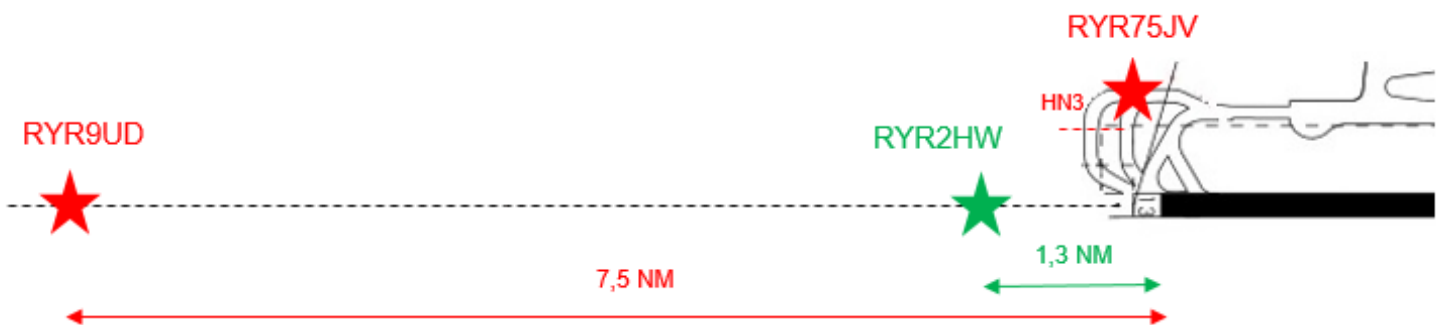
The LCL position controller planned to take advantage of the 6NM gap between two approaches to clear the take-off of the EI-ENH aircraft with callsign RYR75JV. The following image shows the relative positions of the aircraft at 19:51:17 UTC.

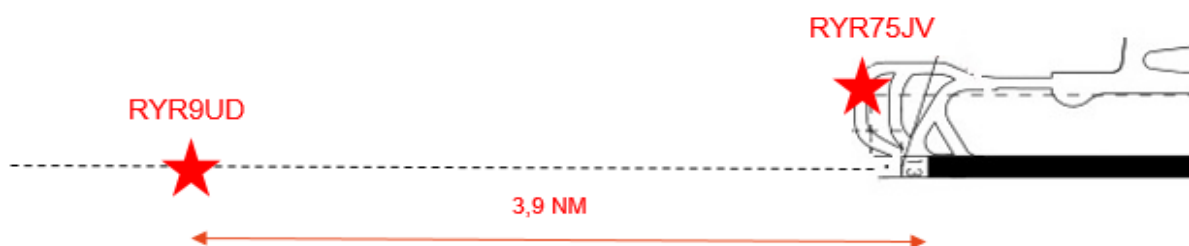
At 19:52:27 UTC, he instructed aircraft RYR75JV to line up on the runway and hold, when, at that moment, the approaching RYR9UD aircraft was established on final at a distance of 3.9 NM from the threshold of RWY 13. The following image shows the relative positions of the aircraft:

The crew of the RYR75JV aircraft took 6 seconds to acknowledge the instruction to line up and another 7 seconds to select the power to taxi. Because of the time it takes for the aircraft to begin moving after the power selection, the N1 and GROUND SPEED parameters did not become active until 19:52:49 UTC. This data does not signify the delay in the actions carried out by the crew is considered significant or excessive.

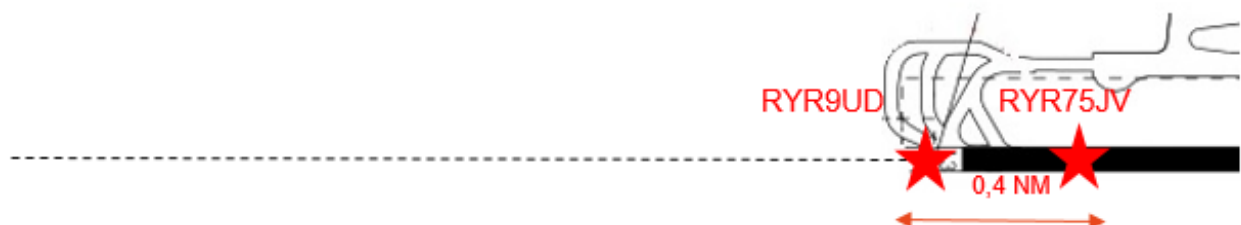
However, at 19:53:59 UTC, the LCL TWR LEMG controller cleared the RYR9UD aircraft to land with the preceding traffic in view on runway 13 when it was established at 200 ft of altitude AMSL, and aircraft RYR75JV was on its take-off run on RWY 13 at a speed of 90 kt (GS). The distance between the two aircraft was 0.4 NM.

The landing was authorised when the aircraft was practically above the runway threshold, allowing it to cross said threshold while the outbound aircraft was still on the runway. Moreover, there was no degree of assurance that the regulatory separation could be maintained, as the aircraft on approach was travelling faster than the aircraft on take-off, increasingly reducing the separation between the aircraft. The air traffic controller failed to anticipate the required separation between the aircraft.

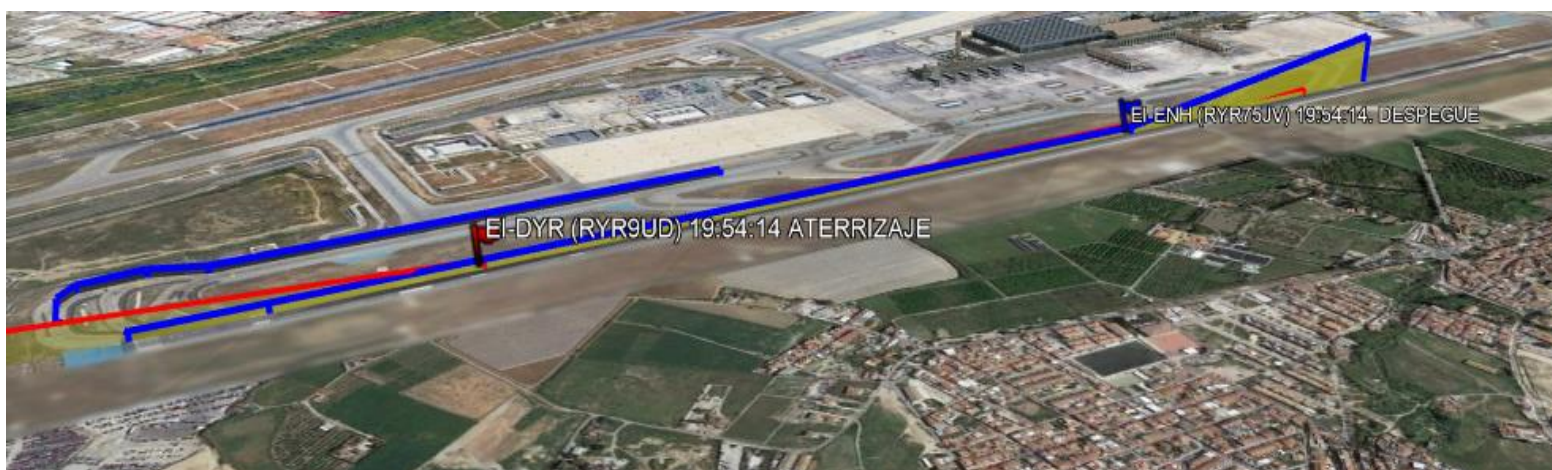
Illustration 18 Aircraft trajectories at the moment of touchdown

From the data obtained from the flight recorders we have been able to determine the exact moment at which the landing aircraft, with registration EI-DYR, makes contact with the runway for the first time with its main landing gear. This instant (19:54:14 UTC) has been represented in the following graphic, where the trajectory of the inbound aircraft is indicated in red, and that of the outbound aircraft is indicated in blue.

The landing EI-DYR aircraft touched down on the runway with a ground speed of 141 kt. For its part, the EI-ENH aircraft was on its take-off run executing the rotation manoeuvre, with a ground speed of 157 kt. The distance between the two aircraft was 520 m (0.28 NM). This was the point of minimum separation between the two aircraft.
