**Incident to the BOMBARDIER CL600 2C10 (CRJ700)
registered F-GRZL
on 23 January 2020
at Lyon - Saint-Exupéry (Rhône)**

Deviations from flight path on short final, missed approach, flight over airport buildings, in LVP conditions

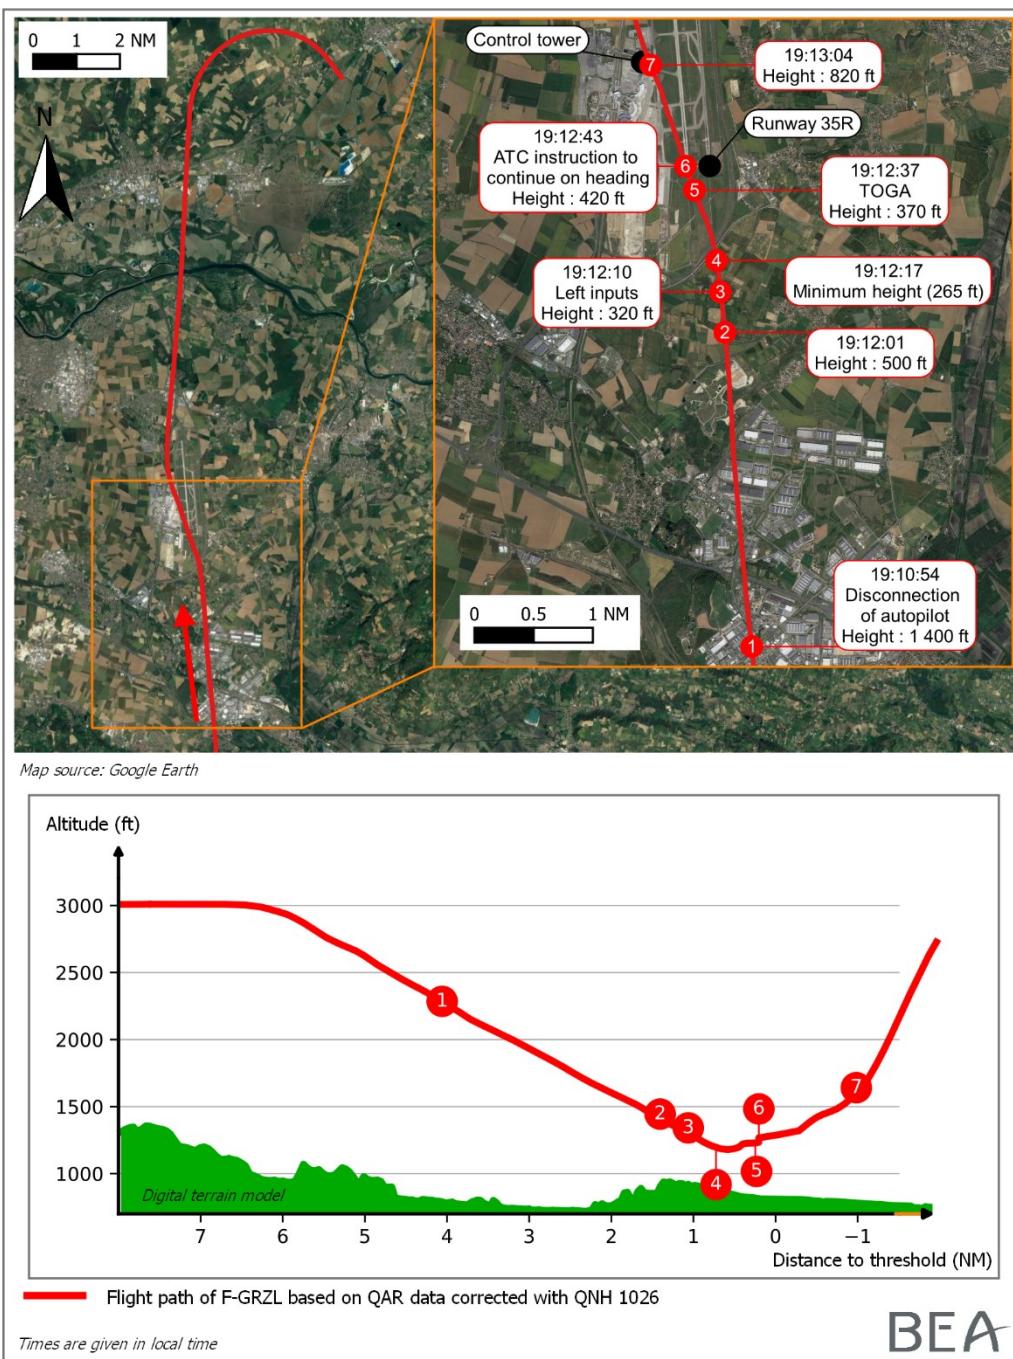
Figure 1: flight path of F-GRZL

At 19:12:10, at a height of 320 ft, the PF made four successive left roll inputs for a total time of around seven seconds, of a greater and greater amplitude³ (refer to Figure 1, point ③). The left roll angle of the aeroplane reached 11°.

At 19:12:17, the aeroplane reached a minimum height of around 265 ft (refer to Figure 1, point ④). It was left of the centreline (1/4 dot of deviation from localizer) and above the ILS glide path (1/2 dot of deviation from glide).

At 19:12:37, i.e. 23 s after the start of the nose-up input, the power levers were moved forward for the last time, from 37° to 50° (TOGA detent). The PF pressed the TOGA button which activated the "Vertical go around" and "Lateral go around"⁸ modes (see Figure 1, point ⑤). The aeroplane's pitch attitude stabilized at 8°.

At 19:12:41, the controller asked the crew if they were going around which the latter confirmed (refer to Figure 1, point 6). The aeroplane flew over the threshold of the parallel runway (35L) at a height of 420 ft with a magnetic heading of 341°. The controller asked the crew to continue on the heading and to climb to 5,000 ft.

F-GRZL flew, in succession, over the taxiway parallel to the runways, over an aircraft parking area and then in proximity to the control tower at a height of 820 ft (refer to Figure 1, point 7).
