Aviation Investigation Final Report

Location:	St Petersburg-Clearwater, Florida	Incident Number:	OPS21LA002
Date & Time:	April 29, 2021, 15:07 Local	Registration:	N306NV (A1); N370SD (A2)
Aircraft:	Airbus A319-112 (A1); Cessna M337B (A2)	Aircraft Damage:	None (A1); None (A2)
Defining Event:	Air traffic event	Injuries:	129 None (A1); 1 None (A2)
Flight Conducted Under:	Part 121: Air carrier - Scheduled (A1); Part 91: General aviation - Personal (A2)

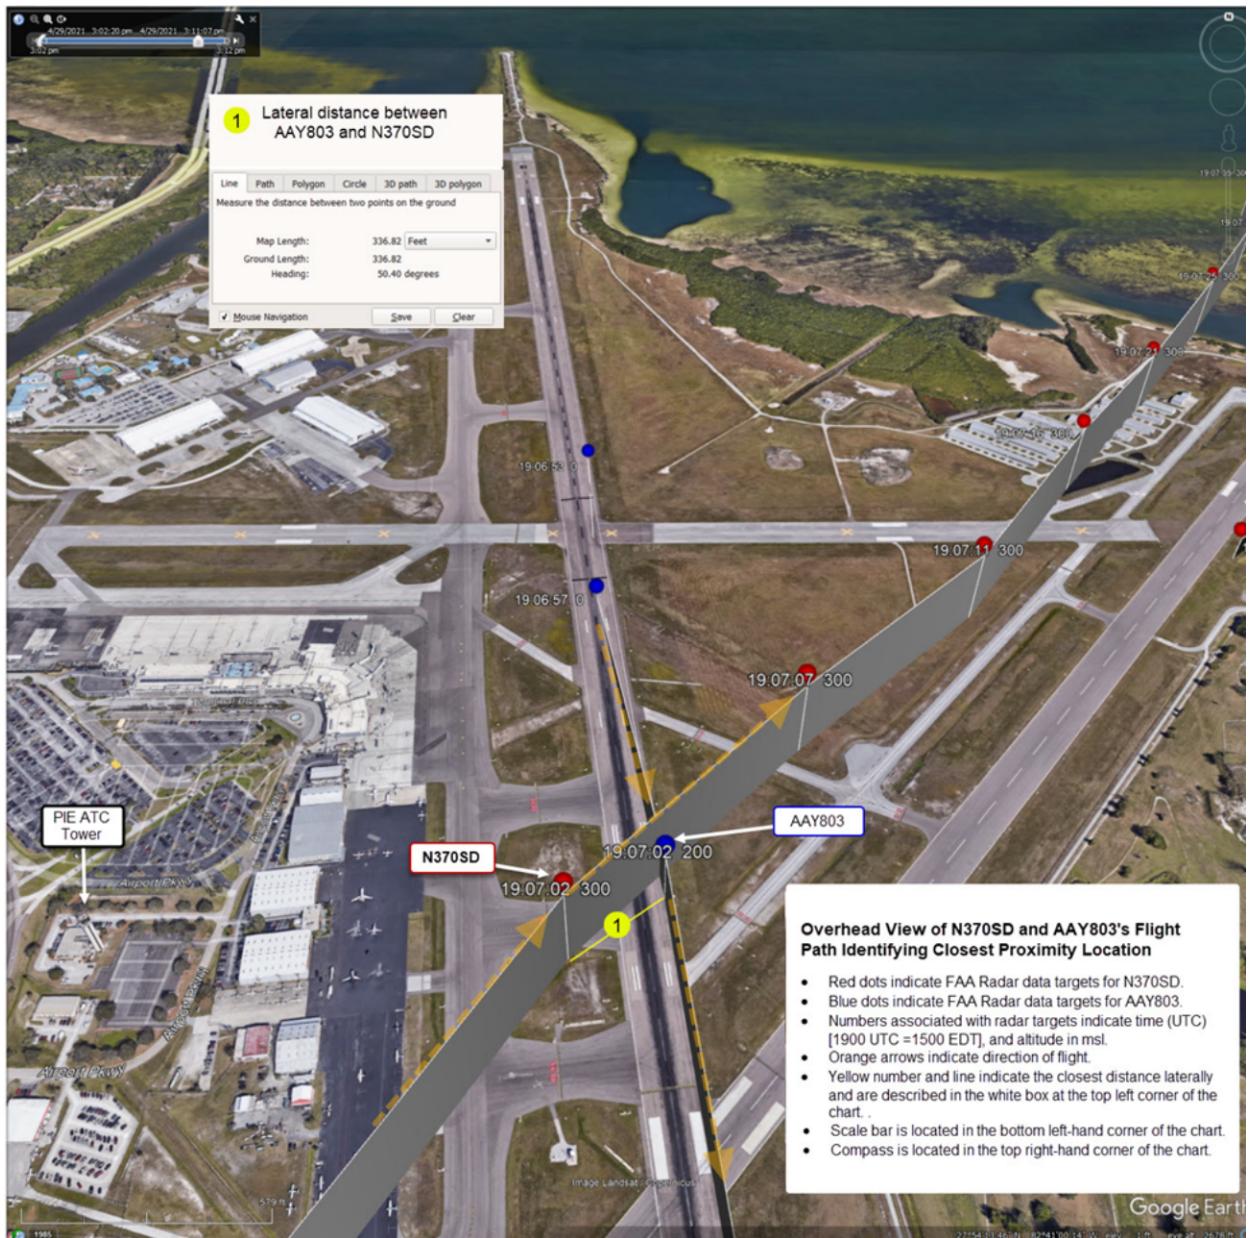
Figure 2. FAA Radar data overlaid on satellite imagery illustrating the flights routes of N370SD and AAY803, and the location of the closest proximity to each other.

FAA radar data showed that at 1507:02 N370SD was on a right downwind for runway 22, at an altitude of 300 feet and a lateral distance of about 800 feet from the centerline of runway 22, when it overflew runway 18. At the same time AAY803 was at 200 feet departing runway 18. The closest proximity was 100 feet vertically and 369 feet laterally.
