Oven overheated in aft galley

Oven overheat in aft galley

The Hague, June 2024

Synopsis	Explanation
Identification number:	2023012
Classification:	Serious incident
Date, time of occurrence:	9 February 2023, 12.30-12.45 hours ¹
Location of occurrence:	Mediterranean Sea south of Marseille, France
Operator:	KLM Royal Dutch Airlines
Registration:	PH-BQO
Aircraft type:	Boeing 777-200
Aircraft category:	Fixed wing aircraft – passenger
Type of flight:	Scheduled commercial air transport (passenger)
Phase of operation:	En route
Damage to aircraft:	Galley floor heat damage
Number of flight crew:	3
Number of cabin crew:	10
Passengers:	291
Injuries:	Breathing difficulties by three cabin crew members and twelve passengers
Other damage:	Oven damaged beyond repair
Light conditions:	Daylight

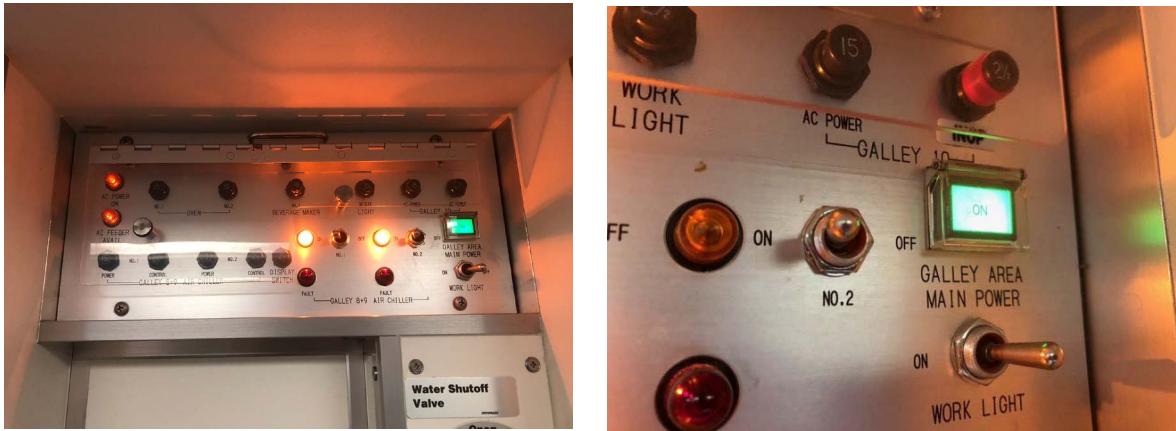
At 10.59 hours, the aircraft departed Schiphol from Runway 18L. Twenty minutes after take-off, the cabin crew turned on the ovens in the galleys. After approximately 1 hour and 20 minutes into the flight, while the aircraft was cruising at FL330, a passenger seated in the aft part of the cabin alerted the purser, who was serving the passengers with meals, that smoke was coming from the aft galley. The purser immediately put aside her meal trolley and made her way to the aft galley, where she discovered smoke originating from oven number 3. She returned to the cabin to warn other cabin crew members about the smoke and to start the standard firefighting procedure, the so-called 'ABC procedure' (see Appendix B). Under this procedure, the purser assumed the role of A (Attack) in charge of firefighting, while a second cabin crew member became B (Buddy) to assist A and a third cabin crew member took on the role of C (Communication), taking care of communications with the flight deck and senior purser. Hereafter, the purser returned to the galley to start the Oven smoke/fire procedure (see Appendix B). The first step of this procedure requires the galley area main power to be switched off. Upon checking the galley area main power button, the purser discovered that the green indicator light (see Figure 1) was not illuminating. She interpreted this as an indication that the galley area main power must have turned off automatically.

▲ Figure 1: On the right in both pictures, the green lit galley area main power button.

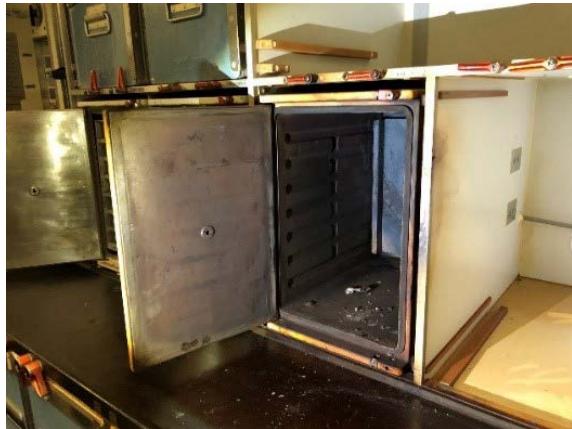
The oven suffered overheat damage, consisting of a melted aluminium fan and damage of the entire inner side. During the incident, the insert of the oven together with its trays was removed and placed on the galley floor. The galley floor sustained heat damage from the hot insert through melting of the contact surface.

◀ Figure 2: The failed oven.

Upon teardown of the oven, the 3-phase safety device appeared to have been damaged by one of the three heating elements of the oven rendering it inoperable. Additionally, a meal carrier insert from another manufacturer was discovered in the oven as well as seven trays, although the insert is designed for only six trays. The oven was damaged beyond economical repair. Severe heat damage was observed inside the oven and on the back of the oven. No heat damage was found on the oven's outer shell.

Molten aluminium parts of the fan were found on the bottom of the oven and on the back wall near the heating elements. The complete inside of the oven was covered with a brownish substance. Also, the outside walls of the oven were covered with a brownish substance. The inside parts of the oven sustained severe heat damage, especially near the heating elements as well as the power control board on the back of the oven.

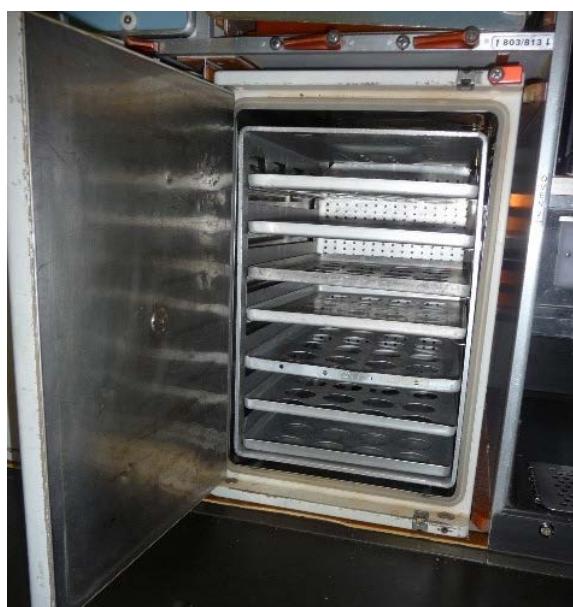
The meal tray carrier mostly had a closed perforated backside (see Figure 3, left). As a result, the heating time of the oven was significantly extended because of the disturbed airflow of the fan and heating elements. Confirmed by previous investigations of the manufacturer, this increased the temperature of the area behind the baffle plate as the closed backside reduced the heat distribution to the meals inside the carrier.

▲ Figure 3: Left, carrier with meal trays and mostly closed perforated backside in oven.

The use of an aftermarket meal tray carrier with a mostly closed perforated backside had a negative effect on the reliability of the oven, as well as placing the oven at a higher risk for an overheat condition.

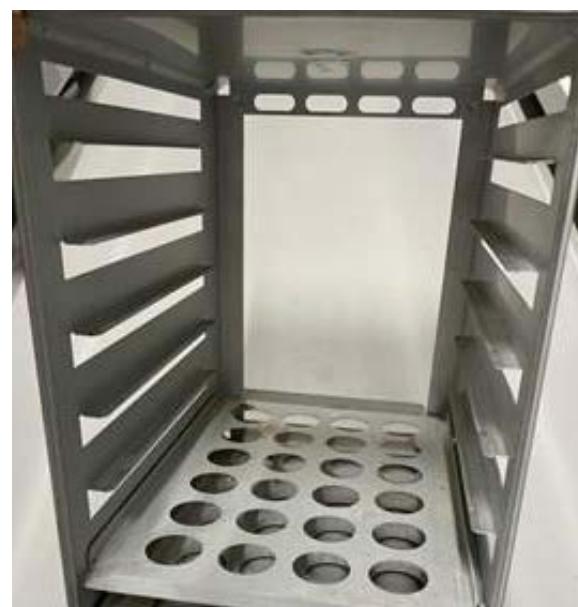
▲ Right, meal tray carrier with an open back.
(Source: B/E Aerospace)

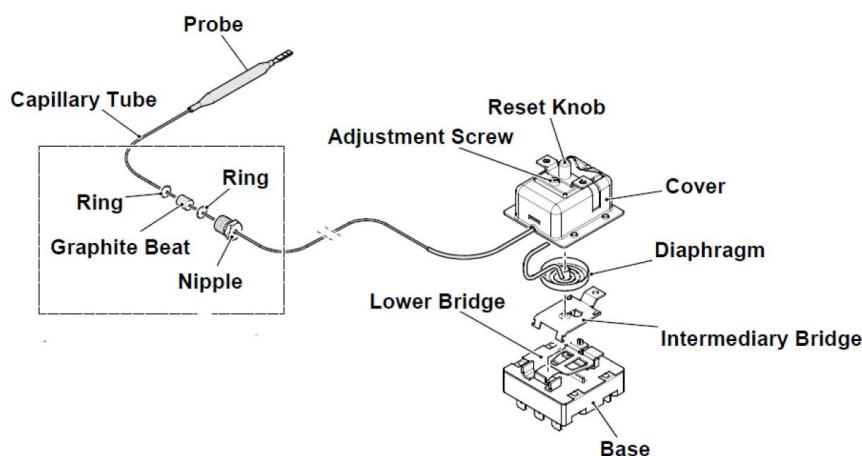
Some time prior to this event, the 3-phase safety device's capillary tube was damaged by the heating element. This is evident from the fact that the ends of the line are fused, the damage to the surface of the heating elements, and the observation that the 3-phase safety device activation indicator did not show the device had been triggered by the overheat event.

▲ Figure 4: 3-Phase Safety Device Exploded View. (Source: B/E Aerospace)

If the temperature inside the oven is increasing, a probe installed inside the oven will heat up and will react to the expansion medium inside the probe and capillary tube. The pressure inside the closed-circuit system will therefore increase. When the maximum temperature is exceeded, the pressure inside the tube will be high enough to exert sufficient displacement of the diaphragm so that a snap-action switch will open the electric circuit rendering the oven powerless. The probe inside the oven is located close to the heating elements and before the fan. The capillary tube runs from the probe through the back wall of the oven to the safety switch installed at the back of the oven and is very sensitive for bending.

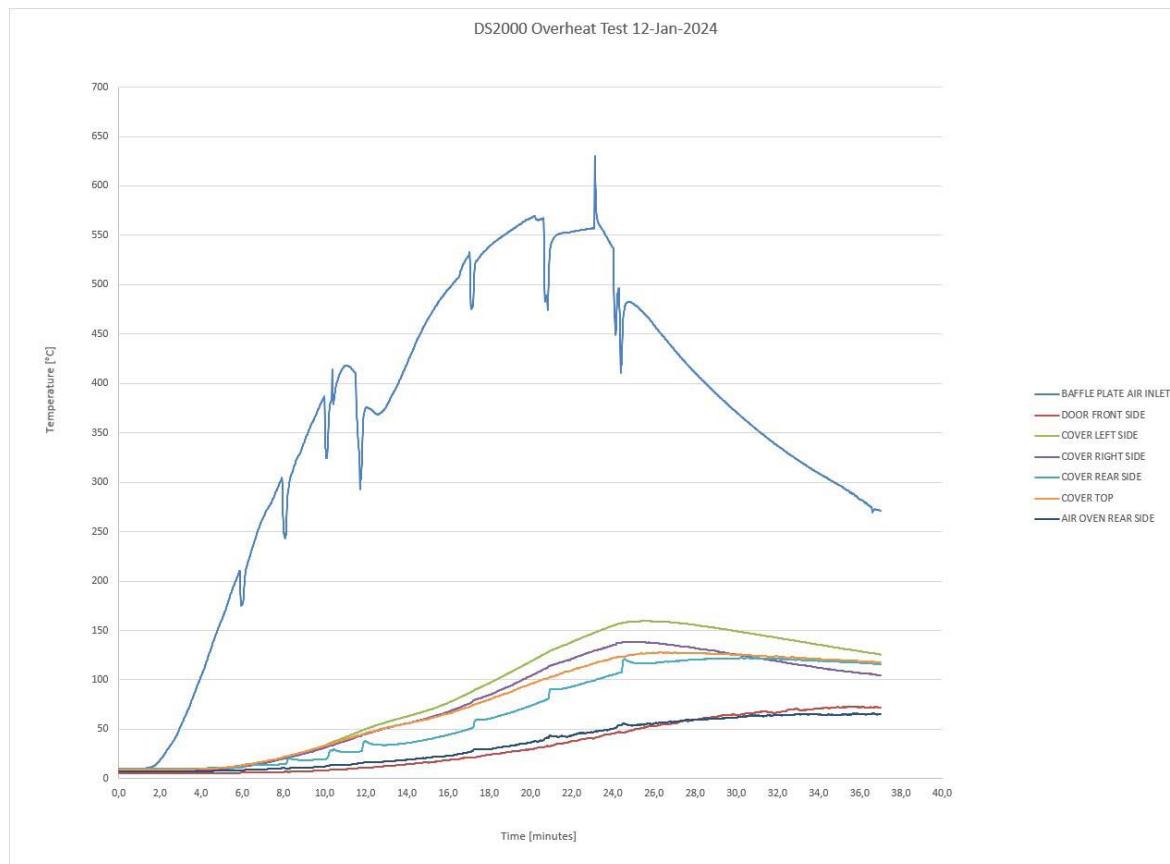
In Houten, during the testing of the oven in an overheat condition, the same damage to the oven as the incident oven could be reproduced. During this test, the failure of the heating elements happened approximately 20 minutes after continued electrical powering.

▲ Figure 5: The values measured by the various temperature meters on the test oven while duplicating an overheat condition. (Source: B/E Aerospace)

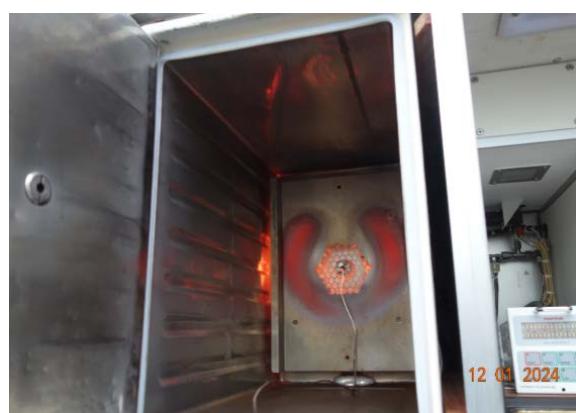
◀ Figure 6: The inside of the test oven at maximum temperature. (Source: B/E Aerospace)

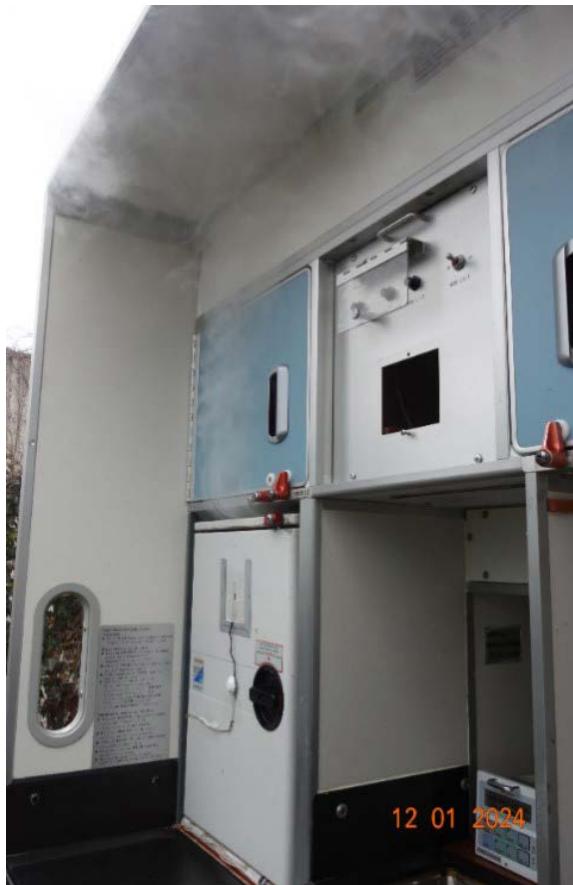
◀ Figure 7: Smoke coming from the oven in the test setup.
(Source: B/E Aerospace)
