# Investigation Report

Type of Occurrence: Accident

Type: A320-214

State File Number: BFU21-0555-2X

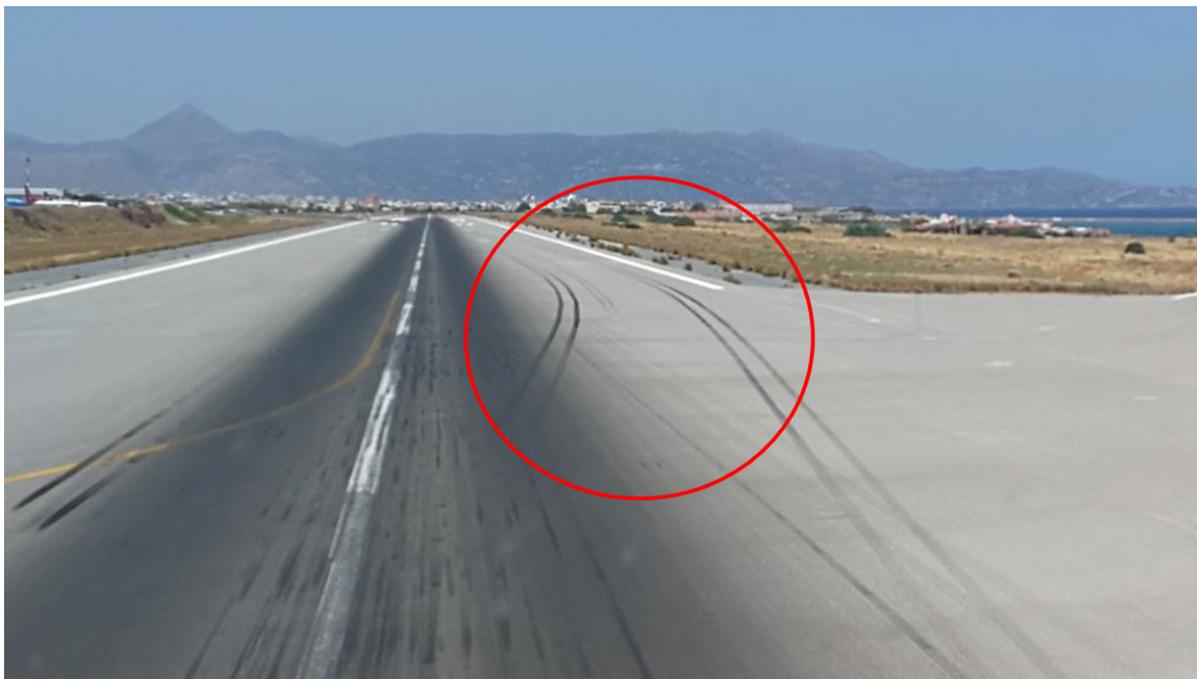
Figure 1 shows the rubber abrasion traces (take-off direction), which could be attributed to the rejected take-off on 10 July 2021 and had been caused by the tires of all three landing gears.

Fig. 1: Rubber traces on runway 27 caused by the rejected take-off

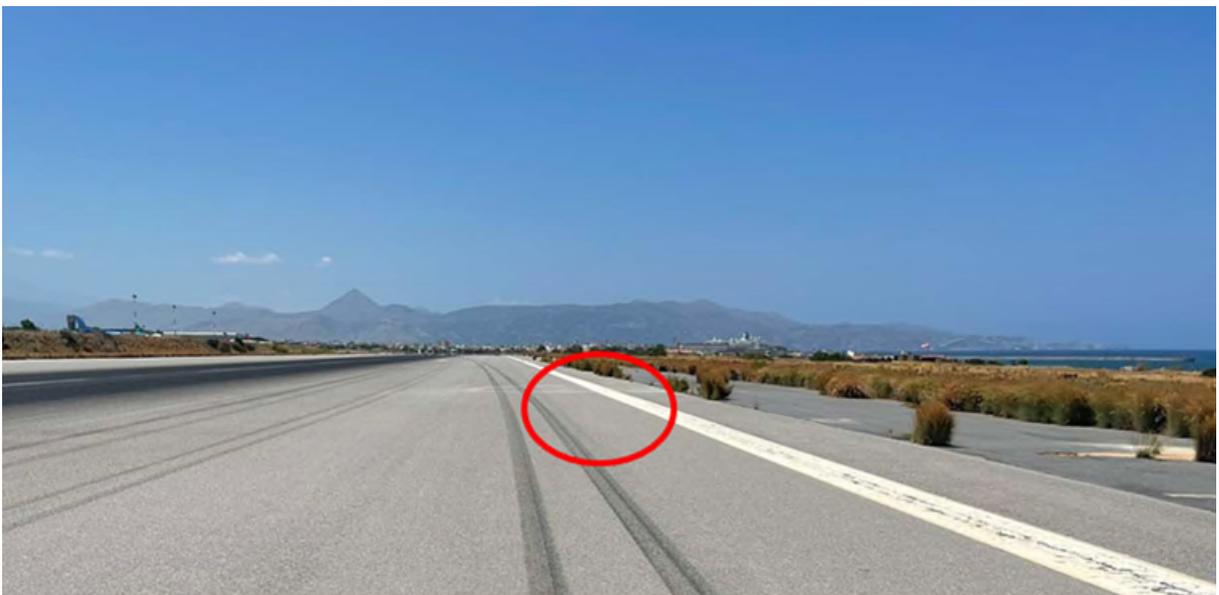
Figure 1 shows the rubber abrasion traces of all landing gear tires caused by the rejected take-off. Employees of Heraklion Airport measured the closest distance between the right main landing gear tire trace (tire No. 4) and the right runway edge with 3.7 m (Fig. 11). This position was located about 230 m beyond the intersection of runway 27 and runway 30.

Fig. 11: Closest distance between the right main landing gear tire marks and the right runway edge

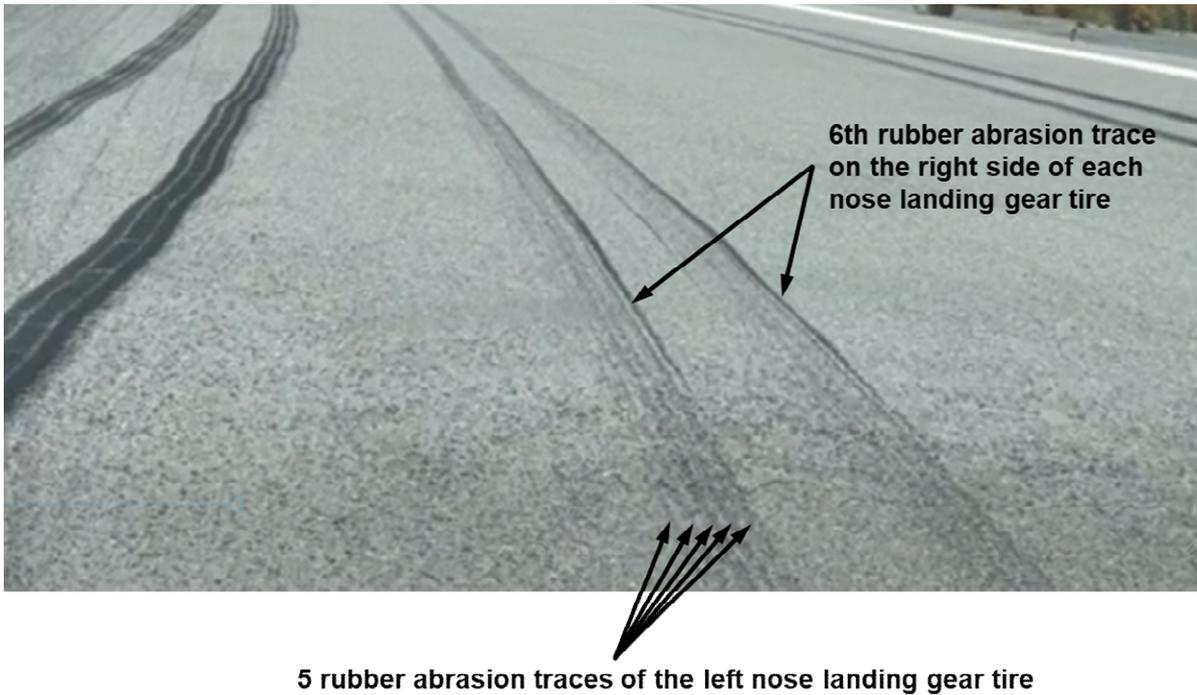
Figure 12 shows the rubber abrasion traces of both nose landing gear tires shortly after they touched down again. The five rubber abrasion traces (Fig. 13) of the five treads of the left nose landing gear tire are clearly visible. A sixth rubber abrasion trace, which is darker, runs for about 5 m right of the two nose landing gear tire rubber marks.

Fig. 12: Rubber abrasion traces of the nose landing gear tires Source: Heraklion Airport, adaptation BFU

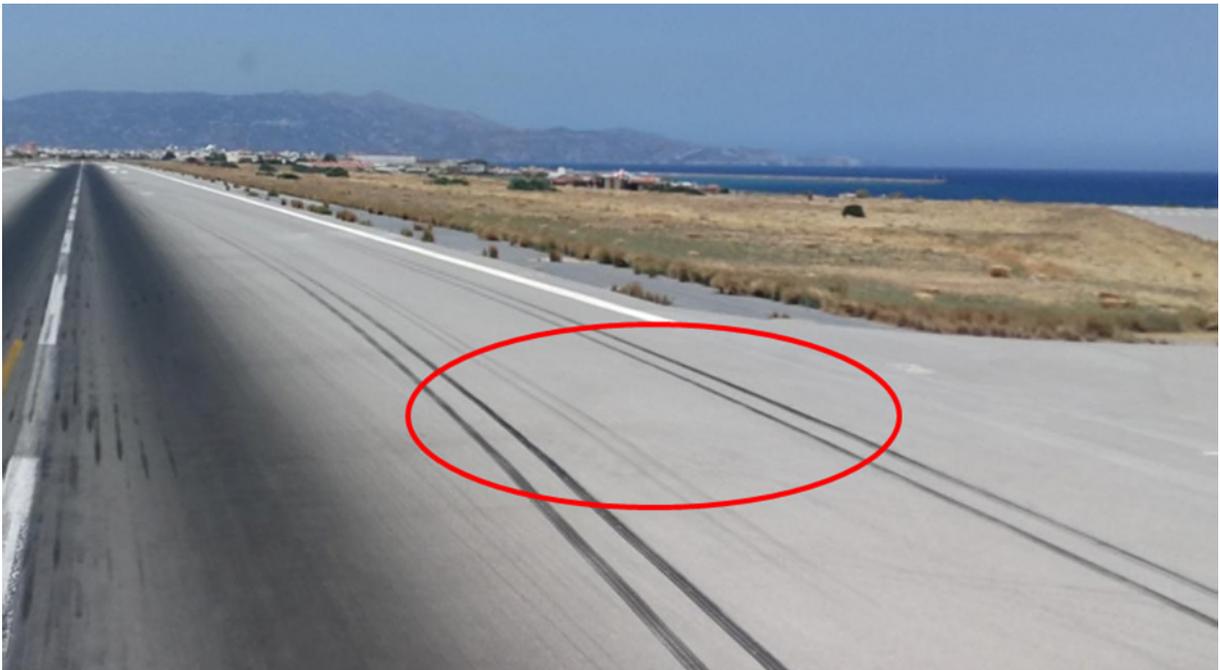
Figure 14 shows the relative position of the nose landing gear traces with respect to the main landing gears traces. It can be seen that after the nose landing gear touched

down again, the traces of the two nose landing gear tires run over a longer distance closer to the traces of the left main landing gear than to those of the right. This is approximately the distance for which the aircraft manufacturer calculated a positive drift angel of  $6^\circ$  to  $7^\circ$  by reconstruction of the rejected take-off track.

Fig. 14: Relative position of the nose landing gear traces and the main landing gears traces

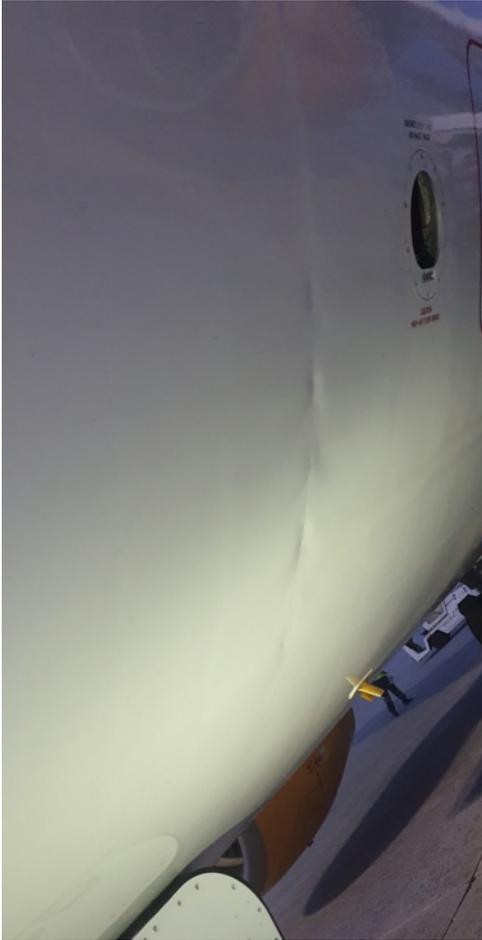
Figure 15 shows the deformation of the fuselage skin in the area of Frame 20 at the lower left fuselage side. Figure 16 shows almost the same damage at the right lower fuselage side, also in the area of Frame 20. Other deformations were found at the lower fuselage area at Frame 21 and in the upper at Frame 24.

Fig. 15: Damage of the fuselage skin on the left side  
Source: Operator

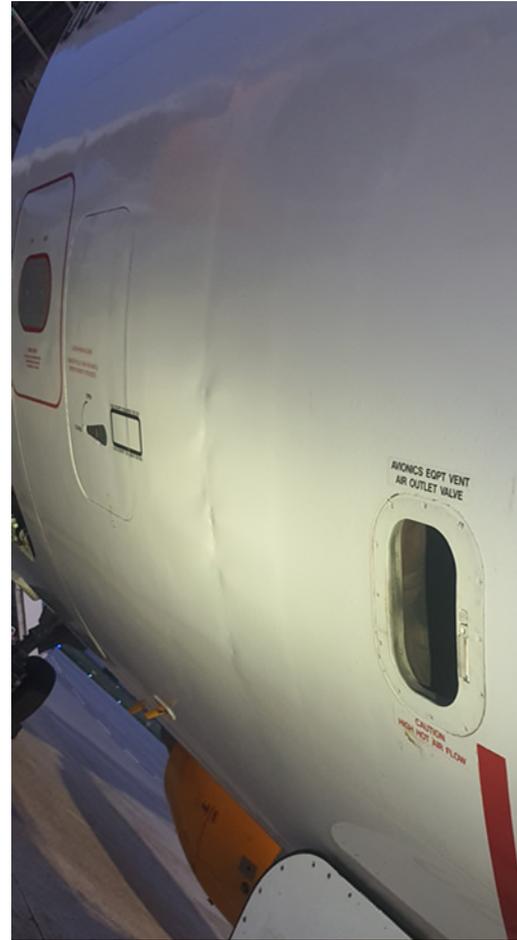
Fig. 16: Damage of the fuselage skin on the right side  
Source: Operator

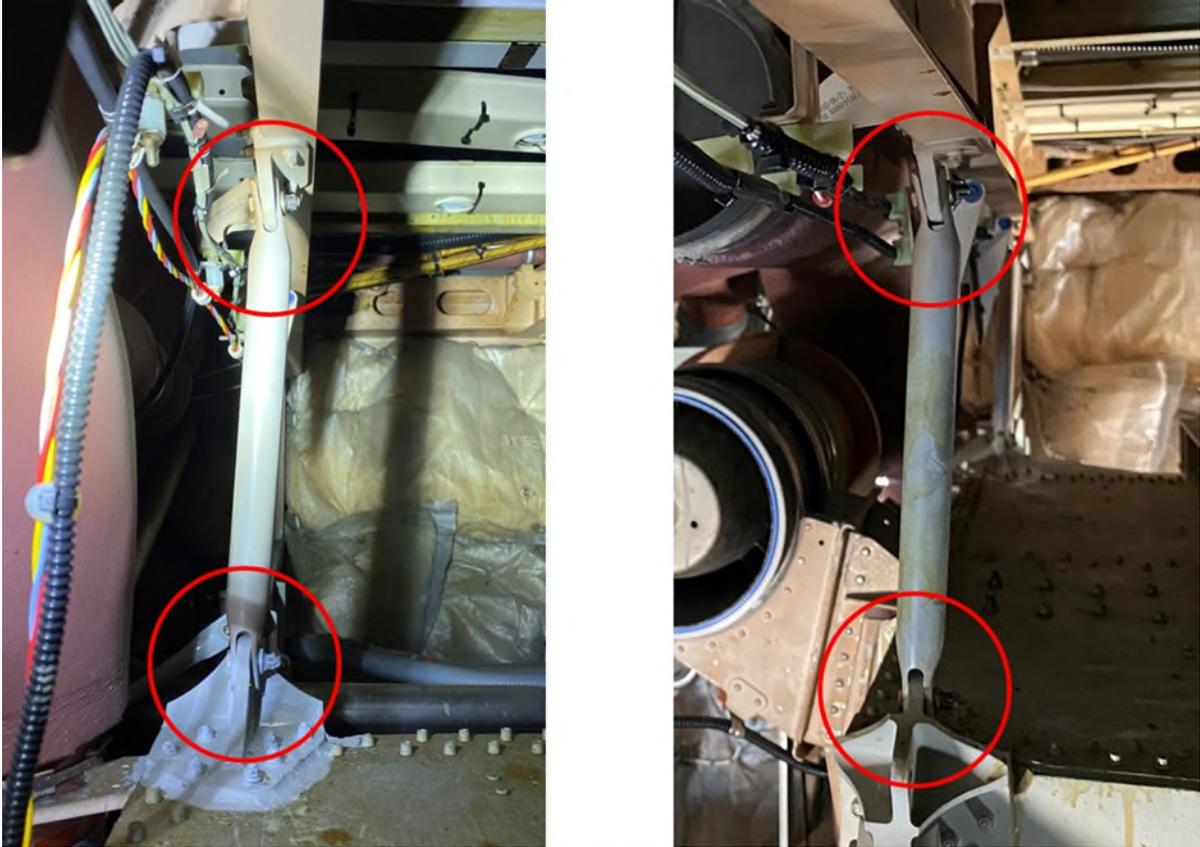
The struts between NLG torque box and the cross beams above were bent at their junctions in the area of Frame 20 and Frame 16, among others.

Figure 17 shows the two bent struts on the left and right in the area of Frame 20.

Fig. 17: Struts between NLG torque box and cross beam of Frame 20

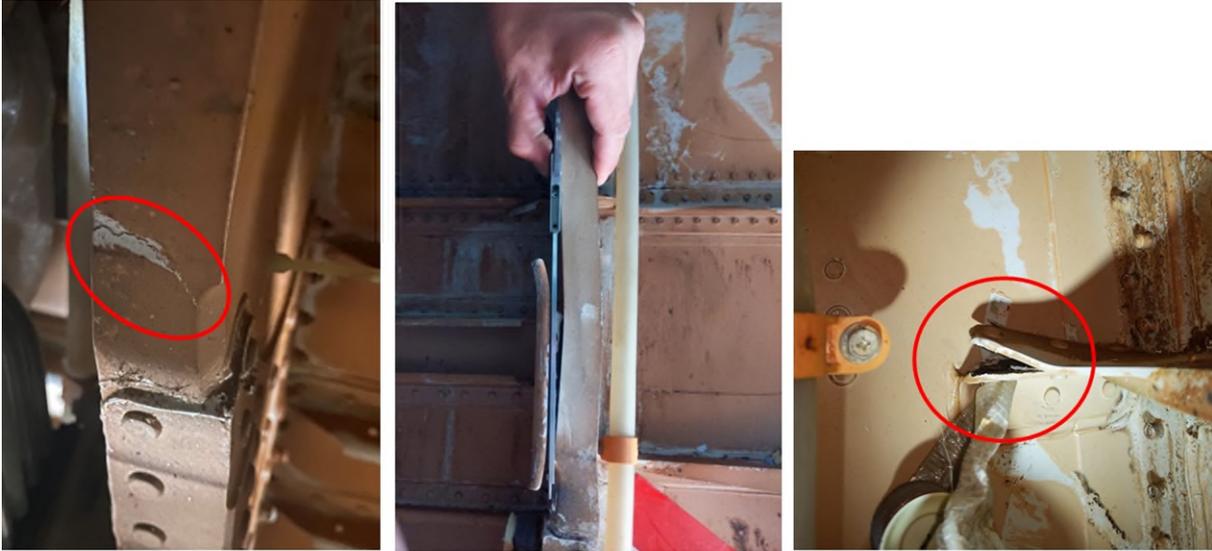
At Frame 20, the left lower side showed a crack (Fig. 18, left) and at the right lower side deformation (Fig. 18, centre). On the right side of Frame 20, the connection between a stringer and the frame had separated (Fig. 18, right).

Fig. 18: Damage of Frame 20

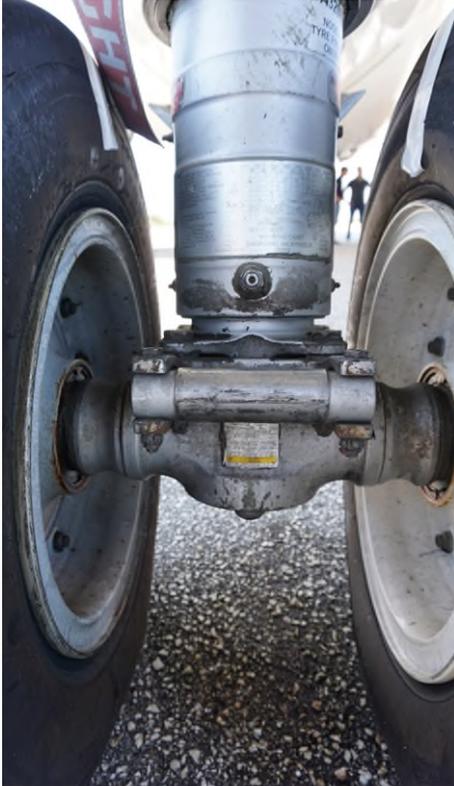
After the landing, the nose landing gear shock absorber was found depressurised. The chromium layer of the shock absorber's sliding rod was no longer visible (Fig. 19, left). Initially, there was no leakage at the nose landing gear shock absorber; it occurred the next day (12 July 2021). Figure 19 right shows the hydraulic oil spill below the shock absorber.

Fig. 19: Deflated nose landing gear shock absorber  
Source: BFU

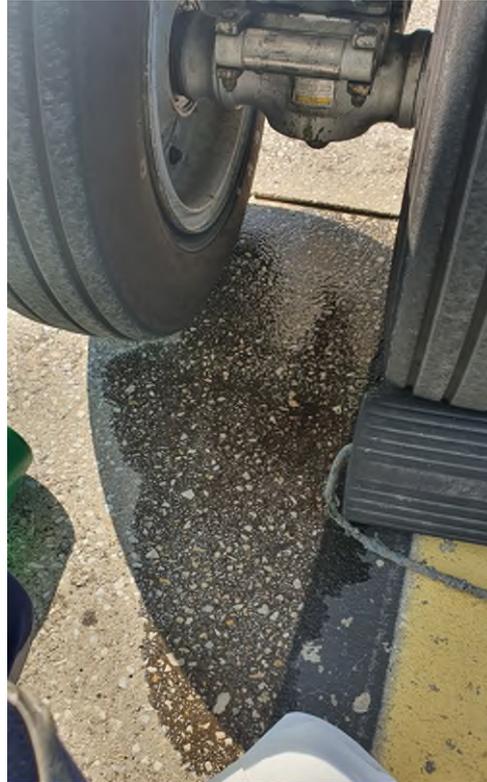
Leakage at the nose landing gear shock absorber  
Source: Operator

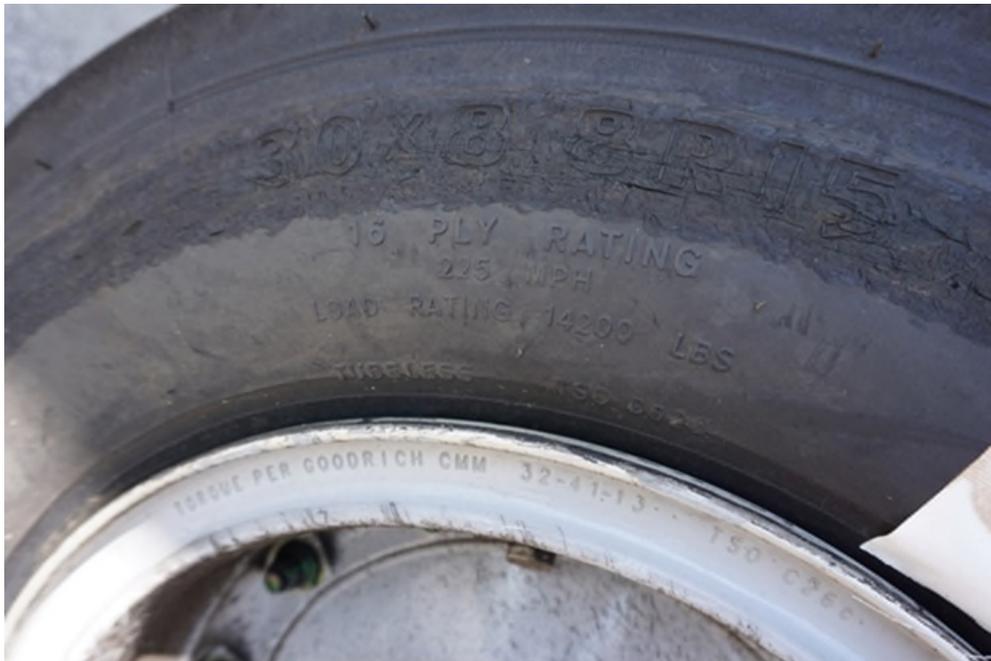
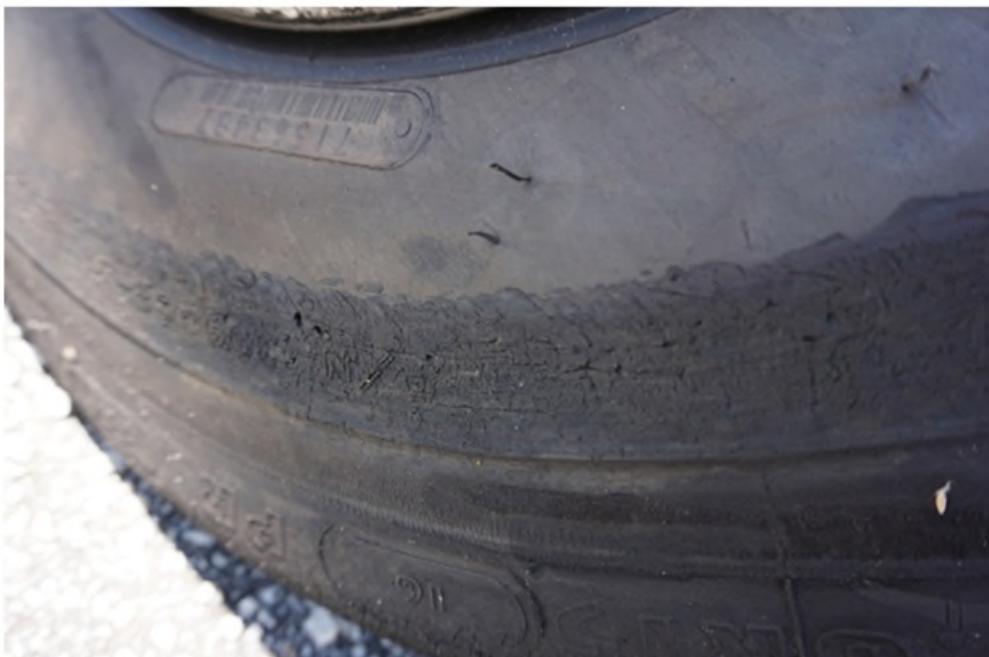
Both nose landing gear tires showed clearly visible damage at their respective right tire sidewalls (Fig. 20).

Fig. 20: Damage at the right tire sidewalls of the nose landing gear tires Source: BFU

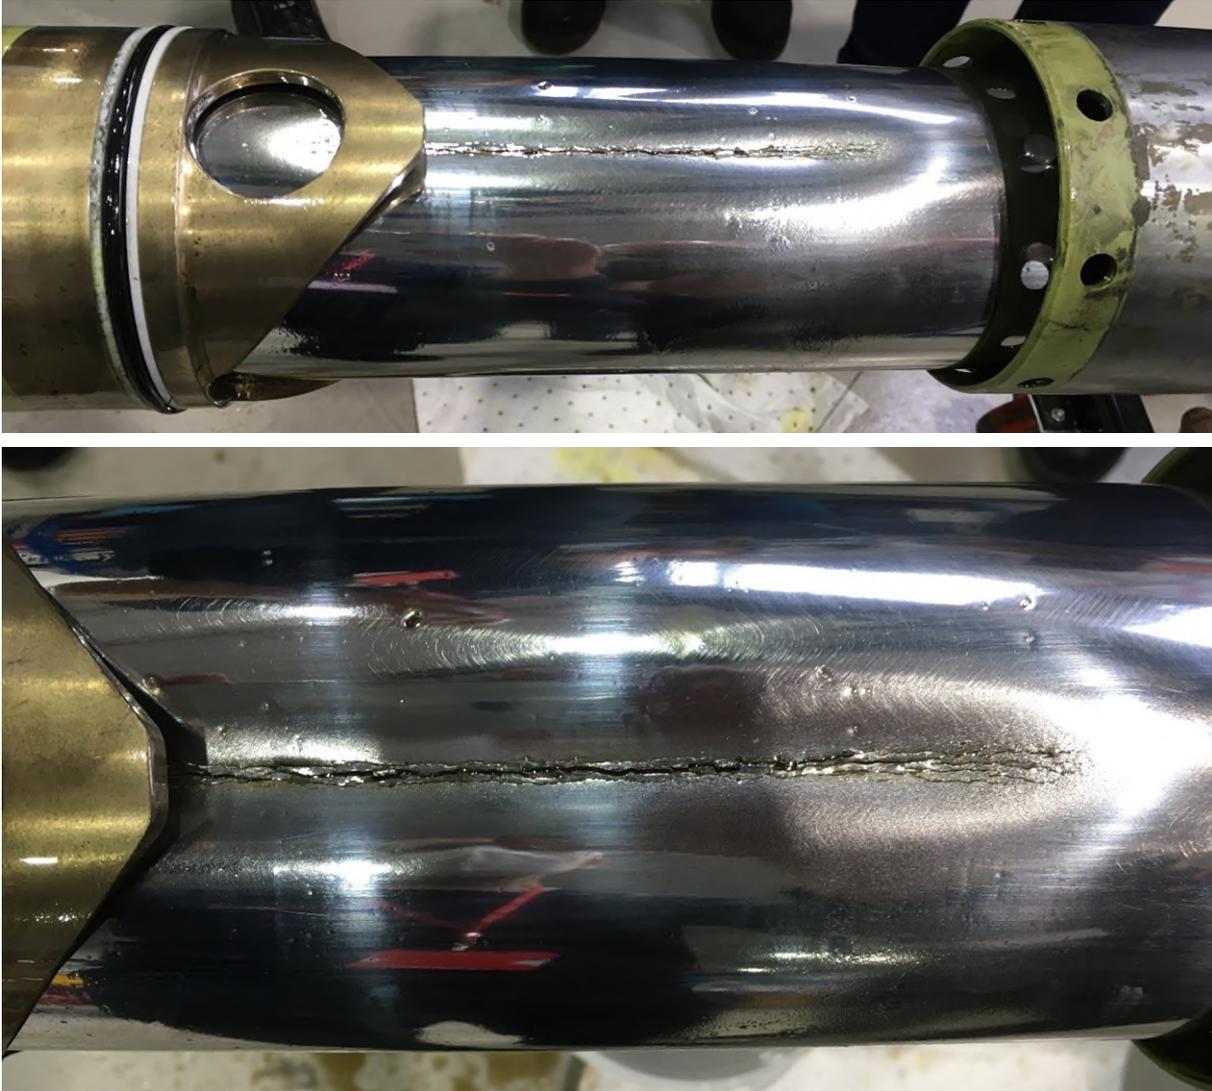
At the landing gear manufacturer's, a severely deformed nose landing gear shock absorber cylinder was found during disassembly. It was so severely deformed that it was difficult to remove it from the sliding tube. It was also difficult to detach the upper cam from the cylinder. In the area of the strongest deformation, which ran inwards, there was a 160 mm long crack on the outside (Fig. 22). On the piston's inside, the crack was 120 mm long.

Fig. 22: Crack and deformation of the cylinder

According to the landing gear manufacturer, the high de-rotation rate while the nose landing gear touched down again during the rejected take-off at Heraklion resulted in the initial buckling of the cylinder and the beginning of the crack. These were enlarged by the following flights where the crack became an open crack. The final deformation of the cylinder and the open crack contributed to the complete loss of pressure and the external leakage of the nose landing gear shock absorber. Finally, the severe deformation of the cylinder resulted in the jamming of the nose landing gear shock absorber after take-off at Kavala and no longer extended fully.

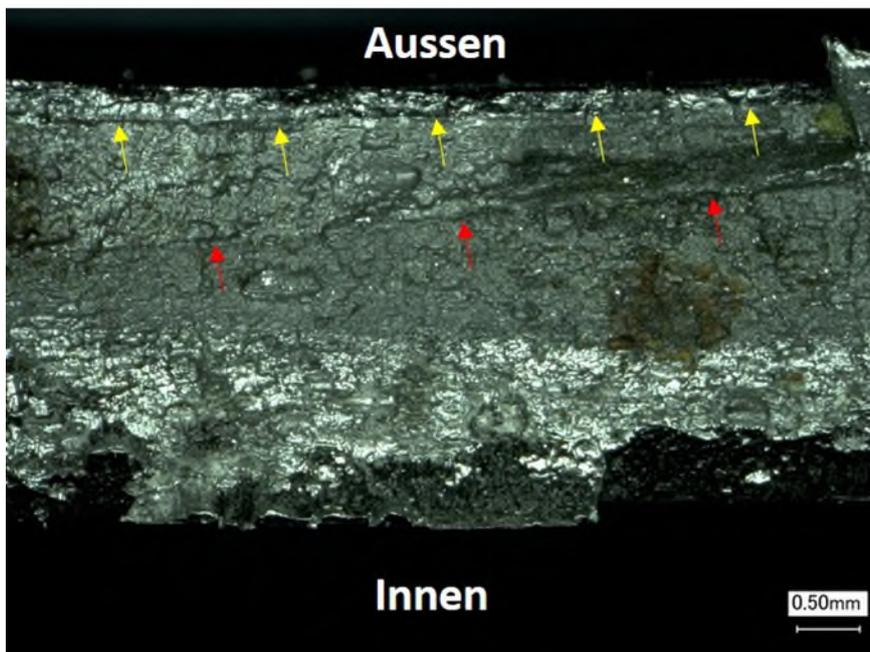
The landing gear manufacturer performed a fractographic analysis of the crack surfaces. Different arrest lines were found. Figure 24 shows the main arrest line which is marked with red arrows, a second with yellow arrows. Generally, arrest lines indicate a change in crack growth rate or a local variation in propagation direction. According to the landing gear manufacturer, the arrest line marked with red arrows indicates that

the crack propagated from inside to outside. The arrest line marked with yellow arrows, which is closer to the outer diameter, indicates that the complete crack occurred in several steps.

Shear lips were found on both sides of the wall section which indicate the location of the final overload fracture, according to the landing gear manufacturer.

The fractographic analysis shows that the entire crack was the result of a succession of ductile cracks running from the inner to the outer diameter of the cylinder, according to the landing gear manufacturer. The analysis of the arrest lines indicates that an overload event was the origin of the initial crack and that at least two more load events followed until the crack finally opened through the cylinder's wall.

Fig. 24: Different arrest lines in the crack's surface

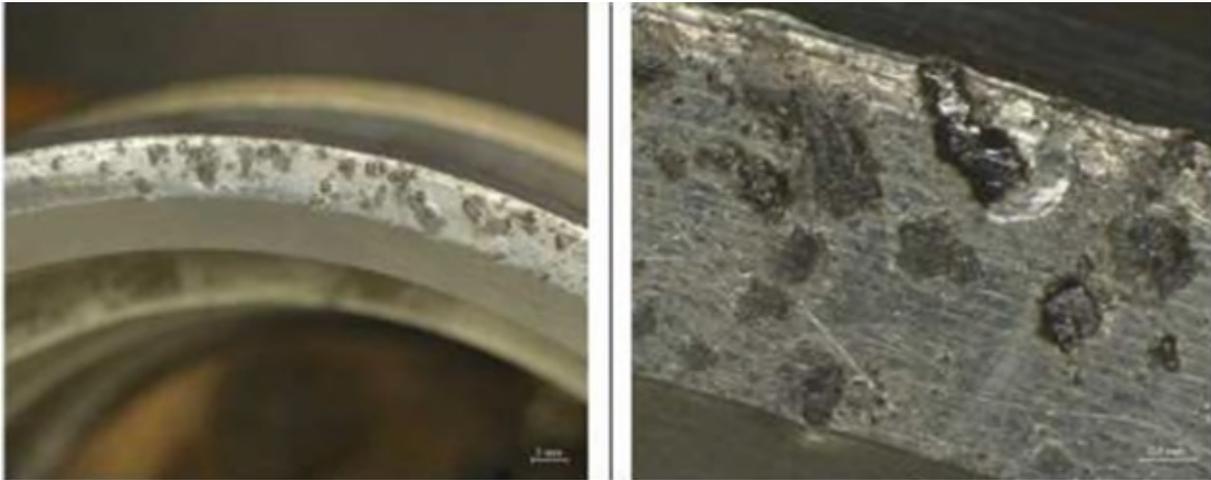
The landing gear manufacturer's examination determined that a strong mechanical contact between the lower restrictor surface and the corresponding surface inside the sliding tube, which would have caused a deformation of the components, could be ruled out. Only slight contact traces were found, which are depicted in Figure 26.

Fig. 26: Slight contact traces at the lower surface of the restrictor

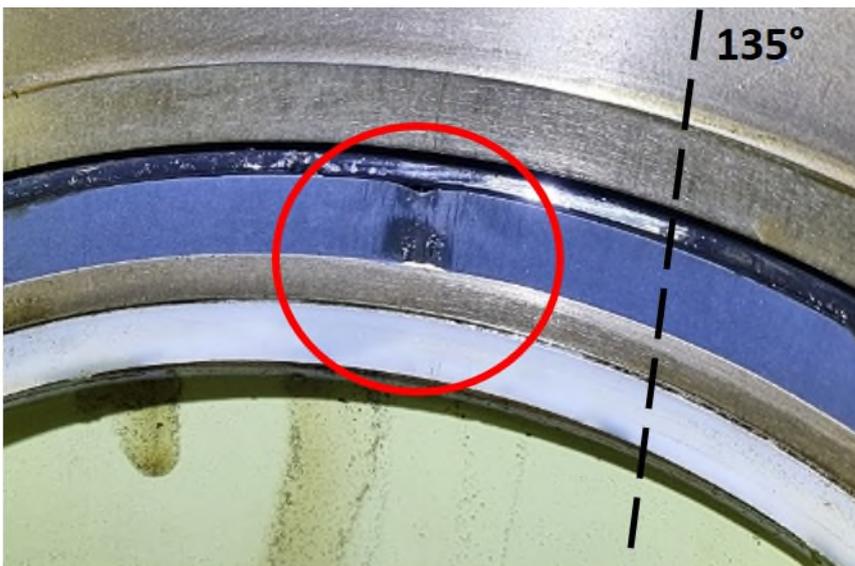
The dynamic seal is located at the inner diameter of the upper cam. Typically, it contributes to the sealing between sliding tube and cylinder. The landing gear examination revealed that the seal had been damaged (Fig. 27) at the area where the cylinder with the crack showed the largest defect. The landing gear manufacturer stated that the cylinder's damage was the cause for the damage of the dynamic seal which finally contributed to the deflation and the external leakage of the landing gear shock absorber.

Fig. 27: Damage of the dynamic seal

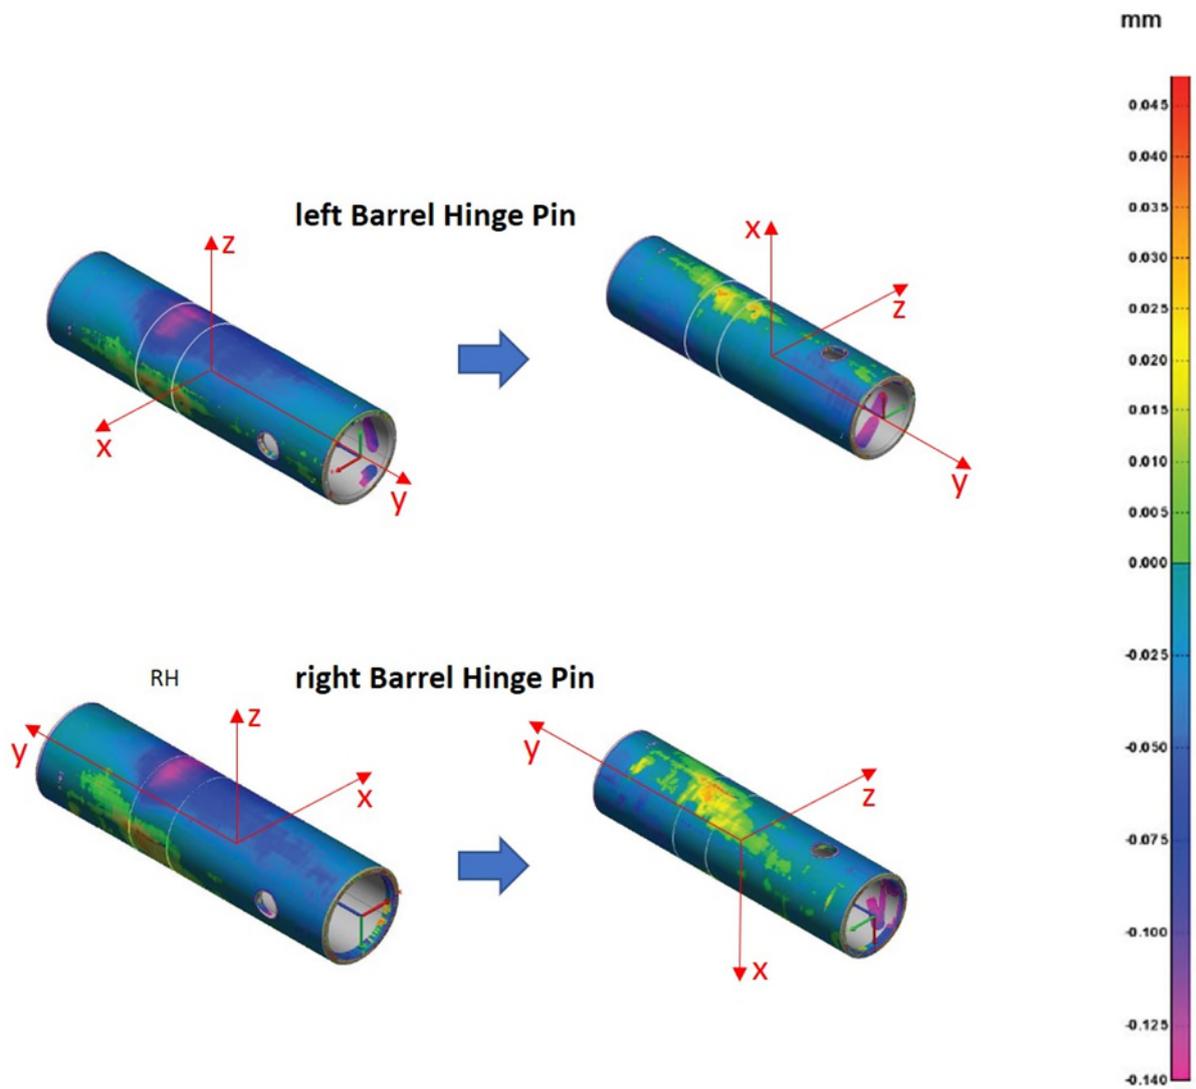
The deformation of the barrel hinge pins was measured using a 3D scan, among others. Figure 29 depicts the measuring results in different colours. The degree of deformation of the right barrel hinge pin was slightly larger than the left.

Fig. 29: Deformation of the two barrel hinge pins

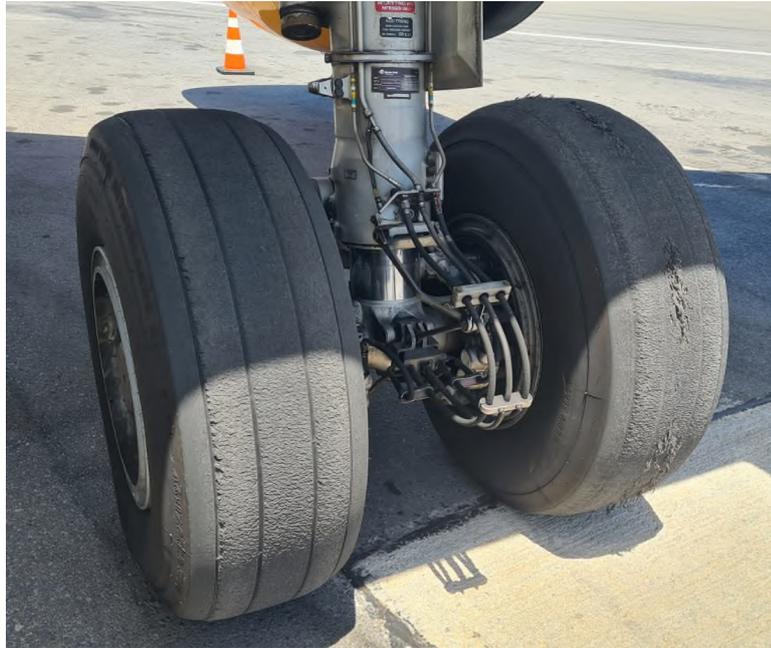
The BFU interviewed the mechanics, who stated that initially they had performed a General Visual Inspection (GVI) and determined that all four tires of the main landing gear, especially the outer tire of the right main landing gear (Fig. 30), had been damaged and had to be replaced. None of the tires was deflated. The mechanics stated that the GVI included a visual inspection of the nose landing gear area, the nose landing gear bay and the front fuselage section, among other things. The results of the inspection of these areas were not documented in detail.

Fig. 30: Condition of the tires No. 3 and 4 after the rejected take-off

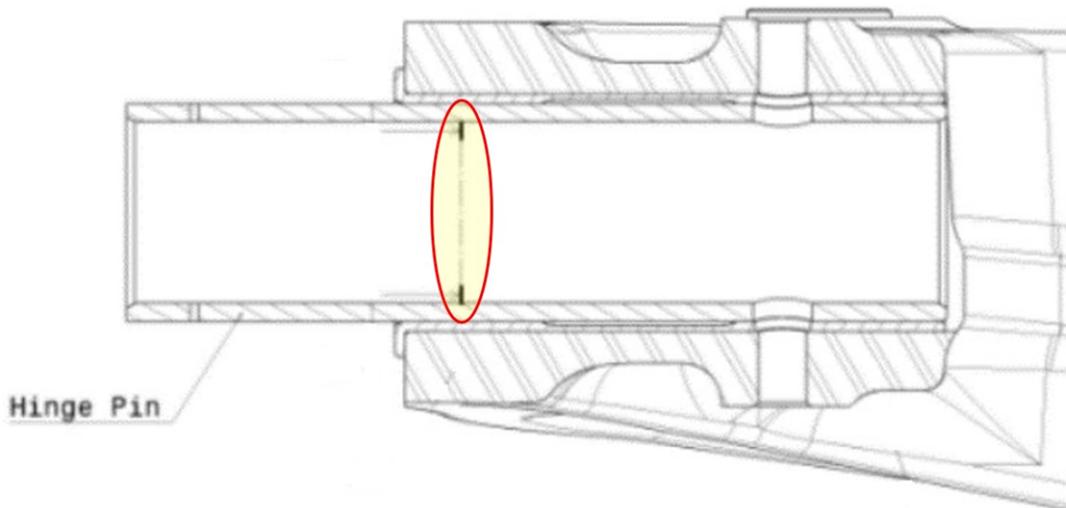
According to the landing gear manufacturer, the maximum vertical load limit in the critical area is 232 kN. At a load of 310 kN or higher the barrel hinge pin begins plastic deformation. Therefore, the landing gear manufacturer assumes that during the

rejected take-off both barrel hinge pins were subject to a vertical load of 310 kN or more each.

Fig. 34: Critical area of the barrel hinge pin
