# Aviation Investigation Preliminary Report

| <b>Location:</b> | Washington, DC | <b>Accident Number:</b> | DCA25MA108 |
| <b>Date &amp; Time:</b> | January 29, 2025, 20:48 Local | <b>Registration:</b> | N709PS (A1); UNREG (A2) |
| <b>Aircraft:</b> | BOMBARDIER INC CL-600-2C10 (A1); Sikorsky UH60 (A2) | <b>Injuries:</b> | 64 Fatal (A1); 3 Fatal (A2) |

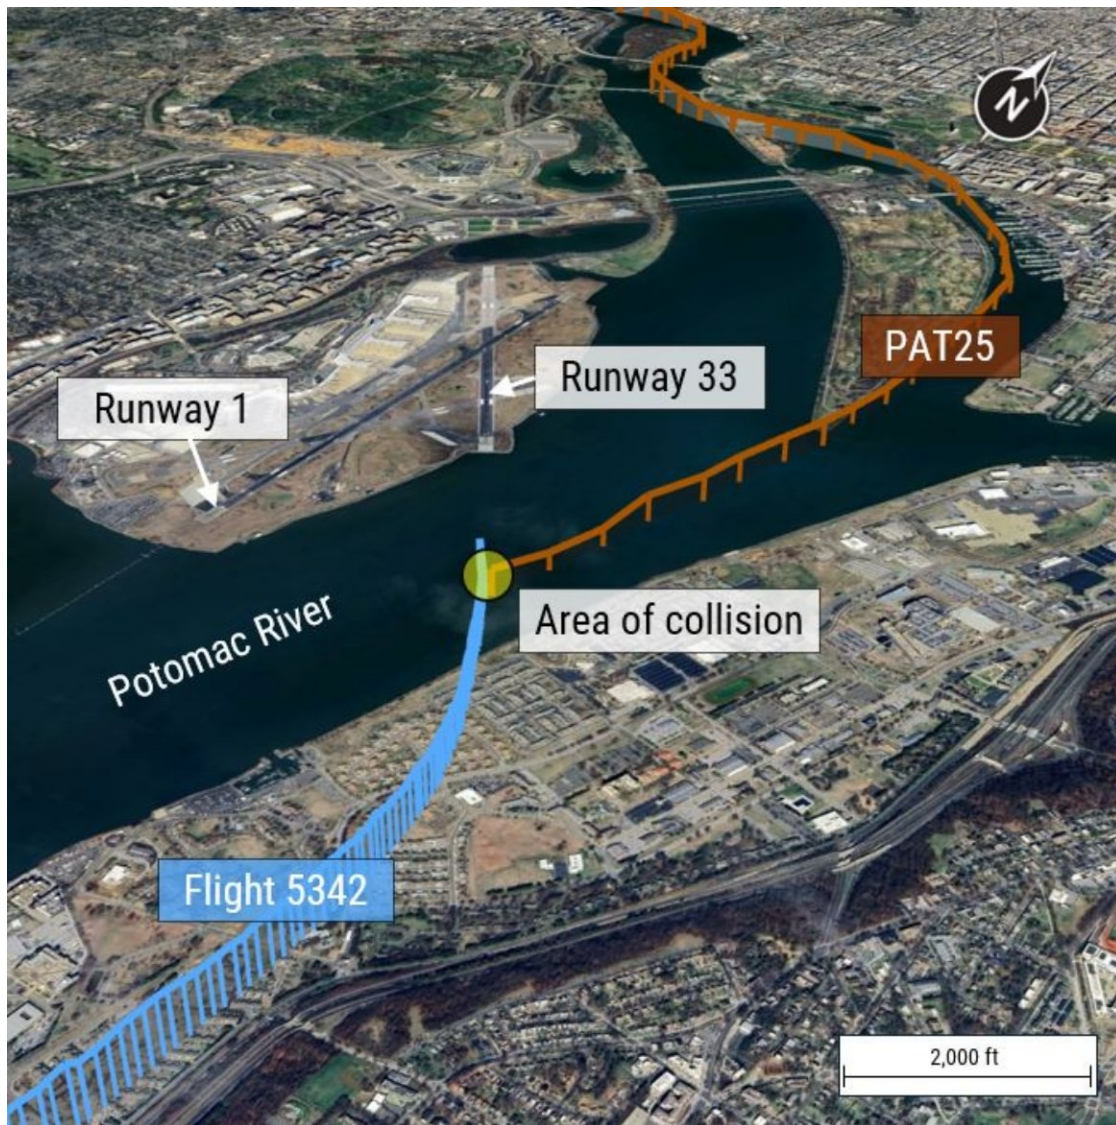
**Figure 1.** Google Earth image with preliminary ADS-B data for flight 5342 (blue line) and radar data for PAT25 (orange line).

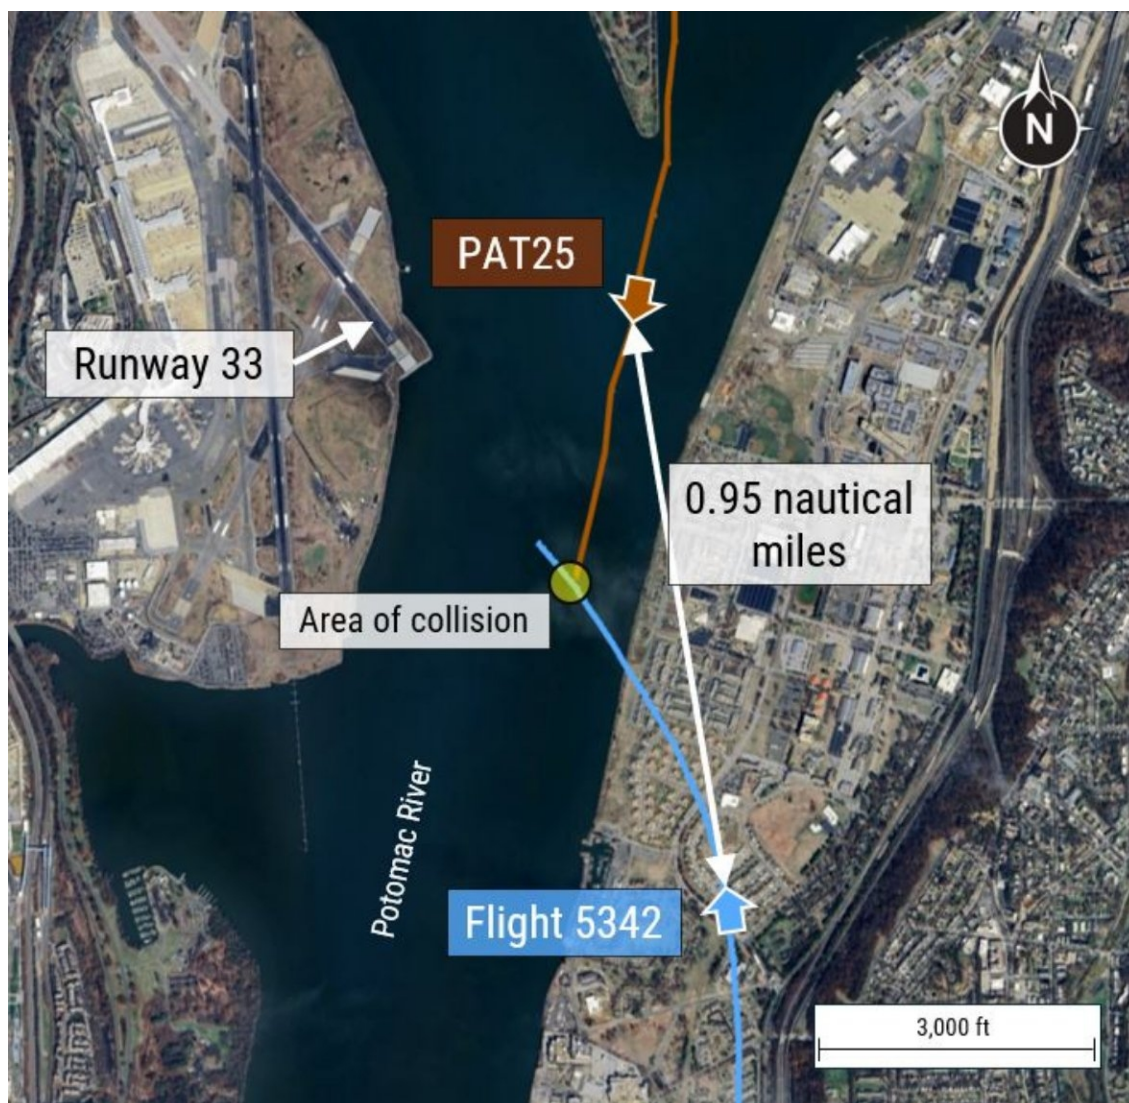
At 2047:40, the crew of flight 5342 received an automated traffic advisory from the airplane's traffic alert and collision avoidance system (TCAS) system stating, "Traffic, Traffic." At this time, the aircraft were about 0.95 nm apart, as shown in Figure 3.

**Figure 3.** Google Earth image showing the approximate positions of both aircraft at 2047:40.

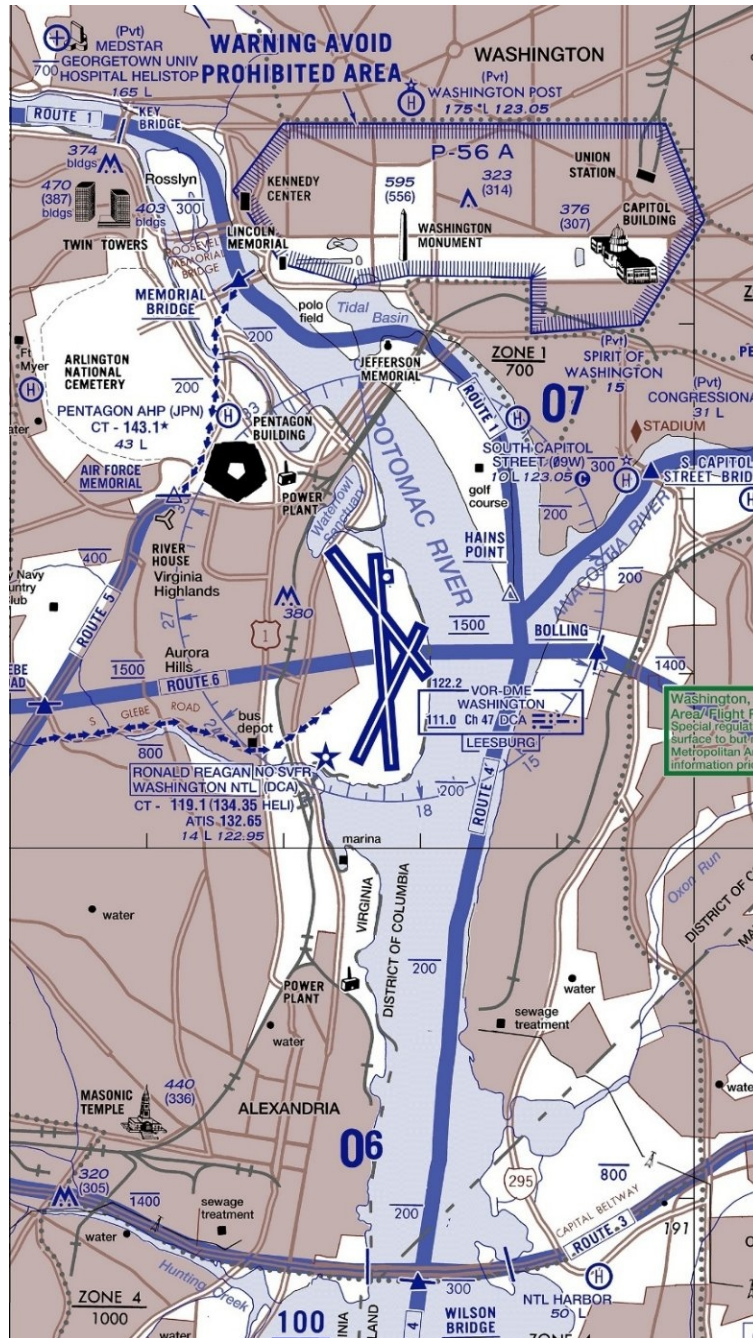
The Baltimore-Washington Helicopter Route Chart contains the helicopter routes for the Washington, DC area; the area immediately surrounding DCA is excerpted below (see figure 4). PAT25’s route on the night of the accident included Route 1, which begins in Cabin John, Maryland, and follows the western shore of the Potomac River southeast toward Washington, DC. After crossing Key Bridge, the route follows the eastern shore of the Potomac with the Kennedy Center and Lincoln Memorial to the east and Roosevelt Island to the west, crossing Memorial Bridge (a compulsory reporting point). After Memorial Bridge, the maximum allowable altitude on Route 1 is 200 ft above mean sea level (msl).

**Figure 4.** Excerpt of FAA Baltimore-Washington Helicopter Chart showing the area surrounding DCA. (Source: FAA.)

Route 1 then continues south of the Washington Monument, crossing West Potomac Park and the Tidal Basin before following the Washington Channel along East Potomac Park. Hains Point, the southernmost tip of East Potomac Park and located at the confluence of the Potomac and Anacostia rivers, is identified as a non-compulsory reporting point and the area where Route 4 intercepts Route 1. Route 4 continues south to the Woodrow Wilson Bridge

along the Potomac River's eastern shore, with DCA to the west. South of Wilson Bridge, the maximum allowable altitude along Route 4 increases from 200 ft msl to 300 feet msl.

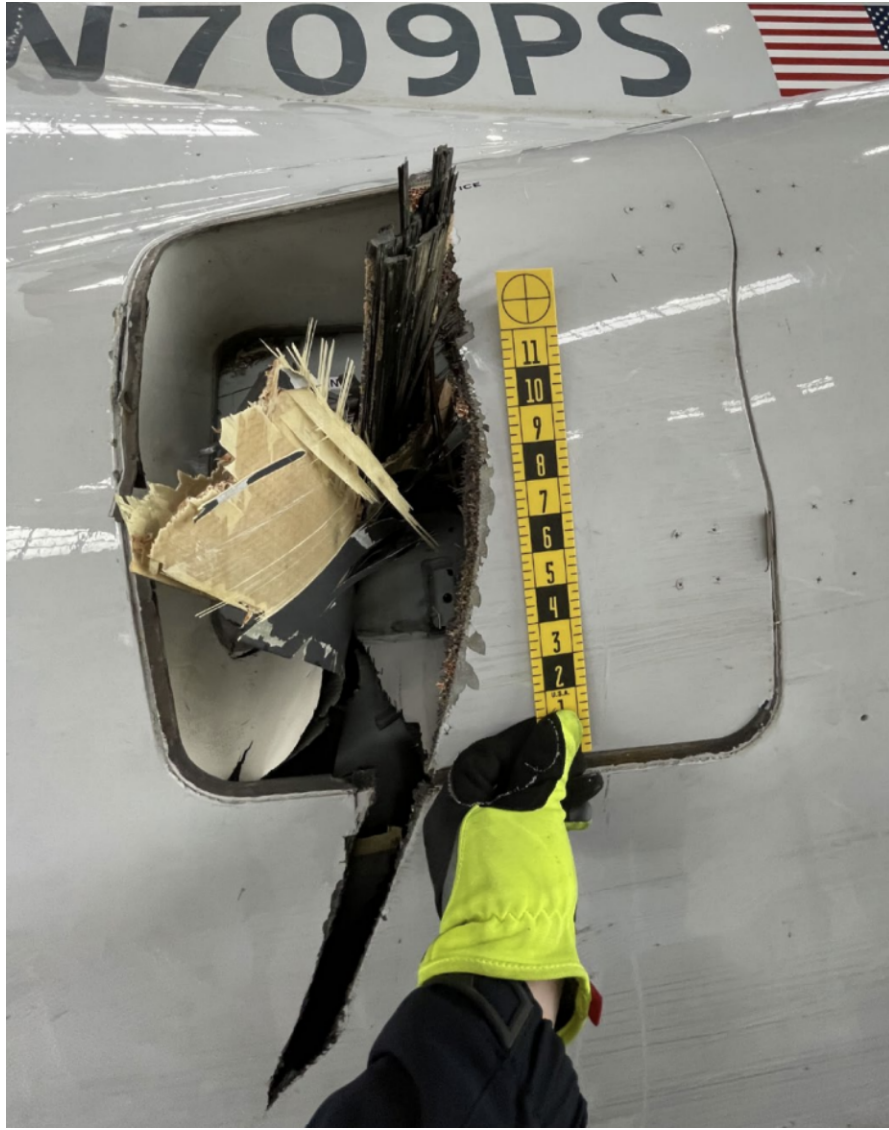
The airplane sustained extensive water impact damage to most of its structure. The fuselage was recovered in 13 major sections comprising the entire length of the airplane, from the radome in the nose to the aft fuselage and tail cone. Two areas of damage were noted to the lower right side aft fuselage wing-to-body fairing. There was a puncture in the right side of the fairing about 10 inches (in) by 8 in, and a slash through the lower surface of the fairing, internal structure, and lavatory access door about 29 in long by 2 in wide. An approximate 2-ft-long section of one of the helicopter's tail rotor blades was embedded in the slash (see figure 5).

**Figure 5.** Damage to aft fuselage with tail rotor blade.

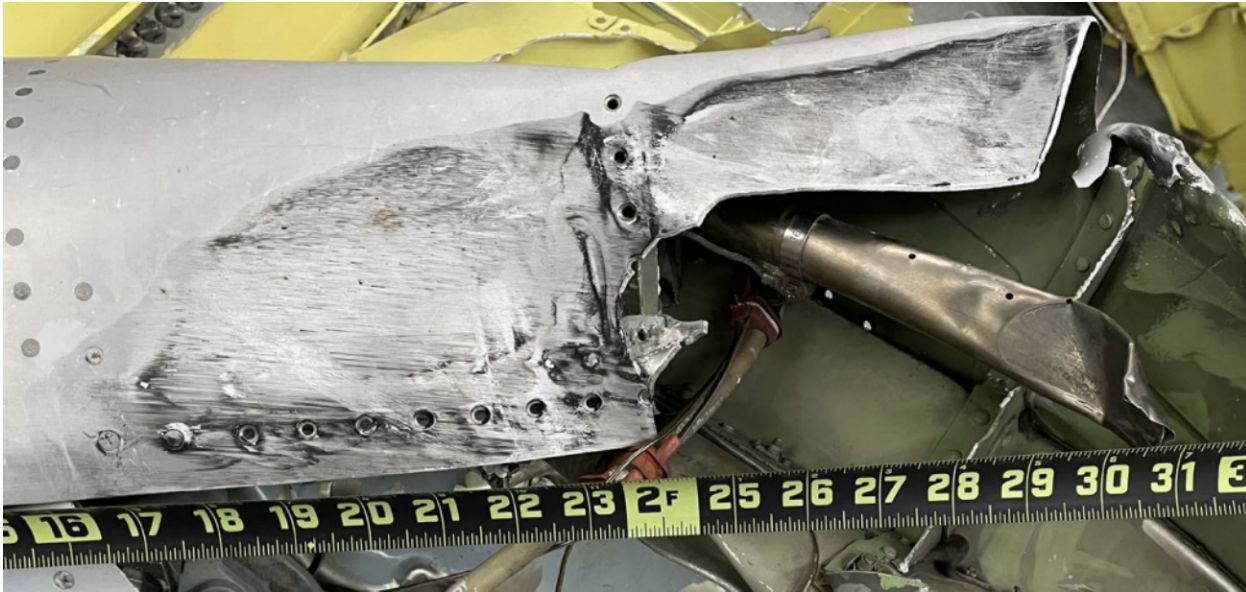
Two other sections of the inboard left slat displayed impact/denting and associated black paint transfer (see figure 7). Various pieces of fibrous materials were found in multiple sections of the airplane, including the left wing and vertical stabilizer. Samples of the fibrous material were collected for documentation and identification at the NTSB Materials Laboratory.

**Figure 7.** Close up view of impact mark on left inboard slat.
