# A review of the effectiveness of emergency locator transmitters in aviation accidents

**ATSB Transport Safety Report**

Aviation Research Investigation

AR-2012-128

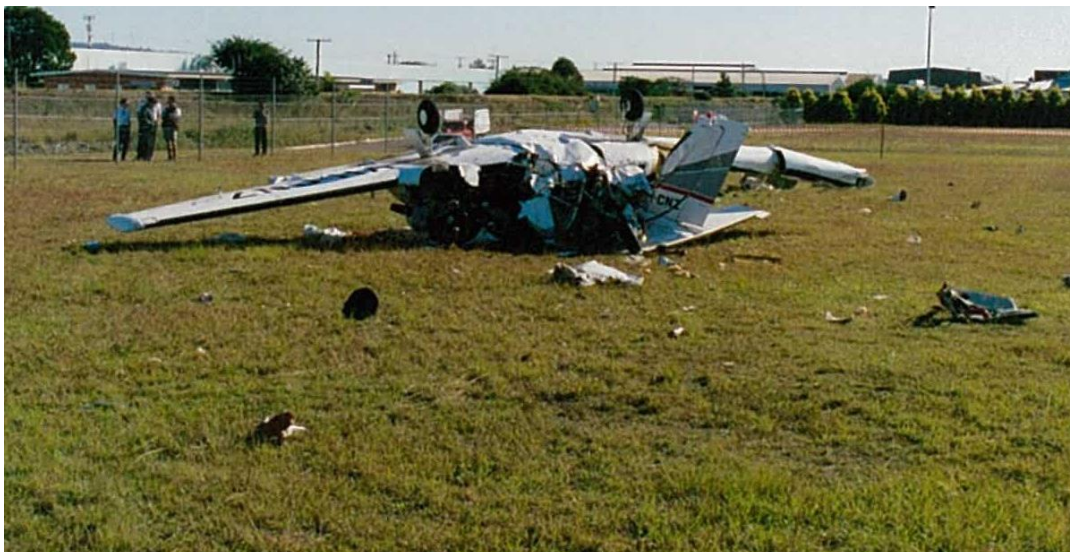
**Figure 7: Wreckage of the Piper Twin Comanche near Archerfield Airport, Qld**

During the initial investigation response by the ATSB, it was noticed that the aircraft was fitted with what appeared to be a reasonably new ELT. Examination of the wreckage found that the ELT was mounted in a fixed cradle on the right side of the fuselage, immediately behind the rear cabin bulkhead. The beacon did not activate as a result of the initial impact. On the day following the accident when the on-site investigation work was complete, the wreckage was transported to a nearby hangar by a tilt bed truck. As the wreckage was lowered from the truck and came into contact with the concrete floor of the hangar, the ELT activated. Closer examination showed that the ELT and cradle had been fitted to the aircraft incorrectly, in that the base of the ELT was facing in the wrong direction.

While the ELT survived the collision with terrain and was fully functional, incorrect installation resulted in it not activating as intended. This type of ELT was fitted with only a single plane g-switch (3-axis g-switches are now available) that required it to be fitted so that the impact forces are felt through the base of the unit. This requires that this type of ELT be fitted with the base aligned in the direction of travel.

An advantage of ELTs with a g-force activated switch that only operates in one axis is that they are not likely to accidentally activate due to turbulence, however, this may result in the ELT not activating in some types of accidents where there is not a high forward load in the aircraft impact (such as in an in-flight breakup, or in a hard landing). Additionally, the use of a g-switch designed to operate in a particular spatial orientation means correct positioning and installation is critical in ensuring the device can function as intended, as demonstrated in this accident.

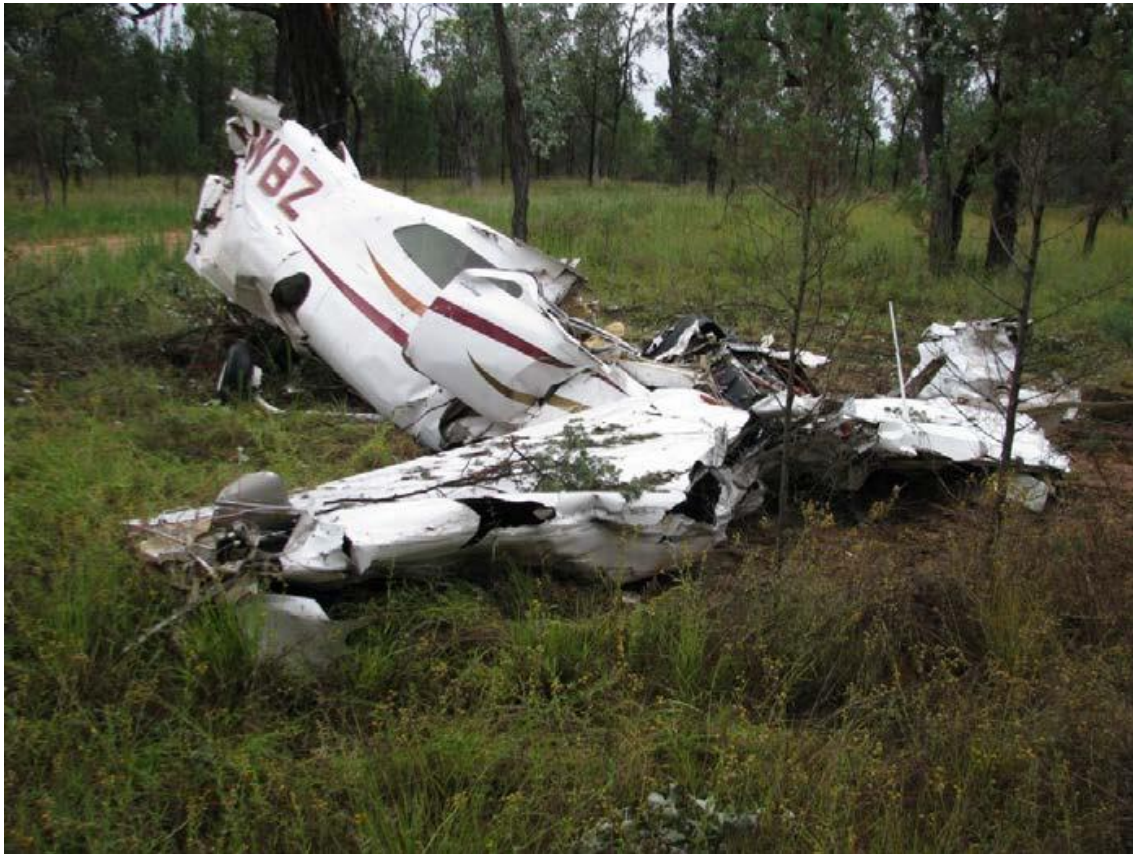
**Figure 8: Wreckage of the Cessna 210M near Injune, Qld**

In situations like in-flight breakups, aircraft debris is likely to be scattered over a wide geographic area, and while an ELT may have activated and survived, it may not indicate the location of the main aircraft wreckage. Although the ELT survived and activated in this accident, during the impact with terrain it detached from its fuselage mounting tray, separating the unit from the aerial cable. Broken antennae and disconnected antenna cables are a commonly observed reason for ELTs not functioning as intended in some high-g force accidents, as either case greatly reduces the transmission range. This is particularly the case in accidents where the aircraft fuselage is seriously disrupted, as in controlled flight into terrain (CFIT) and in-flight break-ups. In this accident, AMSA did not receive position information from the ELT itself, but from on-board mobile phones; a technique which is becoming increasingly frequent.

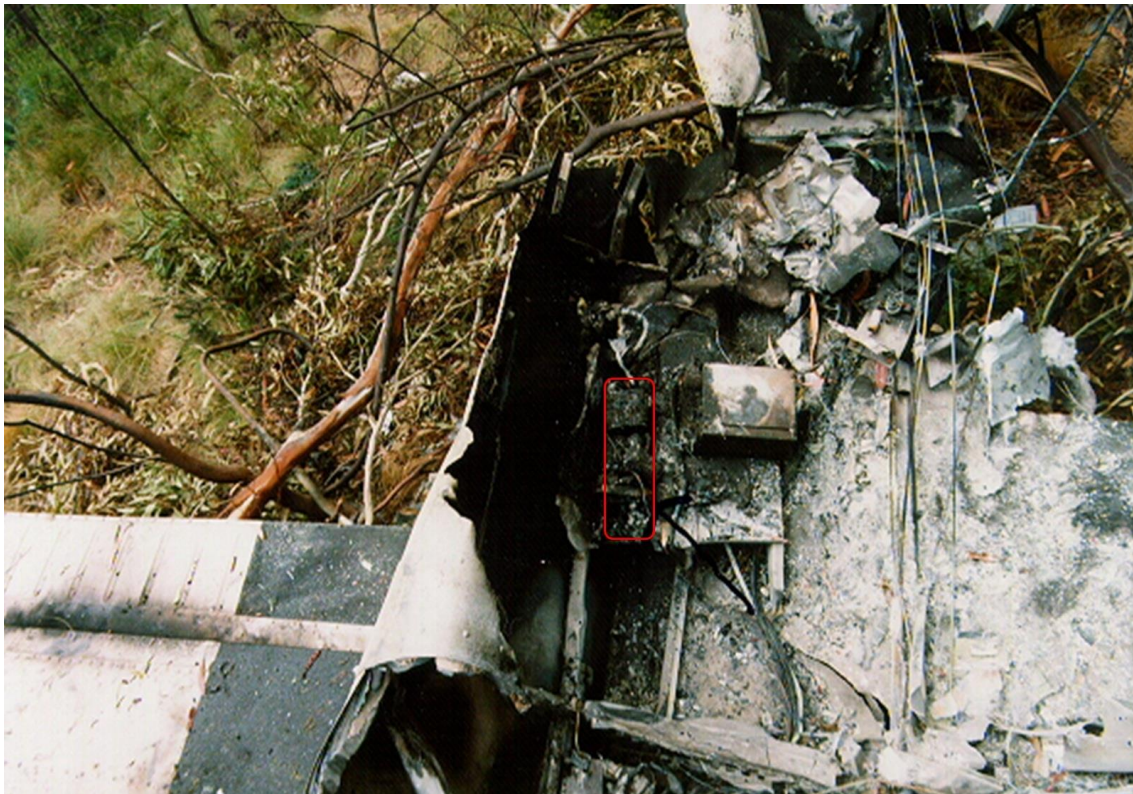
**Figure 9: Wreckage of the Piper Cherokee 37 km east of Coolah, NSW (the location of the burnt ELT is outlined in red)**

accident was survivable, both the pilot and passenger received extensive burns while escaping from the burning wreckage. The pilot died some time later from his injuries, before the aircraft and surviving passenger were located by SAR personnel. An ELT, mounted in the aft cabin area of the aircraft, was destroyed by the fire. While it was not possible to determine if the ELT had activated during the accident sequence, no signal from the ELT had been received by the satellite monitoring system. The pilot was known to possess a personal ELT; however, this was not located after the accident.

Unfortunately, fixed ELTs are not particularly fire resistant and there have been a number of investigated accidents where there was a post-impact fire in which the ELT burnt before a signal was received. In this accident, one of the occupants survived with serious wounds for approximately 40 hours after impact before succumbing to these injuries. Had the ELT survived the initial impact and subsequent fire long enough to send a signal, it may have shortened the time taken for SAR to locate and arrive at the accident site, and could have improved the survivability of the accident.

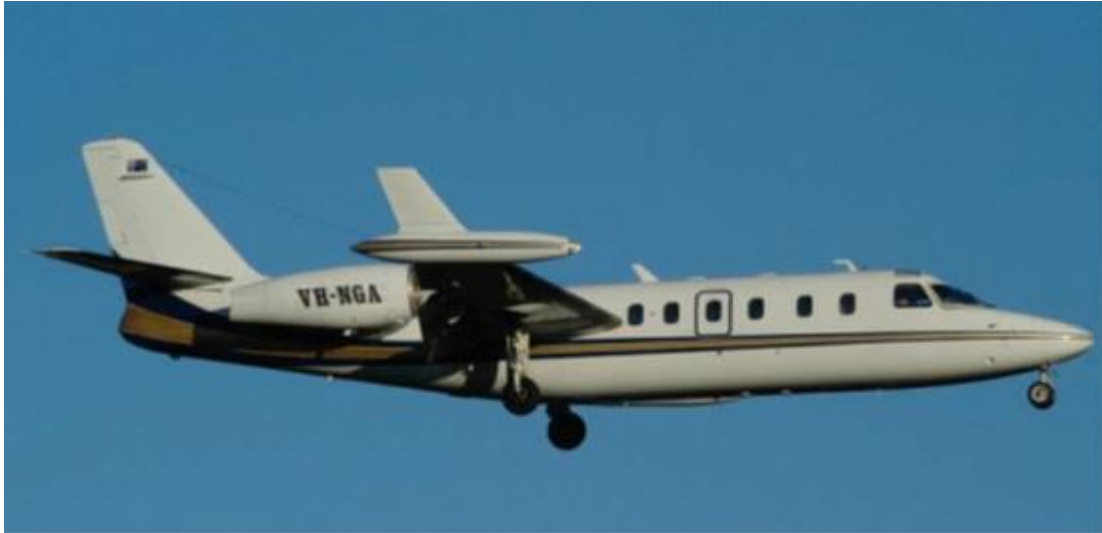
**Figure 10: The Israel Industries Westwind 1124A.**

The aircraft was fitted with a fixed, fuselage mounted 406 MHz ELT. The ELT was equipped with a g-switch and could be manually activated by a switch in the cockpit. The aircraft was also equipped with four personal locator beacons (PLBs) that could be carried separately and manually activated. Two of these beacons were installed in the life rafts, and one of the remaining beacons was equipped with Global Positioning System (GPS) equipment, which would enable it to transmit its position when it was activated. The aircraft occupants were unable to retrieve any of the PLBs or the life rafts before they exited the aircraft after the ditching. The aircraft-mounted ELT was not GPS-equipped. A geostationary satellite received one transmission from that ELT and the information associated with that transmission was received by AusSAR 8 minutes after the aircraft ditched. AusSAR was able to identify the owner of the ELT, but was not able to assess its location from the one transmission.

Although EPIRBs are required to be waterproof, there is no such requirement for fixed ELTs, which could have contributed to this ELT failing 8 minutes after ditching.

The 8 minutes in which the ELT was functioning was sufficient for only one signal to be received by satellites. This first signal contained the unique hex identifier but not any position information. As a result, the registration of the ditched aircraft was received but not any information regarding its location. Had the ELT been GPS-enabled, it is possible that further information regarding its location could have been transmitted in the first signal; however, this is still not guaranteed as the GPS chip requires some time to acquire its location once activated. Although the aircraft registration can be a good starting point for a SAR investigation, rescuers must wait for confirmation of the beacon's position before sending a search and rescue team, so a non-GPS equipped ELT can potentially increase the SAR response time. For very little additional expense, GPS equipped ELTs significantly increase the accuracy of positional resolution from approximately 5 km (non-GPS) to approximately 120 m for GPS-enabled ELTs.

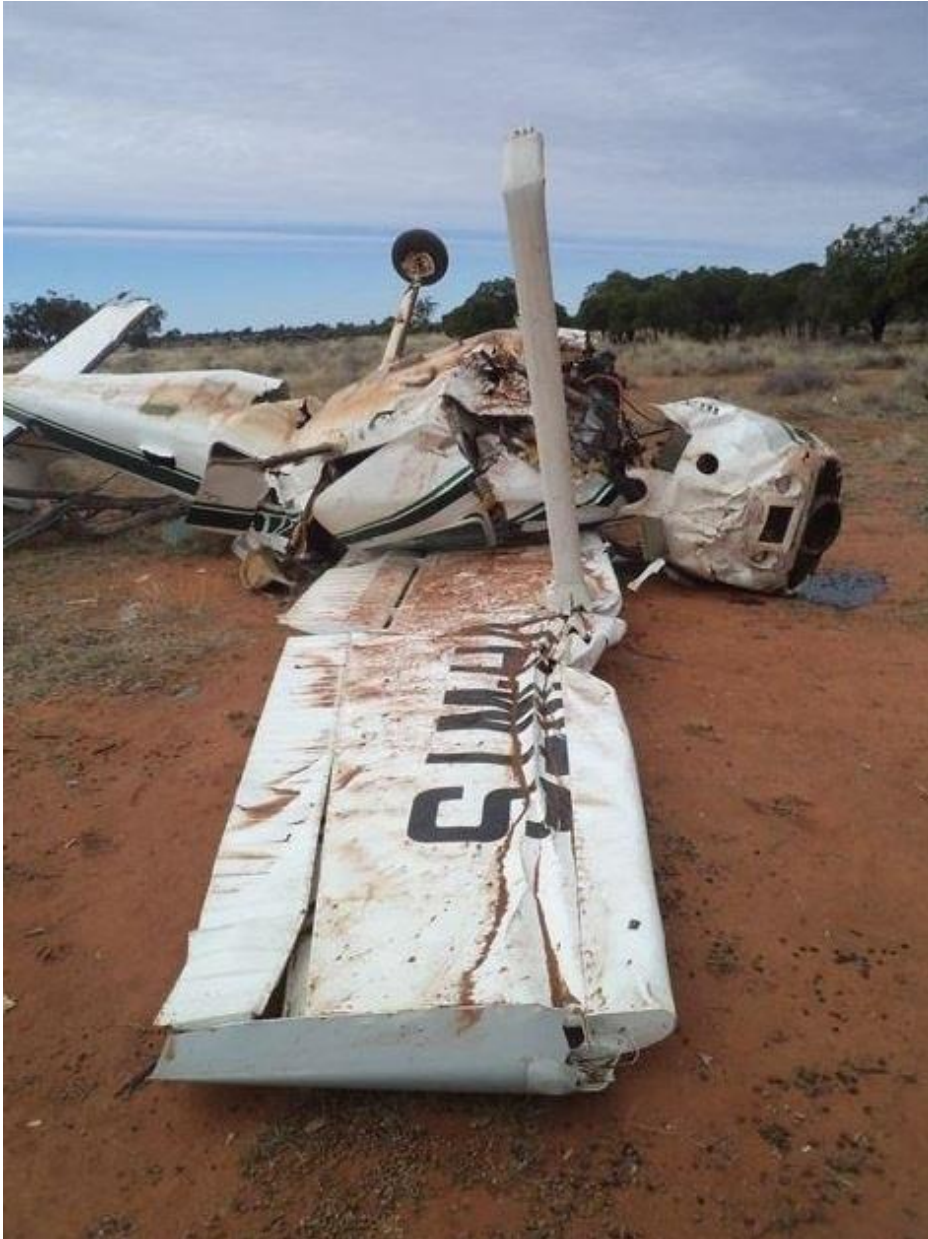
**Figure 11: Wreckage of the Cessna 182P in the vicinity of Mayvale Station, Qld**

The fixed fuselage mounted ELT did not activate during the impact. The reason the ELT did not activate was not determined in the ATSB investigation, but may have been due to shielding or disruption of the ELT antenna when the aircraft came to rest inverted. The pilot was also carrying a PLB on the accident flight, but it was not on his person. Due to injuries sustained in the accident, the pilot was unable to retrieve the PLB from the wreckage. Fortunately, the aircraft was still in the vicinity of the station, and the seriously injured pilot was rescued about 3 hours after the accident.

The ATSB has investigated many general aviation aircraft accidents where the pilot attempted a forced landing, and the aircraft came to rest inverted after impacting trees, ruts, or other obstacles. In many of these accidents, the ELT failed to operate. This is typically due to either the antenna (typically located on the upper surface of the fuselage) being disrupted in the impact or by the signal being shielded by the upturned fuselage.

This case also highlights the importance of carrying PLBs on your person (rather than loose in the aircraft or mounted to the instrument panel) so that they are within arm's reach if objects are displaced, if you are unable to reach the instrument panel, or if you are thrown clear of the aircraft in an accident .

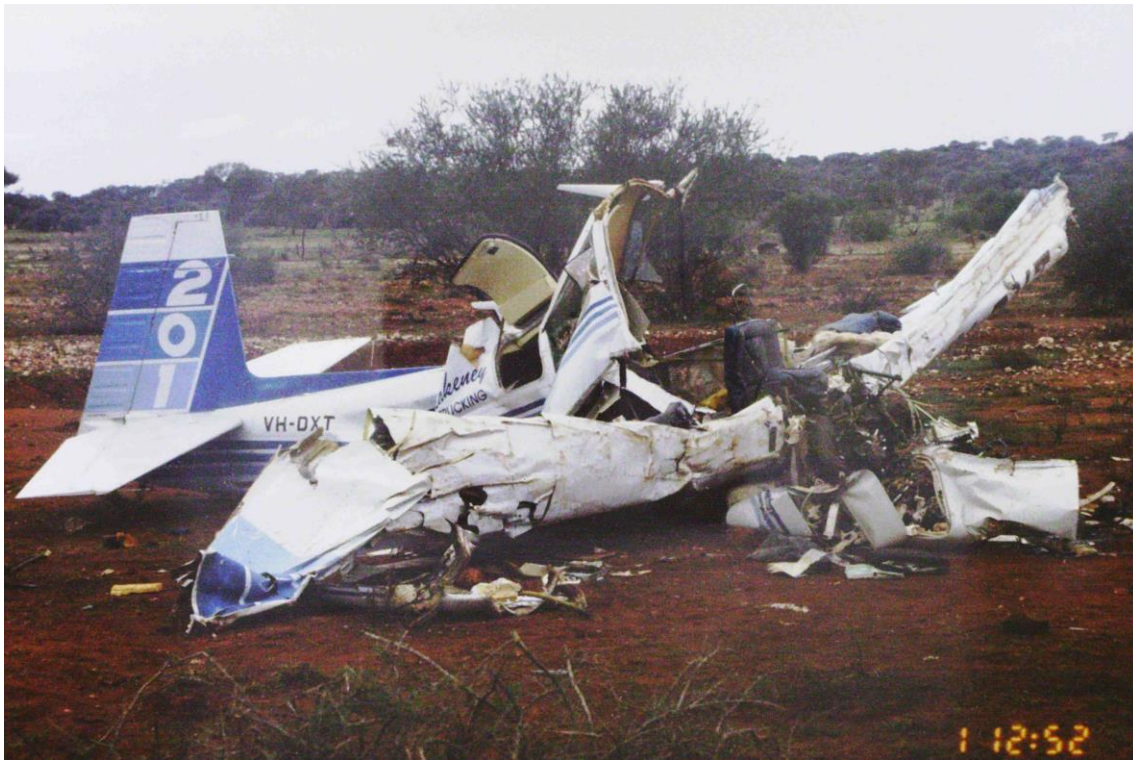
**Figure 12: Wreckage of the Mooney M20J at Melita Station, WA**

The aircraft was fitted with an ELT and although it appeared to be correctly mounted and connected, the ELT did not activate at the time of the accident. The ELT had a remote instrument panel-mounted activation switch which was selected to 'arm' and the switch on the ELT unit itself was selected to 'auto'. The ATSB investigation could not determine why the ELT had not operated during the accident. When tested during the investigation, it operated normally.

There are many cases like this one where there is simply no explanation as to why an ELT failed to activate during a high g-force impact. In this case, the ELT was found by the ATSB to be intact after the impact; the mounting was intact, the unit itself undamaged, and the co-axial antenna cable still attached. Both the switch on the ELT, as well as the remote switch on the instrument panel were found to be in the correct setting, and a functional test of the ELT unit after being removed from the aircraft confirmed that it operated as expected.
