## Maintenance Briefing Notes

### Cabin Residual Pressure Warning

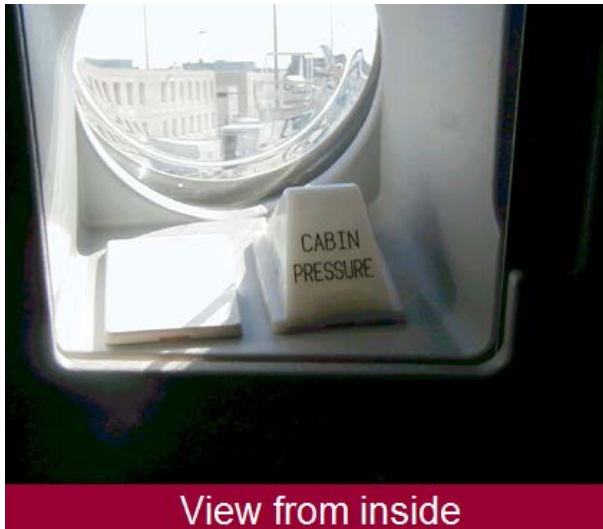
View from inside

During a scheduled maintenance inspection on an Airbus A330 aircraft, the cabin pressure switch static line was found incorrectly connected to the “P1” position instead of the “P2” position.

Under this condition, the Residual Pressure Warning System (RPWS) will not work, and the red warning lights on the doors will not flash in the event of a cabin residual pressure scenario.

Strictly follow, and verify that the maintenance instructions as per the AMM are adhered to.

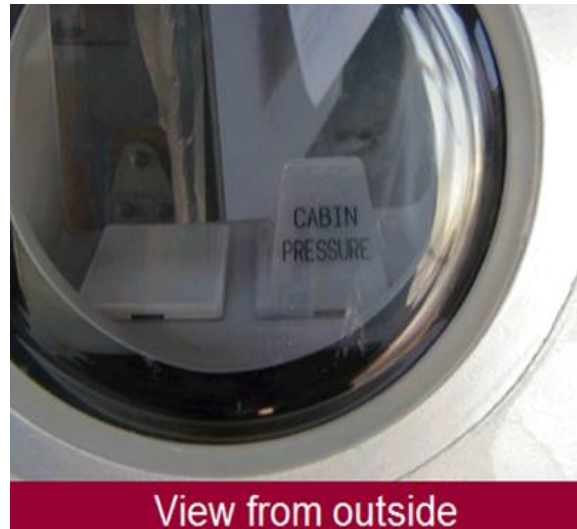
View from outside

The potential consequences are a rapid door opening, which can lead to serious injuries, if in addition other maintenance precautions are not applied.

In addition, it is reminded that the AMM requests that the following precautions are to be made in order to avoid rapid door opening due to pressurisation of the aircraft cabin:

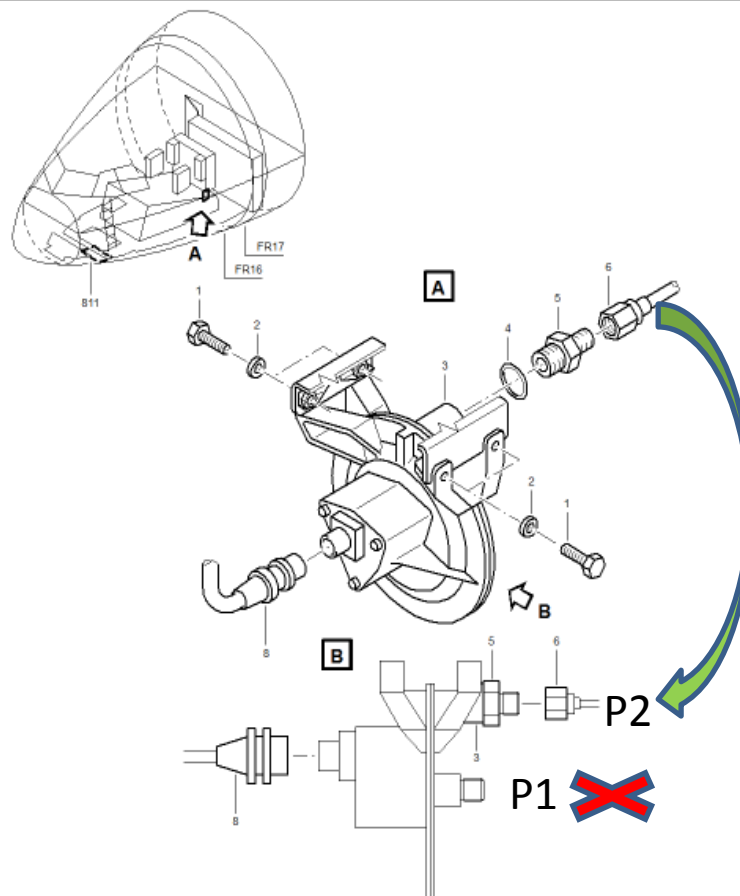
Figure 52-71-19-991-00200-04-A / SHEET 1 - Cabin Pressure Switch (40MJ)

The two pressure ports ("P1" and "P2") of the pressure switch are of different diameter.

The AMM installation procedure (AMM 52-71-19-400-801-A) requires a restrictor to be installed on the "P2" position (IPC 52-71-01-01 item 54).

With the restrictor installed, the connecting ports of "P1" and "P2" have the same diameter as the cabin pressure switch static line.

If instructions as per the AMM are not strictly adhered to, the static line can be connected to the wrong pressure port "P1".
