## Maintenance Briefing Notes

### Aircraft Centre Tank (ACT) fuel leak

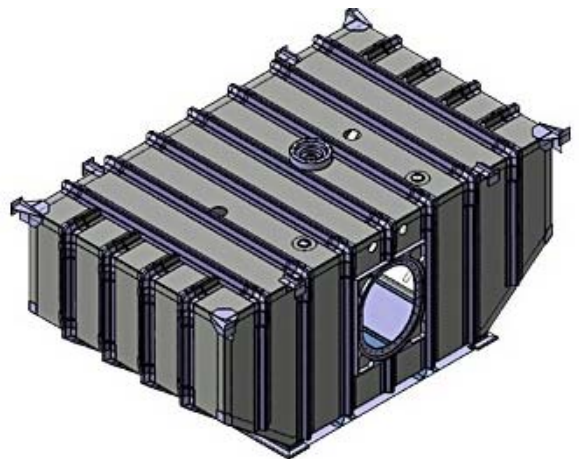
An Airbus A319 operator reported that during the accomplishment of a check of the leak monitor for evidence of fuel leakage (ref. AMM task 28-28-00-200-003-A), a leak was detected through the leak monitor (FIN 253QM, ACT position 4 and 6).

The leakage occurred when the fuel was transferred from the centre tank to ACT, but not in the opposite way.

Following further trouble shooting, all o-ring seals from the affected line (ref IPC 28-11-02-44) were replaced.

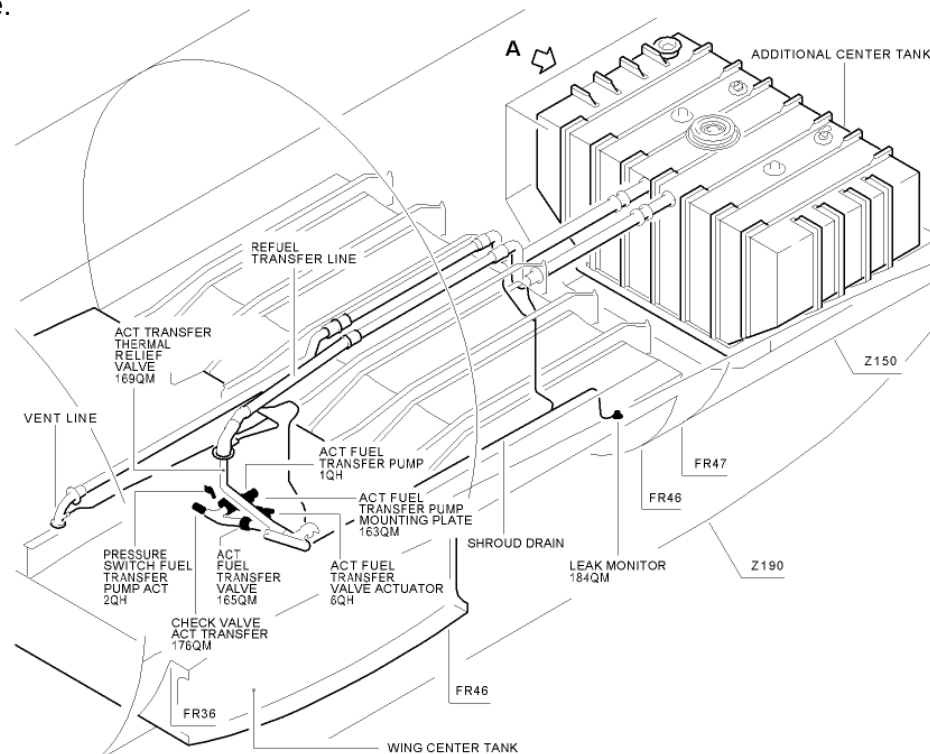
It appeared that the concerned aircraft operated over a longer time with the ACT inoperative and empty.

This has caused the seals to dry out, until they have lost their sealing capacity, leading to the leakage.

Should an operator decide to fly the aircraft over a longer time with the ACT empty, then the AMM task 28-28-00-610-001, "Operation of the aircraft with ACT installed without fuel" should be applied. This task ensures that there is a minimum fuel quantity in the tank to avoid that the seals will dry-out and lose their sealing capabilities."
