# **Incidents in Air Transport**

# Wind Gradients and Turbulence

N° 5 December 2006

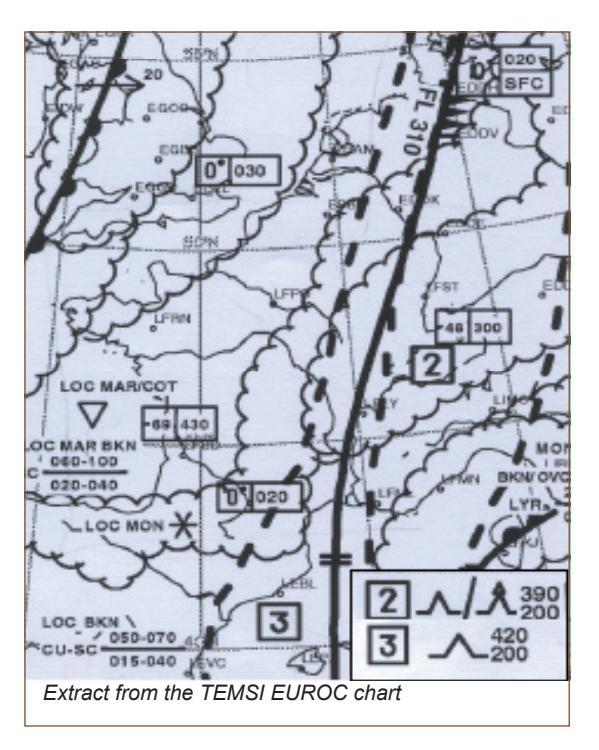
On the TEMSI EUROC chart (valid 1 h 30 later) the crew noted that the planned route entered an

area of moderate turbulence that extended from FL200 to FL420, centred on the jet stream.

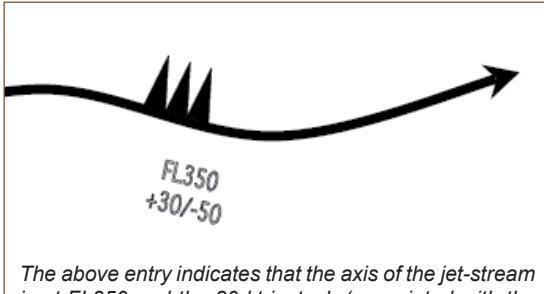
In the area of the incident, the heart of the jet stream was at FL280, 3,000 feet below the level indicated on the TEMSI chart. Winds above 80 kt were forecast between FL160 and FL425, which corresponds to a depth of jet stream of 26,500 feet.

The comparison between the forecast wind values and those encountered by the airplane shows that the wind speed was underestimated by 20 kt on average by the computer model. The wind gradient was forecast.

is at FL350 and the 80 kt isotach (associated with the limits of the jet's envelope) is located between FL300 and FL380

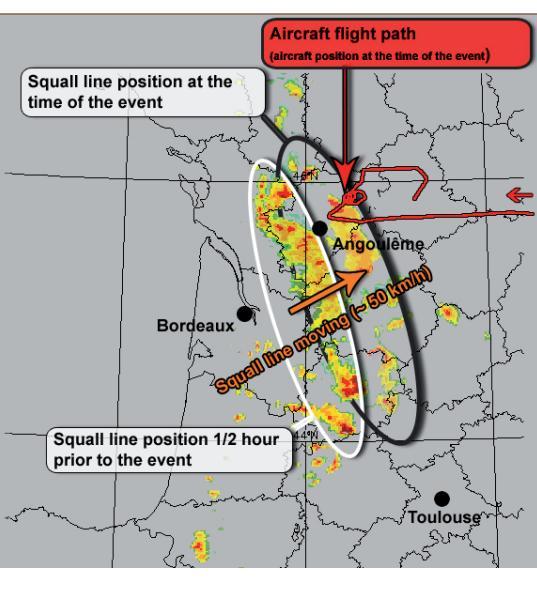
Overlay of two radar meteorological images taken at a 30 minute interval and the radar track of the airplane.

to review the meteorological situation and by manoeuvring to stay out of the clouds. These manoeuvres were performed with the AP in hold configuration at 150 kt, in a calm atmosphere. The crew took the decision to divert towards Limoges, located fifteen minutes flying to the east, and then retracted the flaps. In a turn to the right, the airplane then entered an area of severe turbulence that lasted 2 min 30 s.

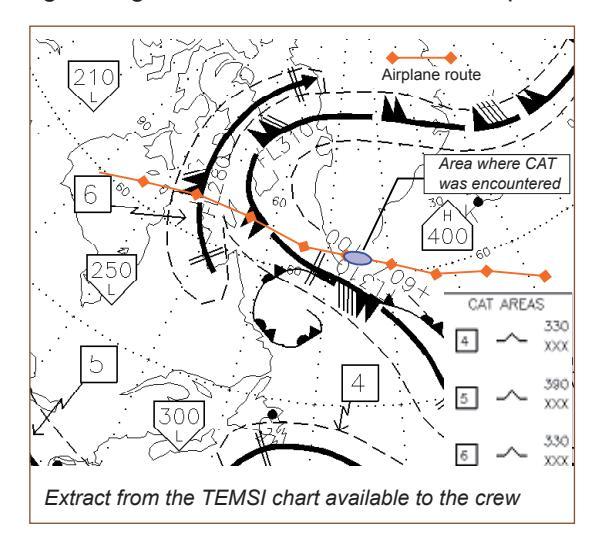
The cross section of the atmosphere, perpendicular to the jet stream shows a tightening of the isotachs towards the top, the

hot air forcing the upper cold air. This tightening, located between FL300 and FL400 generated a vast area of clear air turbulence.

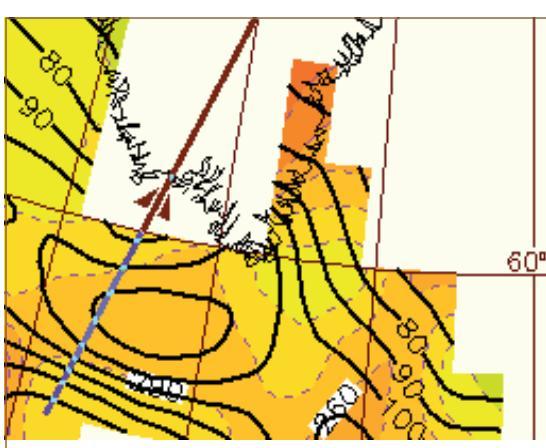
Horizontal position of the isotachs (the brown line corresponds to the axis of the cross section below)
