Aircraft Serious Incident Report

Landed on Unauthorized Runway China Shanghai Airlines B737-800, B-1949 Gimhae International Airport RWY 18L 07 September 2019

Dec. 2020

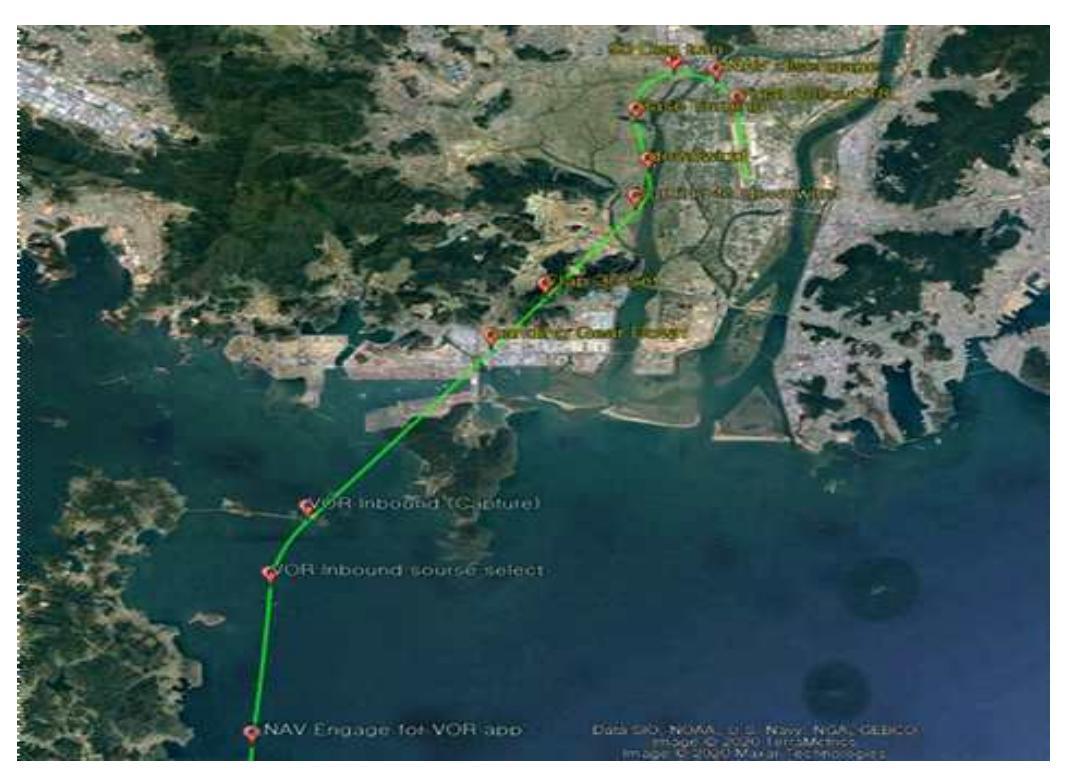
[Fig. 1] B-1949 Flight Path

B-1949, which obtained Gimhae ATC authorization for landing, continued to turn by about 1.5-mile radius from the end of RWY 18R and approached RWY 18R. At 16:46:30, B-1949 overshoot the final approach course of RWY 18R at 700ft and 0.8 mile on final from the threshold of RWY 18R. Overshooting the final approach course of RWY 18R, B-1949 lined up on RWY 18L at 700ft and 0.3 mile on final at 16:46:38.

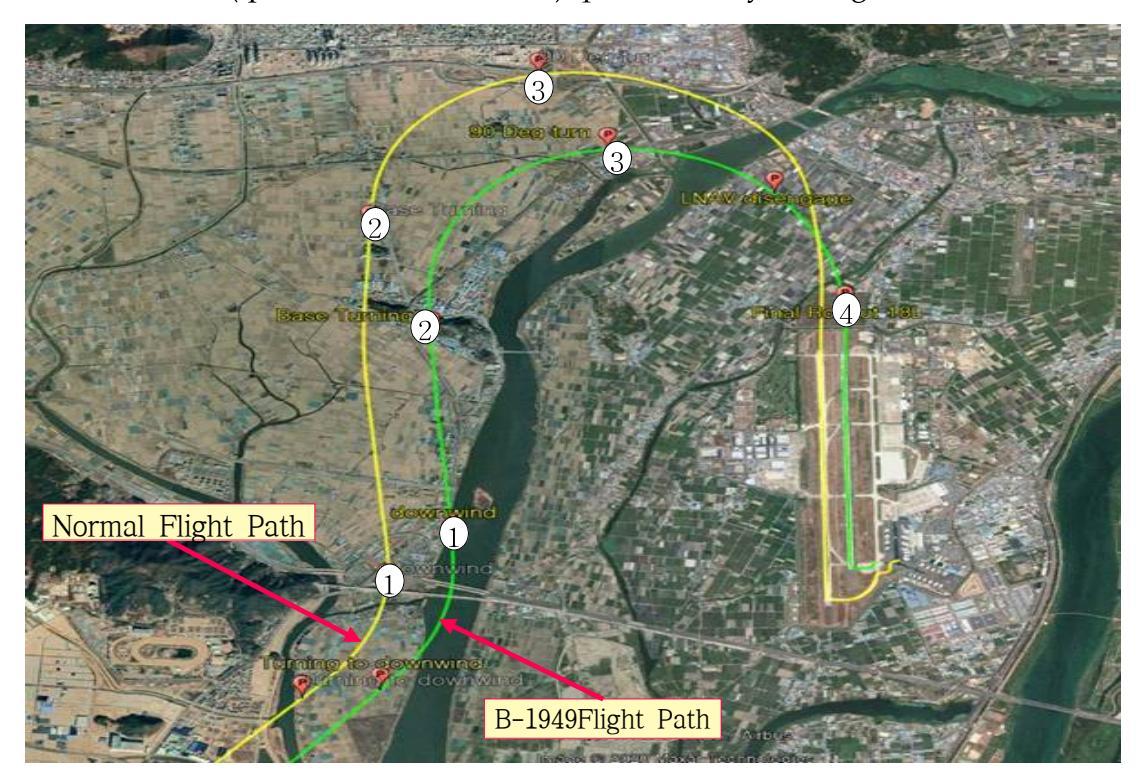
[Fig. 4] Comparison between Normal Flight Path and B-1949 Flight Path

As shown in [Fig. 4], B-1949 flight path started from downwind at ①, base turning at ②, 90° turn at ③, final rollout 18L at ④. Compared to normal circling approach track, the width of circling approach track of B-1949 was narrow.

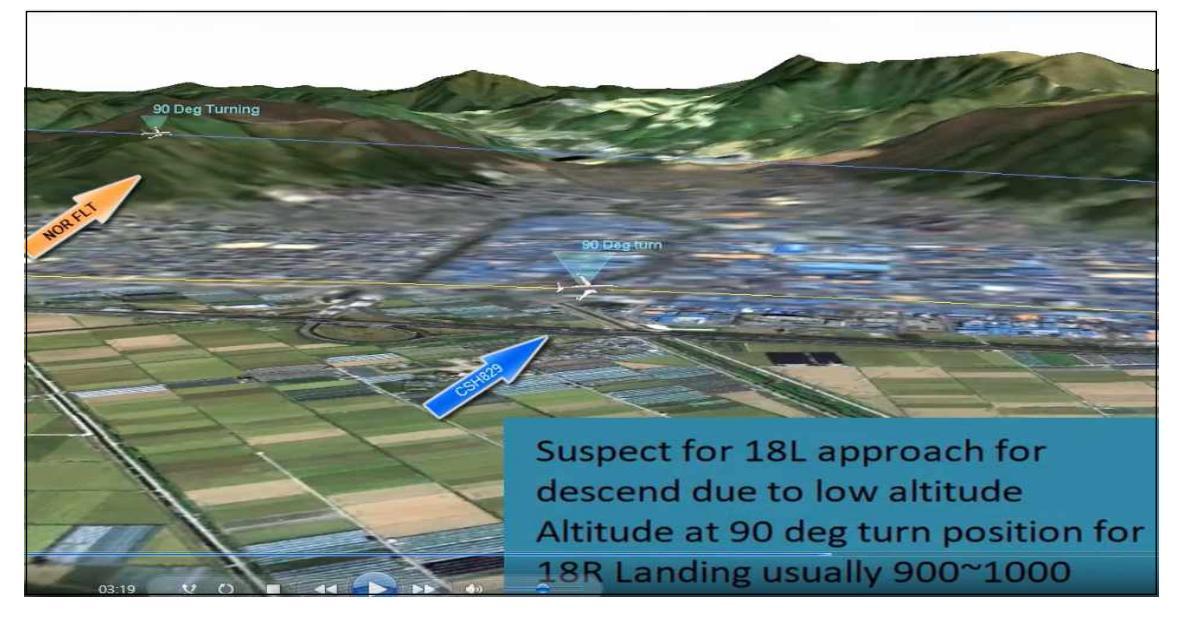
[Fig. 5] Normal Flight Pattern at 90 Degree Turning Position and B-1949 Flight Pattern

At 16:45:57, B-1949 made a right turn by 90° in base leg. As shown in [Fig. 5] and [Fig. 6], an airplane normally maintains its altitude from 900ft to 1,000ft at 90 degrees turning point to land on RWY 18R but B-1949 made a turn at 720ft which was lower than normal altitude by about 200ft.

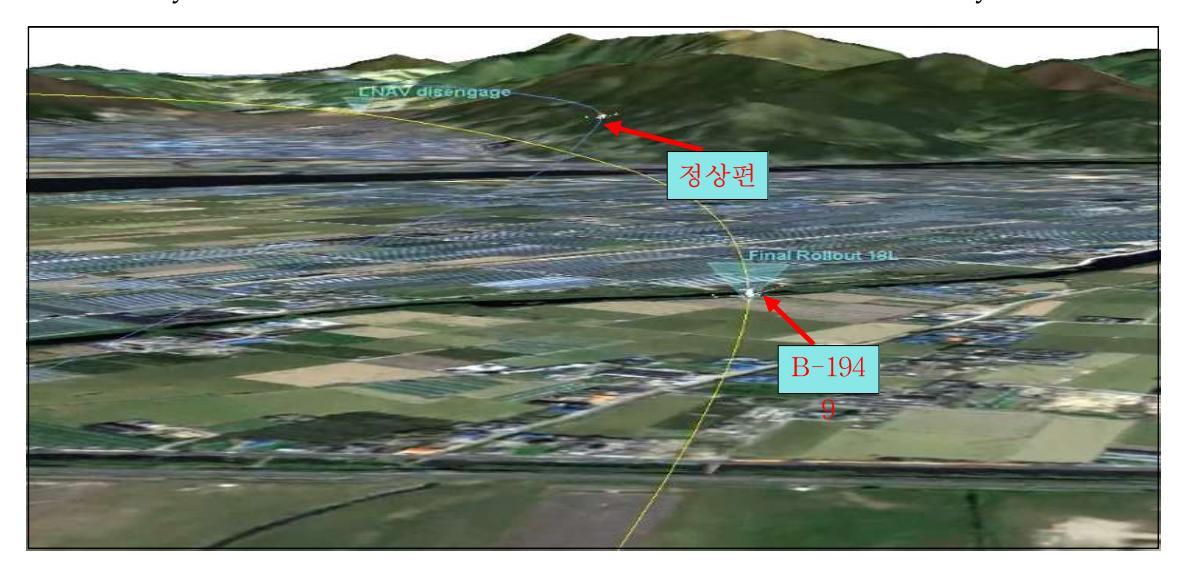
[Fig. 7] Normal Flight Location at Roll out Position and B-1949 Location

As shown in [Fig. 7] and [Fig. 8], an airplane normally maintains its altitude from 300ft to 500ft at the final rollout. However, B-1949 lined up

on runway 18L with its altitude of about 140ft which was very low.

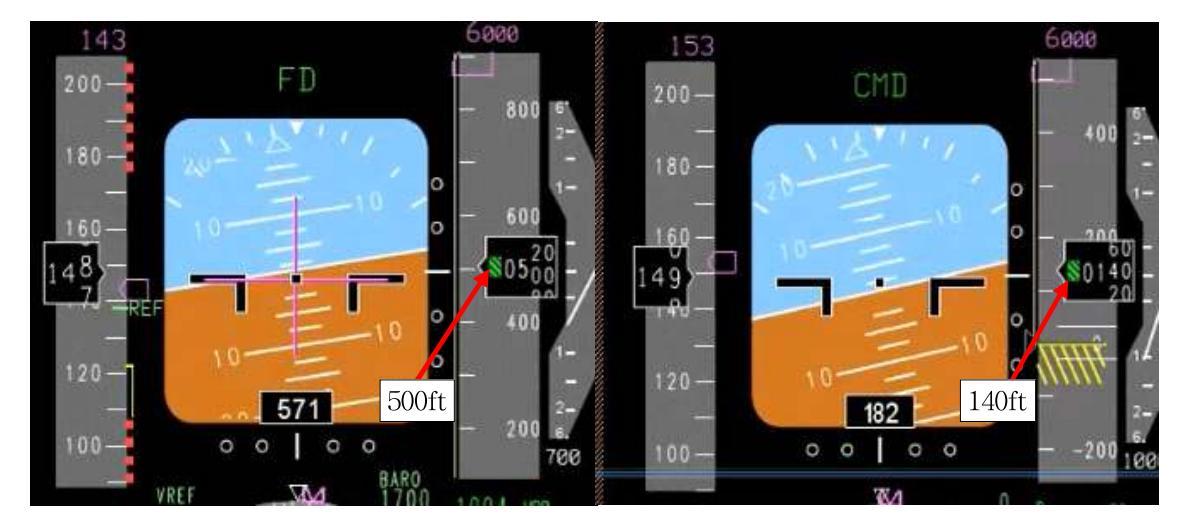
[Fig. 8] Normal Flight Altitude at Roll out Position and B-1949 Altitude

Compared with normal aircraft's circling approach track and B-1949's flight path, B-1949's circling approach radius was narrow. It indicates that B-1949 would have circled and approached at low altitude by about 200ft.

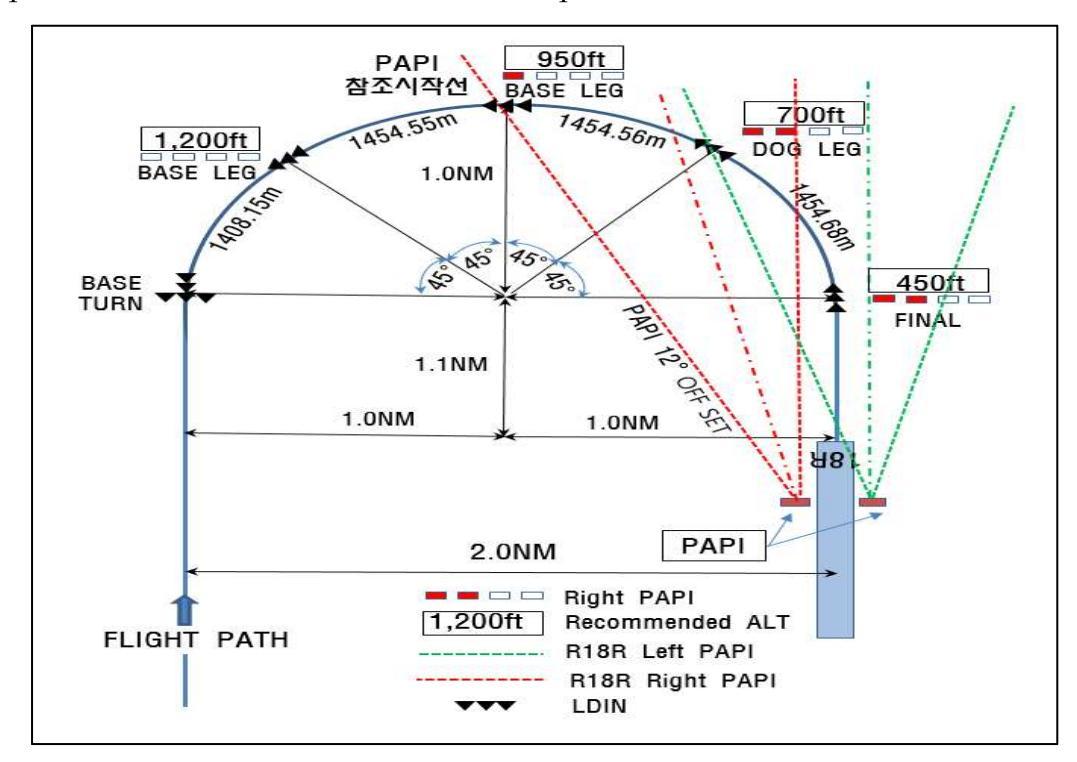
[Fig. 15] Lead-in-Light System for Circling Approach and PAPI Group

As shown in [Fig. 15], there are reference light aids for circling area on ground, which enables aircraft to perform safe operation and effective turning flight towards RWY18L/R. In addition, there is PAPI to the right circling path on RWY 18R, which allows pilots to utilize approach angle before entering the final approach course. Both light aids and PAPI were displaced to the west and have been operated.

As the captain had mentioned in his earlier statement, he focused too much on controlling aircraft attitude due to a strong wind and roar so that he failed to recognize surroundings on flight path. B-1949 overshot RWY 18R final approach course and lined up on RWY 18L.

In addition, the captain mistook RWY 18L PAPI as RWY 18R PAPI an d the aircraft landed on RWY 18L. The captain's failure to check external condition due to excessive attention paid to aircraft attitude control is con sidered as human error caused by the captain's carelessness.

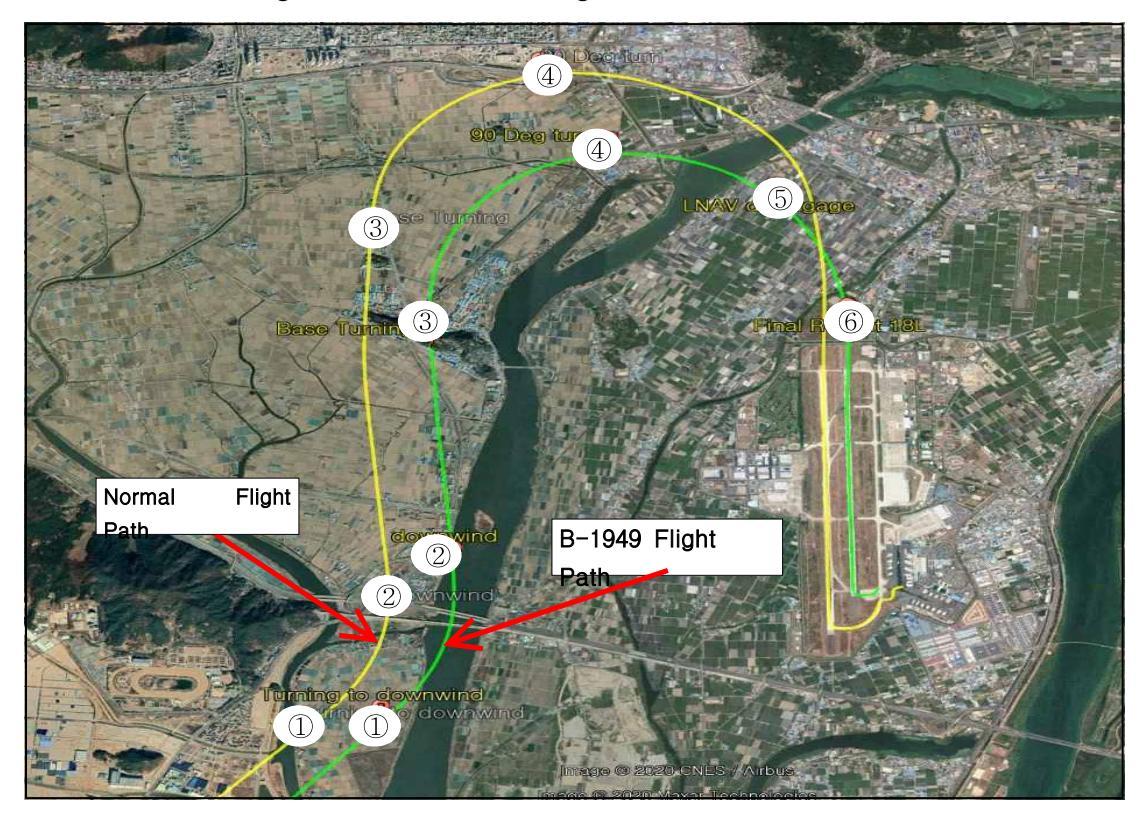
[Fig. 16] Normal Flight Path on RWY 18R and B-1949 Flight Path

B-1949 set the width of the downwind leg to narrow one when wind blew from the right side.

B-1949's circling approach course and normal circling approach course are as shown in [Fig. 16]. B-1949's approach course shown in green indicates that the aircraft turned inward about 600 to 800m compared to the aircraft making the normal circling.

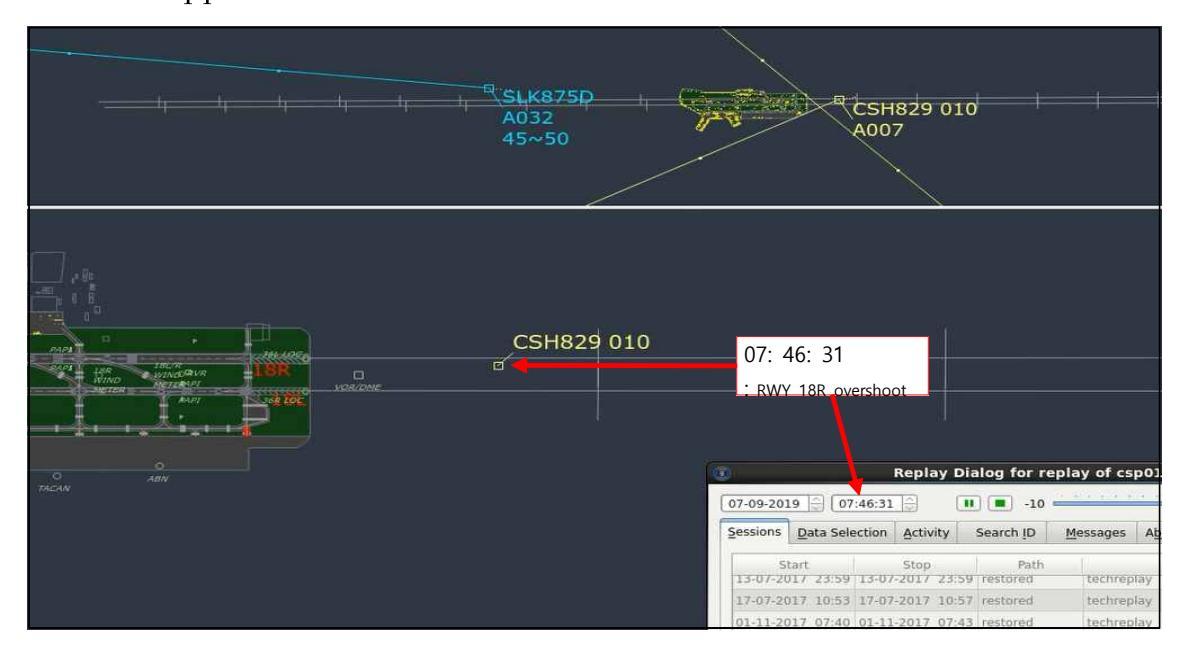
[Fig. 17] Image of B-1949 Overshooting RWY 18R

As shown in [Fig. 17], Gimhae approach control radar screen shows that B-1949 overshot RWY 18R final approach course and lined up on RWY 18L.

It indicates that the captain failed to identify that B-1949 passed over the final approach course of RWY 18R.

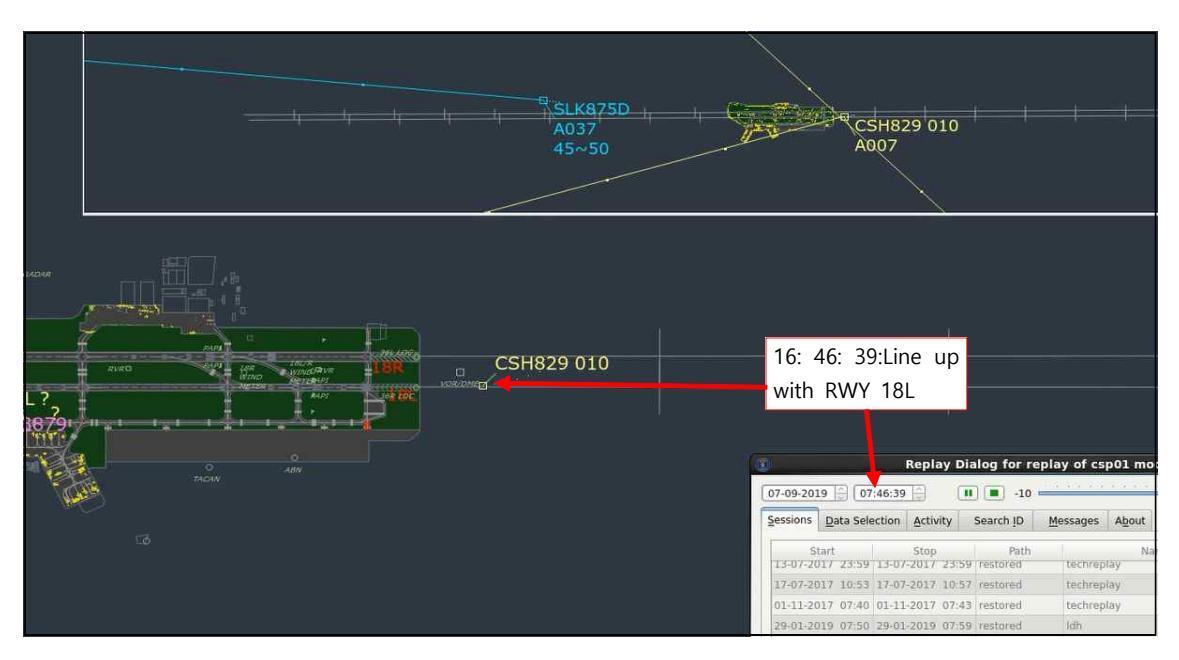
[Fig. 18] Image of B-1949 Line up with RWY 18L

[Fig. 18] shows that the captain or the first officer misidentified runway from the moment of overshooting RWY 18R which was authorized until the moment of lining up with RWY 18L.

Considering all these matters, roles and responsibilities were not properly assigned to the captain and the first officer so that they presumably failed to perform their roles in an appropriate way. It indicates that crew resource management was not sufficiently implemented in a cockpit where the flight crew should have asked and given an accurate advice about flight condition.

- 1. In case of aircraft operations in Grade 1 designated special aerodrome, it is recommended to implement flight plan based on characteristics of special airports and provide measures to captain and first officer in order to cross check their roles during preflight briefing. (AIR1905-1)
- It is advised to review traffic pattern, flight procedure and detailed CRM among flight crew members in case of circling approaches in Gimhae Int'l Airport. (AIR1905-2)
 - * During circling approaches for landing, it is advised to emphasize the importance of landing RWY identification and continuous visual check.
- 3. For flight crew who would first begin to operate flights in designated special aerodrome, it is recommended to provide pre-flight education for special airports and make sure to implement it. (AIR1905-3)
