AIRCRAFT ACCIDENT AND INCIDENT INVESTIGATION AND PREVENTION BUREAU (AIB GHANA)

REPORT ON THE FUEL INCIDENTS INVOLVING SOUTH AFRICAN AIRWAYS, A330-300 AIRCRAFT REGISTRATION ZS-SXM

14TH-15TH APRIL 2022.

AIRCRAFT INCIDENT REPORT AIB/2022/04/14-15/INCID

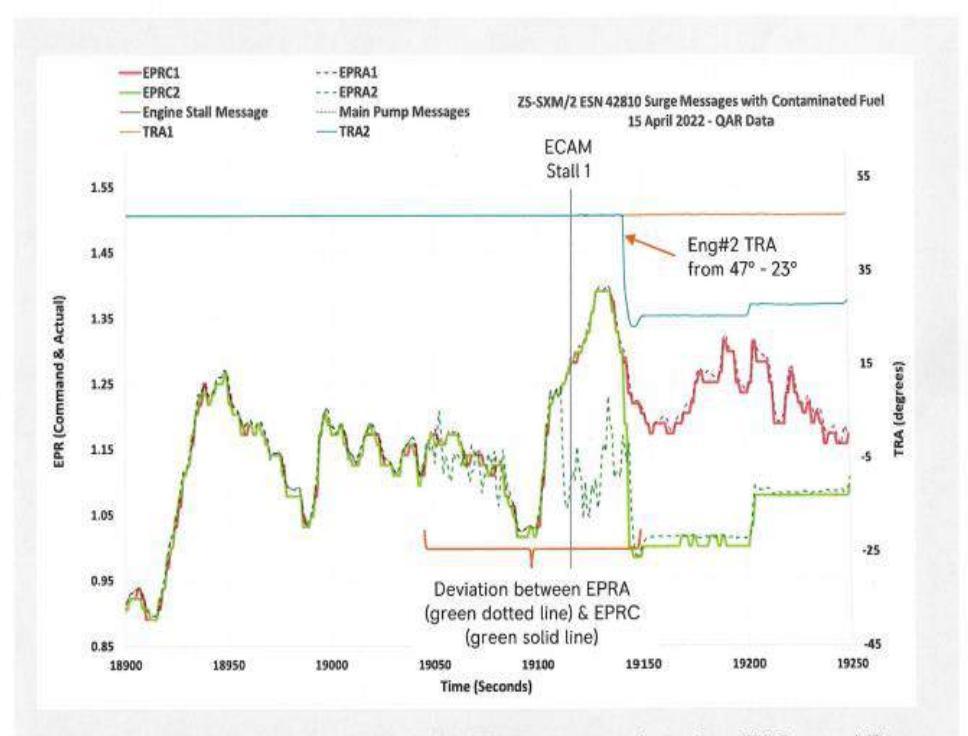
Approximately 3 minutes after levelling off at FL200, EPR Actual starts to deviate from EPR Command. This continues until the throttle is reduced from 47° to 23°, The first ECAM Stall warning occurred within this period.

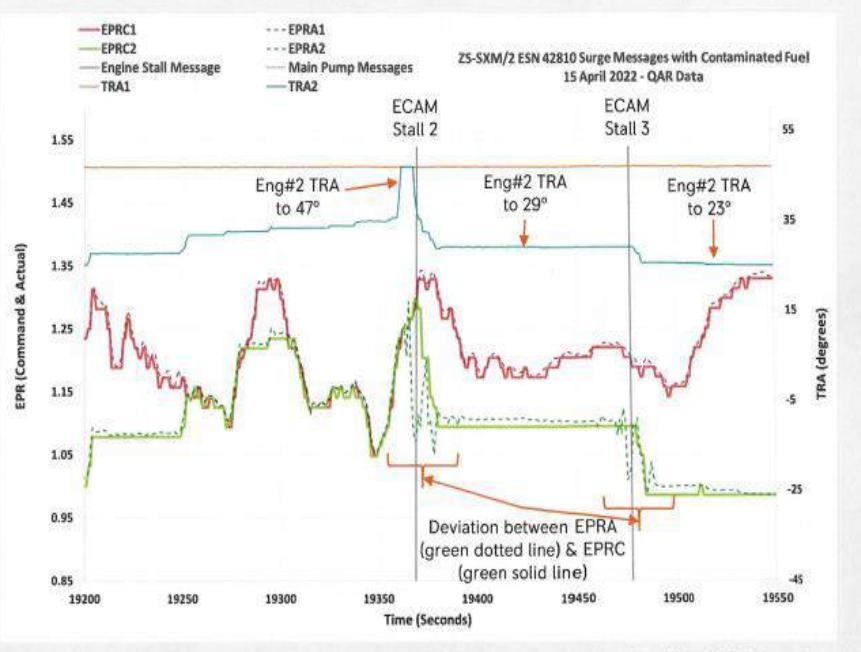
5 Private | © Rols-Royce plc. 2023 | Not Subject to Export Control Approximately 4 minutes after the first Stall Warning, the throttle is advanced back to 47° and EPR Actual again starts to deviate from EPR Command. This continues until the throttle is reduced to 29° but deviation can again be seen to occur approximately 2 minutes later. These deviations coincide with ECAM Stall Warnings 2 and 3. The throttle is then retarded to 23°, and EPRA can be seen to match EPRC once again.

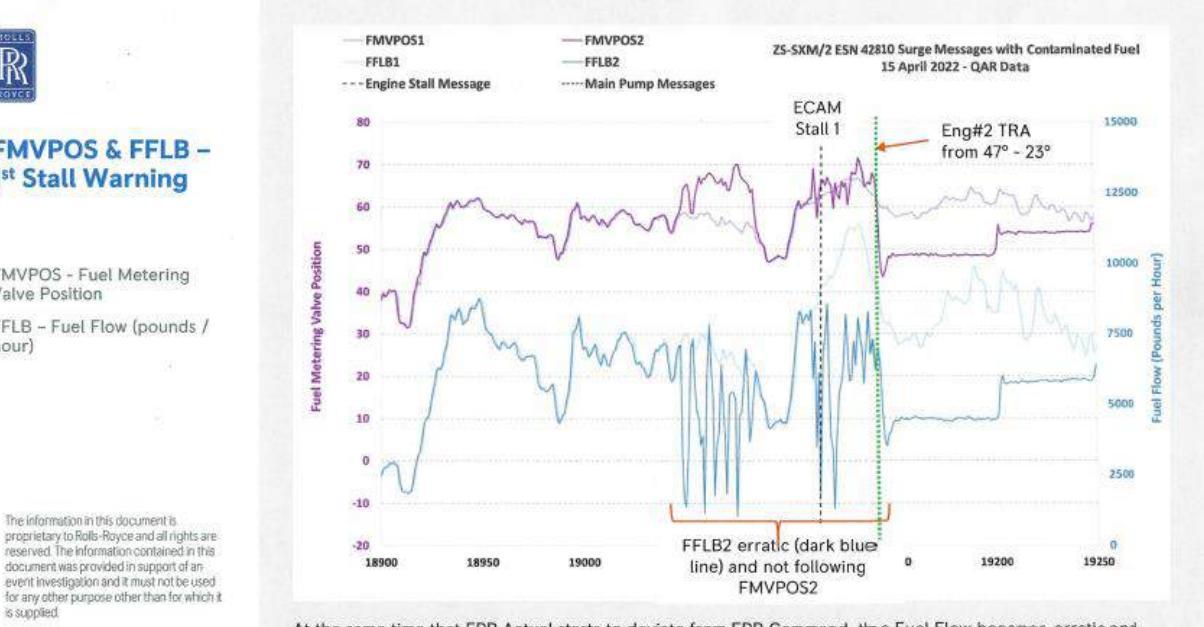
At the same time that EPR Actual starts to deviate from EPR Command, the Fuel Flow becomes erratic and stops following the trend of FMVPOS. FMVPOS can be seen increasing a≤ the engine tries to get more fuel to achieve EPRC. Similarly to EPR, this continues until the throttle is redu ced from 47° to 23°. The first ECAM Stall warning occurred within this period.

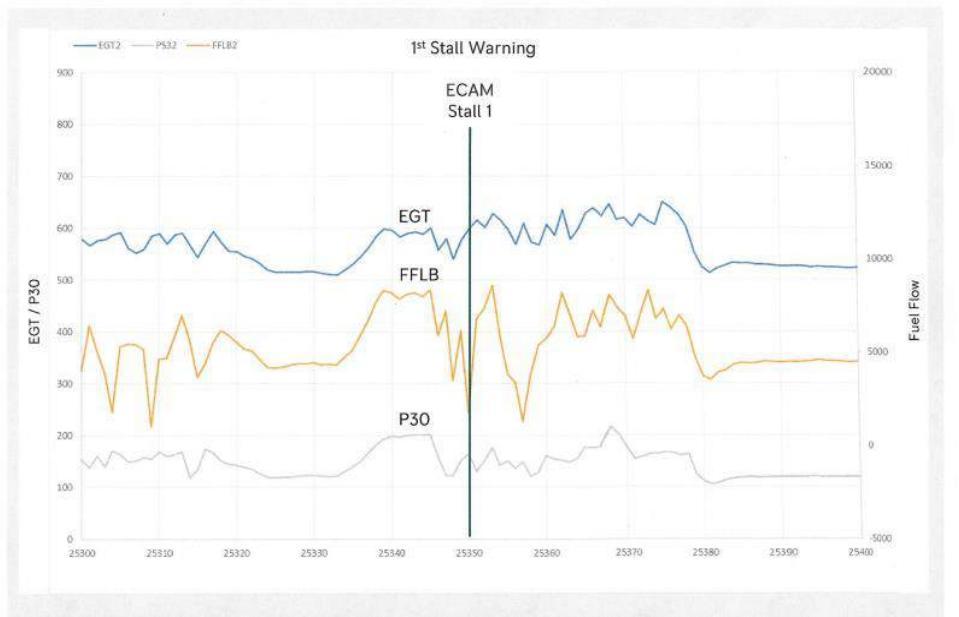
Review of the engine data for the first Stall Warning could not confirm if the engine stalled or if the Surge/Stall Detection Logic was triggered erroneously due to the highly dynamic and abnormal fuel flow experienced during the event (see slide 12 for details of the Surge/Stall D etection Logic).

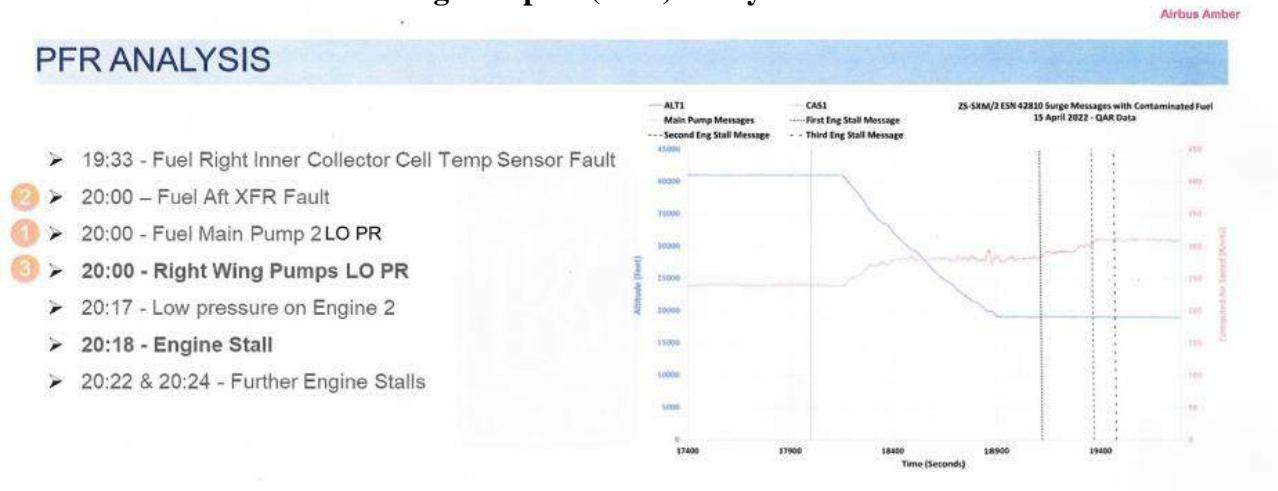
- After the low pressure detected on Fuel Main Pump 2 and then on the 3 pumps, the gravity feed procedure was applied following the applicable FCOM Abnormal Procedure. A/C descent was initiated from FL410 to FL200.
- · First Eng Stall message triggered shortly after reaching FL200 and starting the gravity feed.
