Air Accident Investigation Sector

- Final Report -

AAIS Case Nº: AIFN/0006/2023

Tail Strike

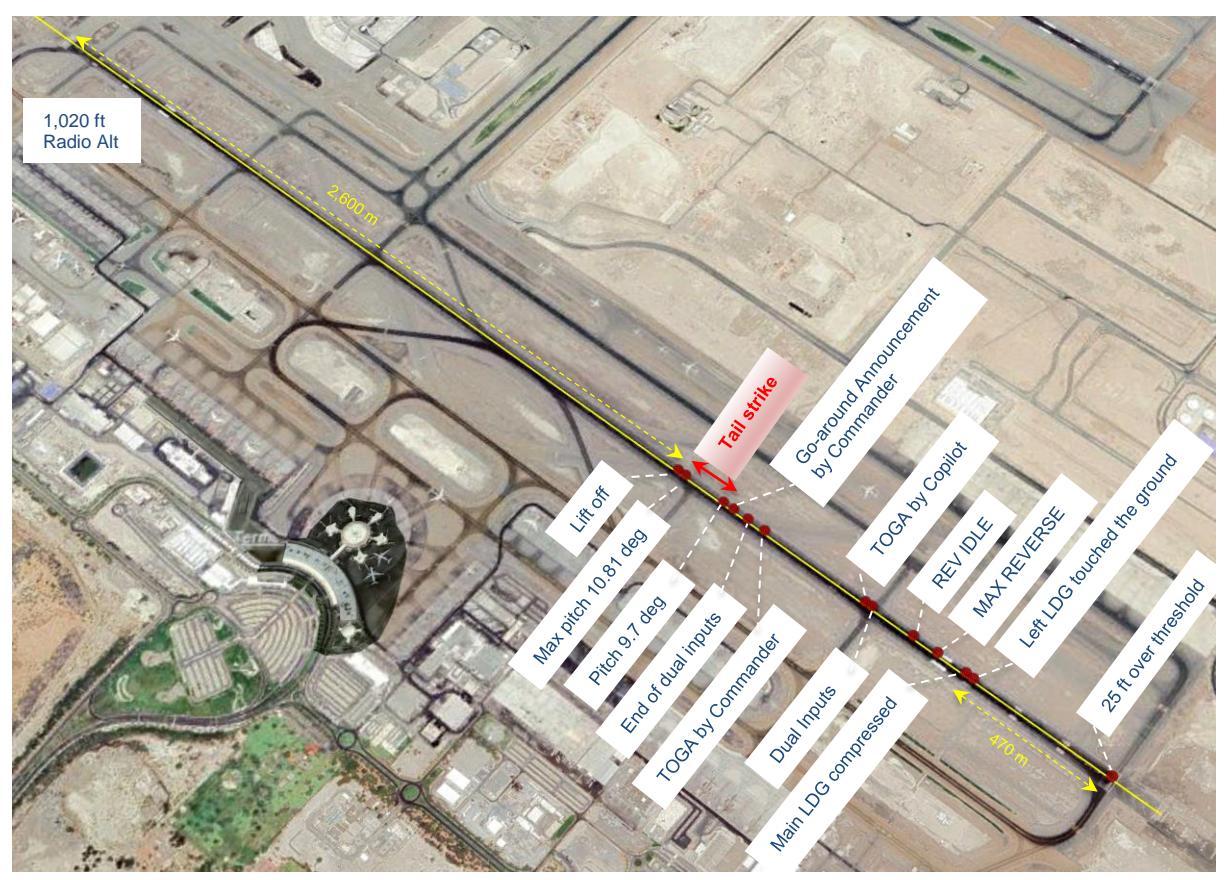
Figure 3. The main events during the first landing attempt

Figure 3 illustrates the main events that took place during the first landing attempt.

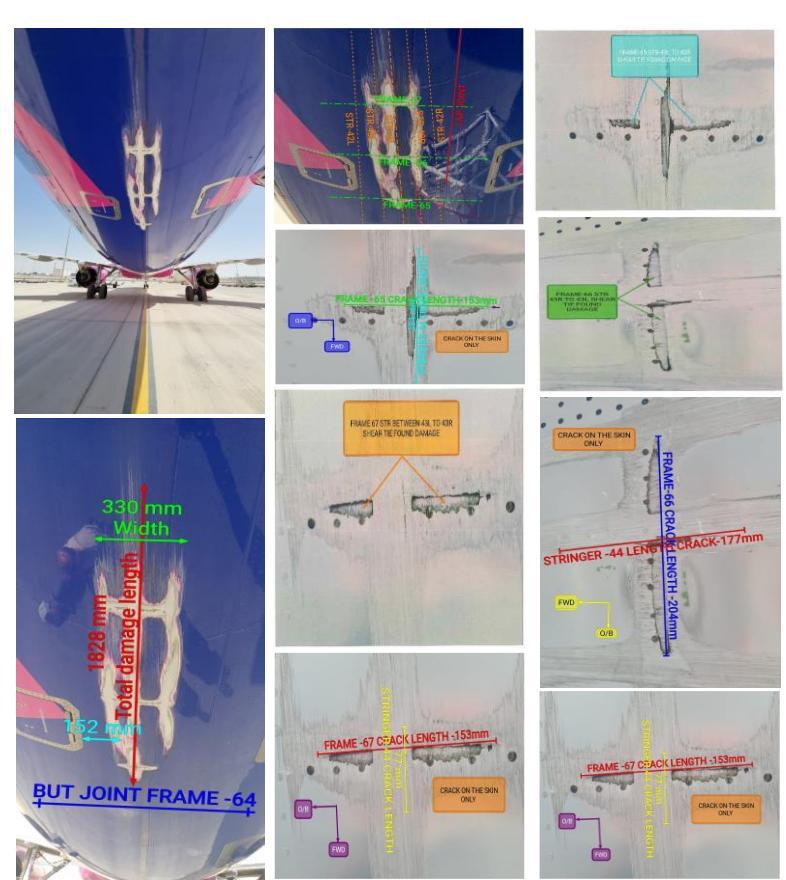
Figure 5. Skin abrasion on the aft lower

The maintenance personnel inspected the Aircraft and reported minor damage to the aft lower fuselage skin.

The tail strike caused minor damage to the underside of the rear fuselage. Figure 5 illustrates the damage and its dimensions.

The aft lower fuselage skin was abraded, between frames 65 - 67 and stringers 42L to 42R. Drain mast assembly was required to be replaced prior to the next flight.

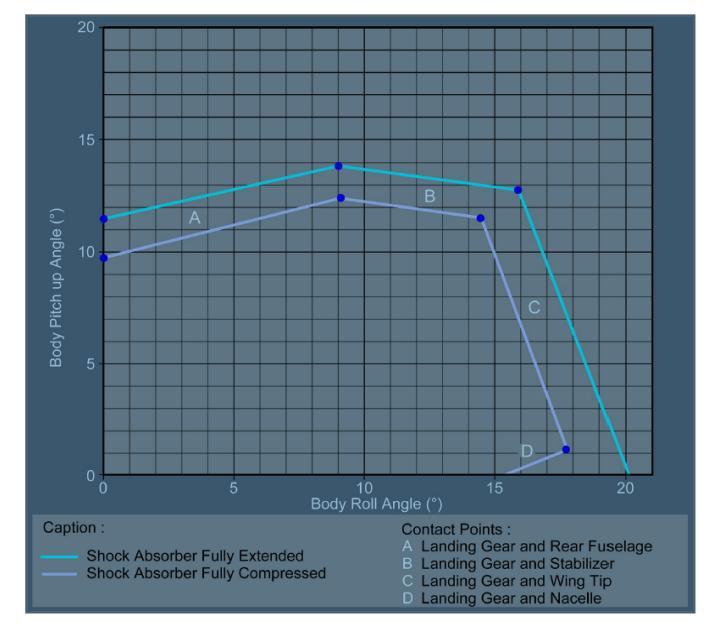
Figure 8. Ground clearance diagram

Two seconds later, the pitch reached about 10 degrees, which was about two seconds before the Aircraft lifted off. Based on the ground clearance diagram (Appendix 2, figure 8) and the appearance of the tail strike pitch limit indicator on the PDF, the Investigation believes that the tail strike occurred when the pitch reached the limit of 9.7 degrees. At this point, both main landing gears were on the ground (compressed shock absorber condition) with a low airspeed of 112 knots. The tail strike condition lasted for about three seconds and ended when the Aircraft lifted off (extended shock absorber condition) with an airspeed of 118 knots and a pitch of 10.8 degrees.

According to the Aircraft's ground clearance diagram (figure 8), with the main landing gear compressed condition, the tail strike pitch limit is approximately 9.7 degrees at a roll angle of 0 degrees and 11 degrees at a roll angle of 4 degrees. As per the *FCOM*, the pitch limit

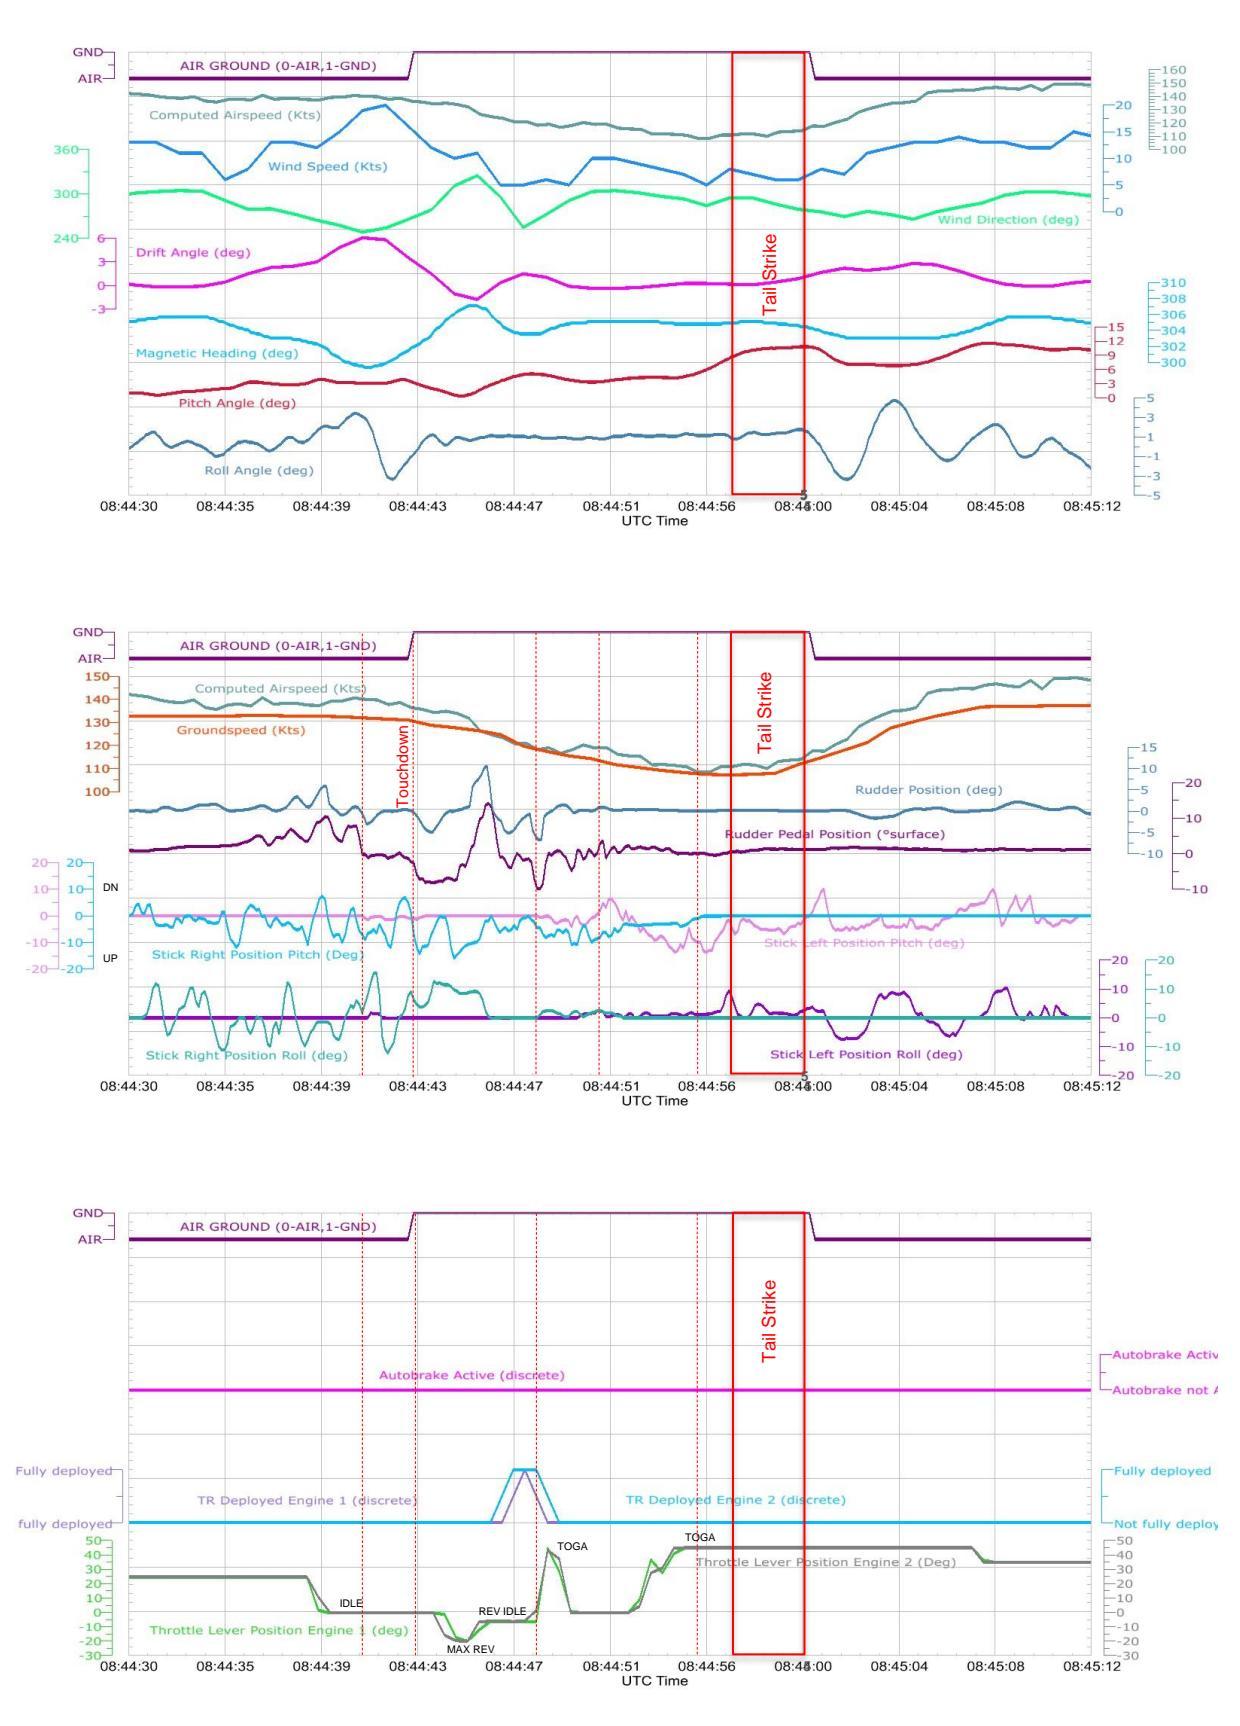
Figure 9. Flight data parameters

At 0845:00, the Aircraft's pitch reached up to a maximum of 10.81 degrees with a maximum right roll angle of 1.76 degrees. At this time, the left main gear lifted off first then followed by the right main gear, which means that the main landing gears were in an uncompressed condition. The airspeed was 118 knots, and N1 of both engines reached approximately 93% RPM shortly after liftoff.

Figure 9 shows the related flight data parameters around the Incident.

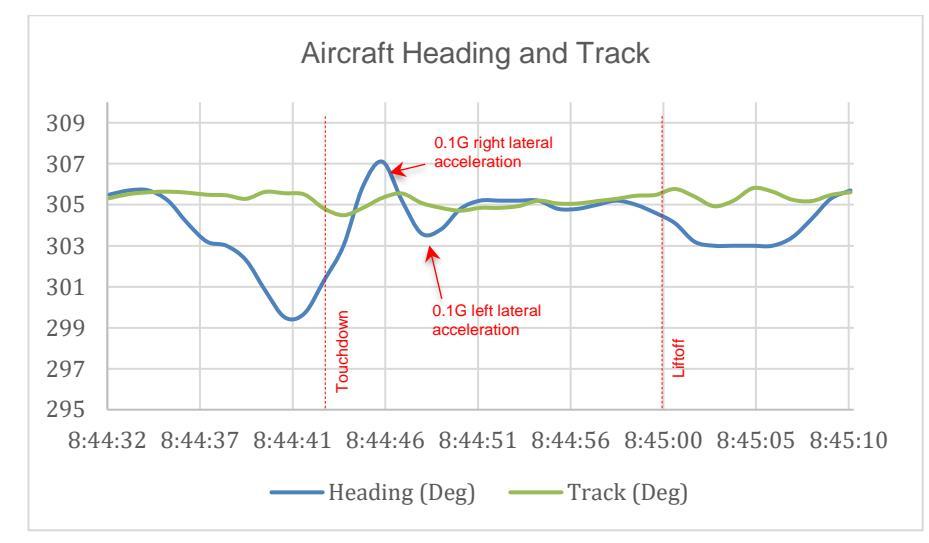
Figure 10. Aircraft heading and track on landing

After the touchdown, the Copilot made continual adjustments to manage the drift and keep the Aircraft in line with the runway centerline. After maintaining a right rudder input (between 7° and 8°) for about one second, the right drift was adjusted to zero, then switched to the left, consequently, the Copilot released the right rudder input and made left rudder input in less than two seconds, which caused an increase in the lateral acceleration to the right by approximately 0.1G. A right drift emerged, prompting the Copilot to release the left rudder input and to make thereafter a right rudder input for approximately one second to reduce the right drift. This corrective action led to a slight increase in lateral acceleration to the left by about 0.1G. However, the Investigation believes the rudder inputs applied by the Copilot were slightly disproportionate contributing to the fluctuations of the drift.

Figure 10 presents the Aircraft heading and track, capturing the span from just before touchdown to after liftoff.

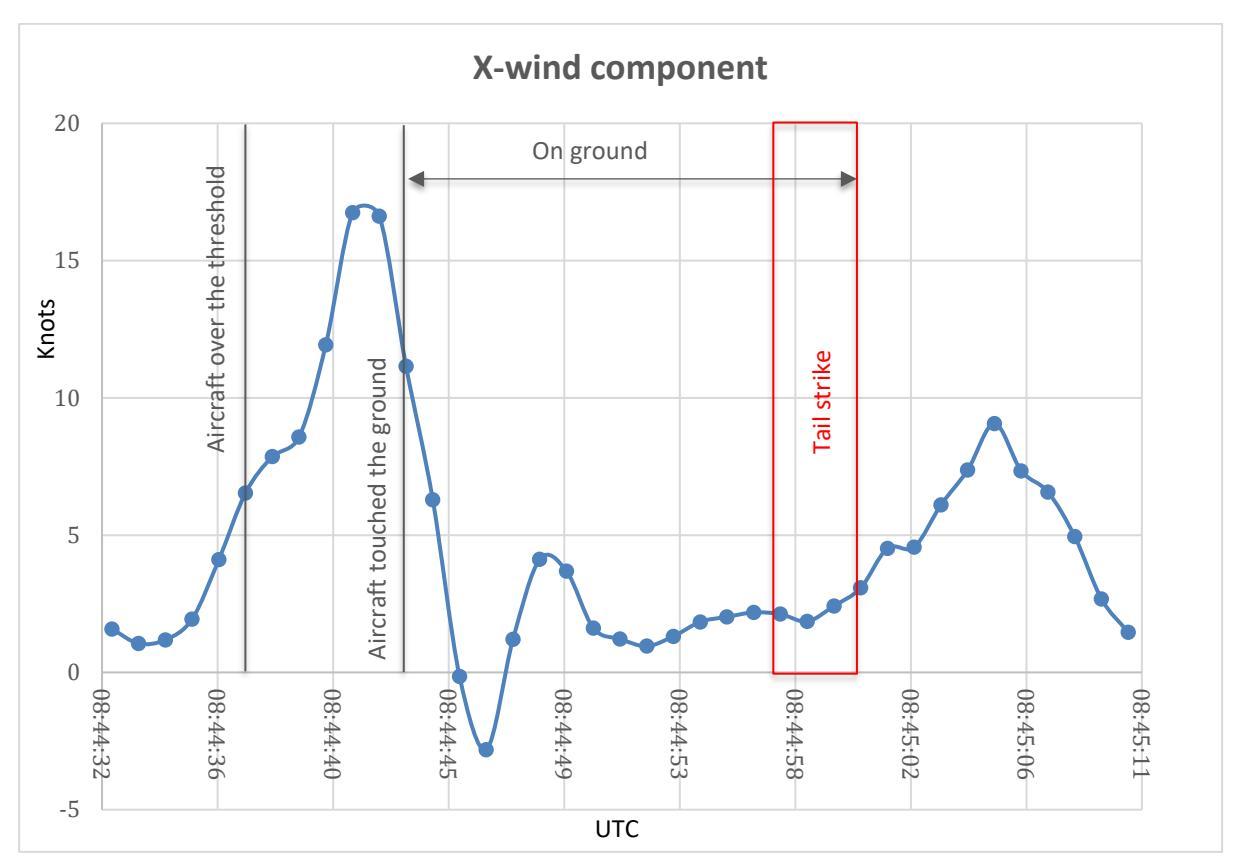
Figure 11. Crosswind Component on landing

- (a) The Aircraft experienced thermal (gusty) conditions starting from approximately 1.2 nautical miles before the threshold and persisted until it reached a position on the runway approximately 1,200 meters past the threshold.
- (b) The Aircraft encountered a peak crosswind component of 17 knots during the initial flare.

Figure 11 shows the crosswind component experienced by the Aircraft, spanning from before the threshold to after liftoff.
