FINAL REPORT

ON SERIOUS INCIDENT OF THE AIRCRAFT type LET-410, registration OK-LAZ

Dubrovnik Airport, 29 November 2018

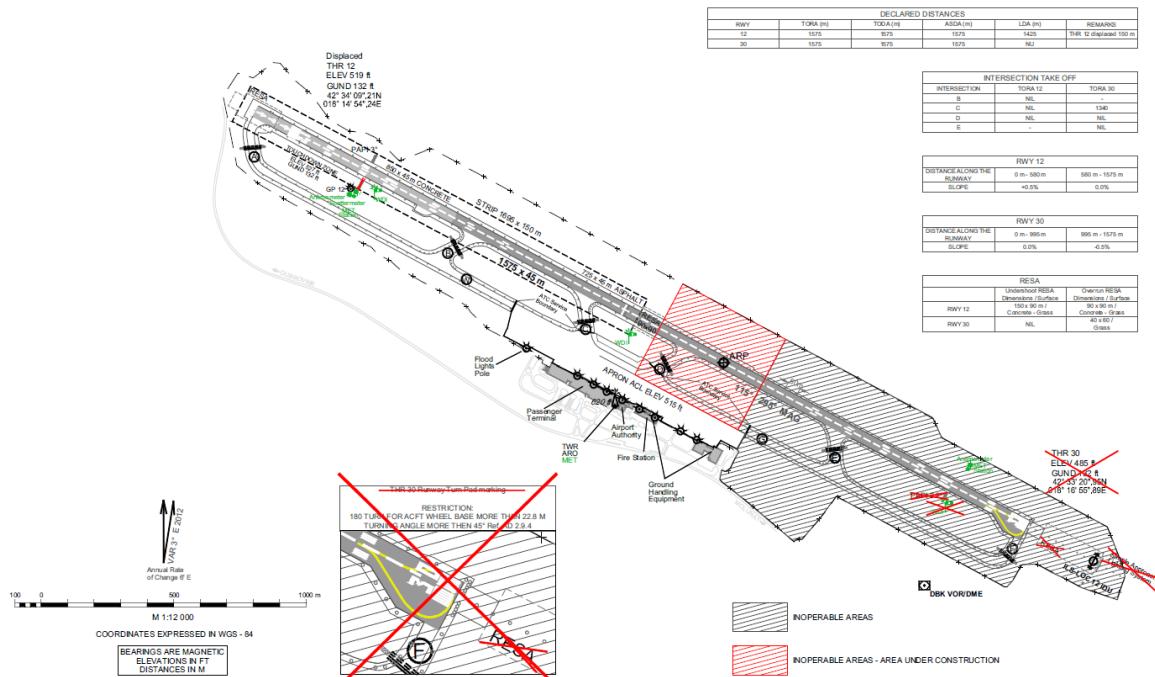
Figure 4 – Phase I of the construction works

At the time of the subject accident, certain construction works were performed in the area of Dubrovnik Airport for the purpose of expanding the capacity of the airport. These works affected the incident in question.

Phases I and II of the construction works are shown in Figures 4 and 5 for easier understanding of the incident.

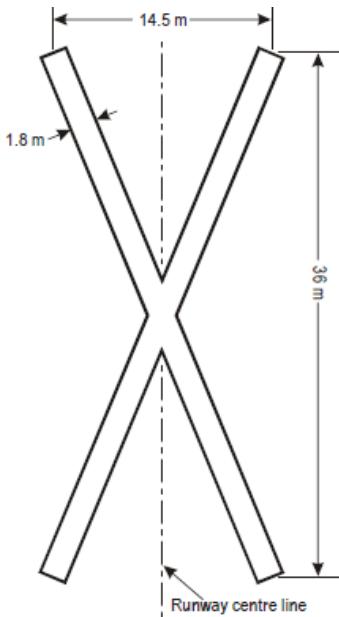
Figure 6 – Closed marking “X”

- 1) »Closed« marking which is placed on:
 - a) the runway, must be of the shapes and dimensions described in the Figure 7-1, figure a), and
 - b) the taxiway, be of the shapes and dimensions described in the Figure 7-1, figure b).
- 2) »Closed« marking must be:
 - a) of white colour when placed on the runway, and
 - b) of yellow colour when placed on the taxiway.
- 3) Where a certain portion of the manoeuvring area is temporarily closed, for marking of the closed areas the following can be used:
 - a) fragile barriers, or
 - b) markings made of materials other than colour, and
 - c) other suitable means.

Figure 6 shows the marking of the closed manoeuvring area “X”.
