# **Incidents in Air Transport**

# Wind Gradients and Turbulence

N° 5 December 2006

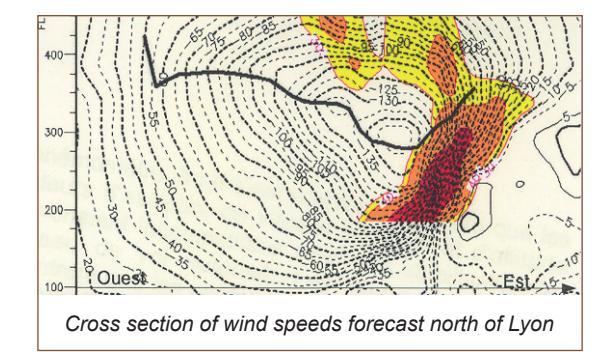
When positioning the turbulence indicator field on the chart, the forecaster draws the various clear air turbulence zones above FL200. He then traces the jet streams analogically, overlaying the speed values of winds over 80 kt. On these tracks, he identifies the points that correspond to the extreme values, marked with the wind speed and the flight level.

In the area of the incident, the heart of the jet stream was at FL280, 3,000 feet below the level indicated on the TEMSI chart. Winds above 80 kt were forecast between FL160 and FL425, which corresponds to a depth of jet stream of 26,500 feet.

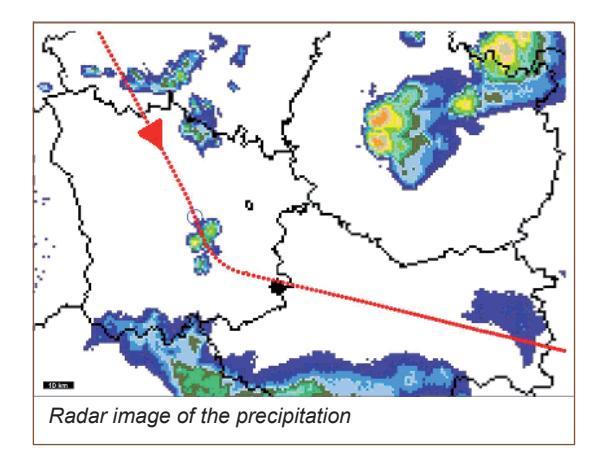
The crew had a meteorological dossier made up of the TEMSI EUROC chart valid 6 hours before the event, forecasting cumulonimbus in the midst of cloud mass on the route up to FL340, all of the TAF's and METAR's and a SIGMET for the Marseille FIR, whose validity had expired, that related to the development of storms in the cloud layer over the north of

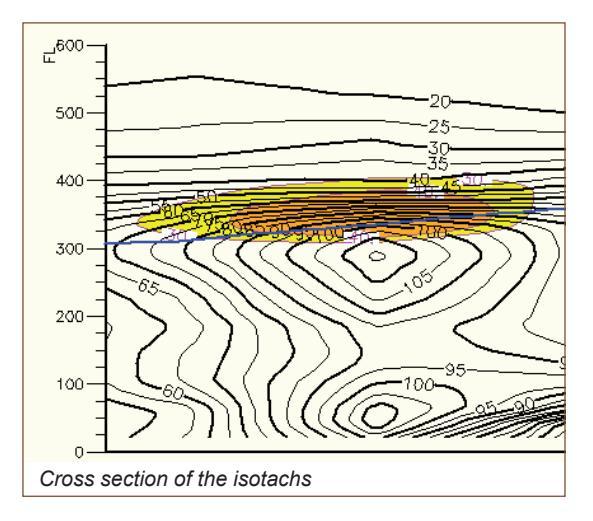
The situation described above was forecast ten hours before take-off by the French Arpège forecast model. However, the TEMSI chart supplied by the WAFS world centre in England indicated moderate turbulence in this area. The following was noted in the flight dossier: «area of CAT MOD from 45 W to 78 W then nothing notable on the rest of the route ». Only one air report (AIREP) concerning this turbulence was received by the ATC.
