**ACCIDENT**

<b>Aircraft Type and Registration:</b>	Boeing 737-33A, G-ZAPZ
<b>No &amp; Type of Engines:</b>	2 CFM56-3C1 turbofan engines
<b>Year of Manufacture:</b>	1991 (Serial no: 25401)
<b>Date &amp; Time (UTC):</b>	14 April 2012 at 1008 hrs
<b>Location:</b>	Chambery Airport, France
<b>Type of Flight:</b>	Commercial Air Transport (Passenger)
<b>Persons on Board:</b>	Crew - 5                      Passengers - 131
<b>Injuries:</b>	Crew - None                      Passengers - None
<b>Nature of Damage:</b>	Damage to rear fuselage skin, frames and drain mast
<b>Commander's Licence:</b>	Airline Transport Pilot's Licence
<b>Commander's Age:</b>	34 years
<b>Commander's Flying Experience:</b>	3,950 hours (of which 1,417 were on type) Last 90 days - 75 hours Last 28 days - 25 hours
<b>Information Source:</b>	AAIB Field Investigation

**Synopsis**

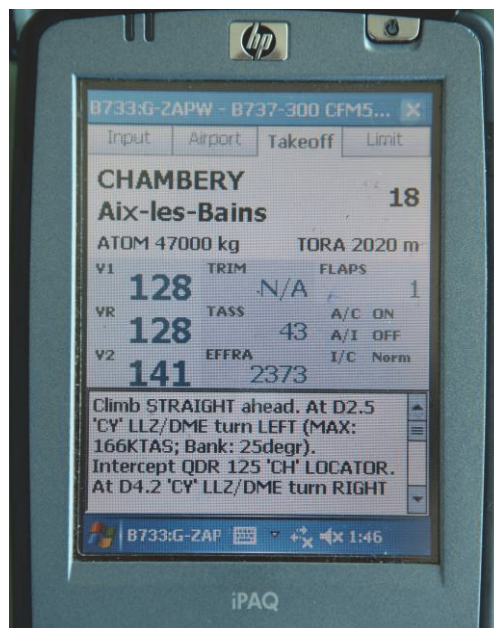
Figure 4

EFB takeoff input screen after software restart

Restarting the Guru program after shutdown takes approximately 36 seconds and results in the 'Input' data fields being reset to a standard data set (Figure 4). It also resets the 'Takeoff' and 'Limit' tabs to prevent data calculated (V speeds etc) from previous sectors being accessed.

As a result of this accident the operator issued NOTAC OMB B733 02/2012, containing revised procedures. These included the requirement to shut down and restart the Guru program prior to conducting takeoff performance calculations. In addition, it instructed that the calculated  $V_2$  should be compared against simple tabulated values of  $V_2$  obtained by comparing flap position against aircraft weight. This was on the basis that  $V_2$  changes little with other variable conditions, such as weather and runway used, and can therefore be used as a gross error check.
