**Emergency landing Bristow AS332L2
search and rescue helicopter**

North Sea, near Den Helder, 21 November 2006

The Hague, (project number M2006LV1121-07)

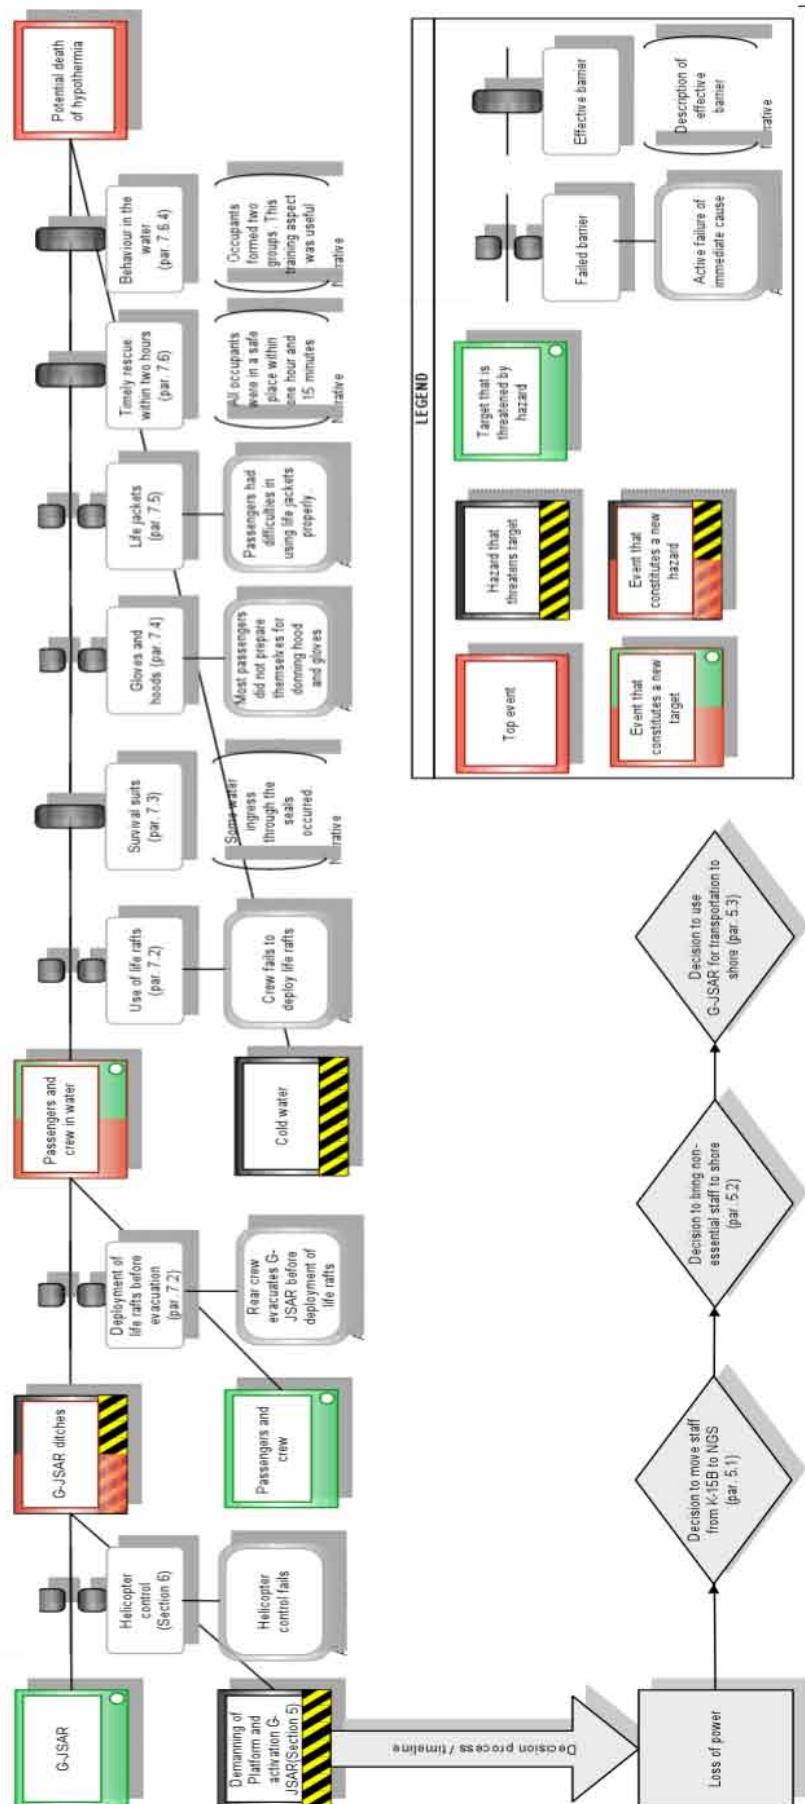
Illustration 1 (next page) depicts the results of the Tripod analysis in a simplified diagram. More specifically, the sequence of events and corresponding hazards and targets (HET-trio's) which, eventually resulted in the top event are presented. Furthermore, illustration 1 indicates which barrier could have prevented the undesirable event for each HET-trio (1) and the active failure that formed the immediate cause for the barrier to fail (2). For both barriers, the present report describes how and why these "controls" failed. In this respect, and in agreement with Tripod Beta, the report distinguishes between preconditions (mainly section 7) and latent failures at an organisational level (mainly section 8). To uphold the legibility of the diagram, the preconditions and latent failures are not included in illustration 1.

Illustration 1. Simplified diagram of the Tripod analysis of the emergency landing in the north sea made by the search and rescue helicopter G-JSAR on 21 November 2006.
