**Republika e Kosovës
Republika Kosova-Republic of Kosovo
Qeveria – Vlada-Government
Zyra e Kryeministrit – Ured Premijera –Office of the Prime Minister**

**Komisioni për Hetimin e Aksidenteve dhe Incidenteve Aeronautike
/Vazduhoplovna Komisija za Istraživanje Nesreća i
Incidenata/Aeronautical Accidents and Incidents Investigation
Commission**

**Report on Serious Incident of aircraft Boeing B737-800, TC-JFY at
the International Airport of Pristina “Adem Jashari”, on 2 May 2016**

Investigation Report no:	ZKM KHAIA 001 / R
Type of Occurrence:	Serious Incident
Date:	2 May 2016
Location:	Pristina International Airport Adem Jashari
Aircraft:	Fixed Wing
Manufacturer / Model:	The Boeing Company/B737 - 800
Registration:	TC-JFY
Injuries to Persons:	No injuries
Damage:	Minor damage to Aircraft
Other Damage:	None

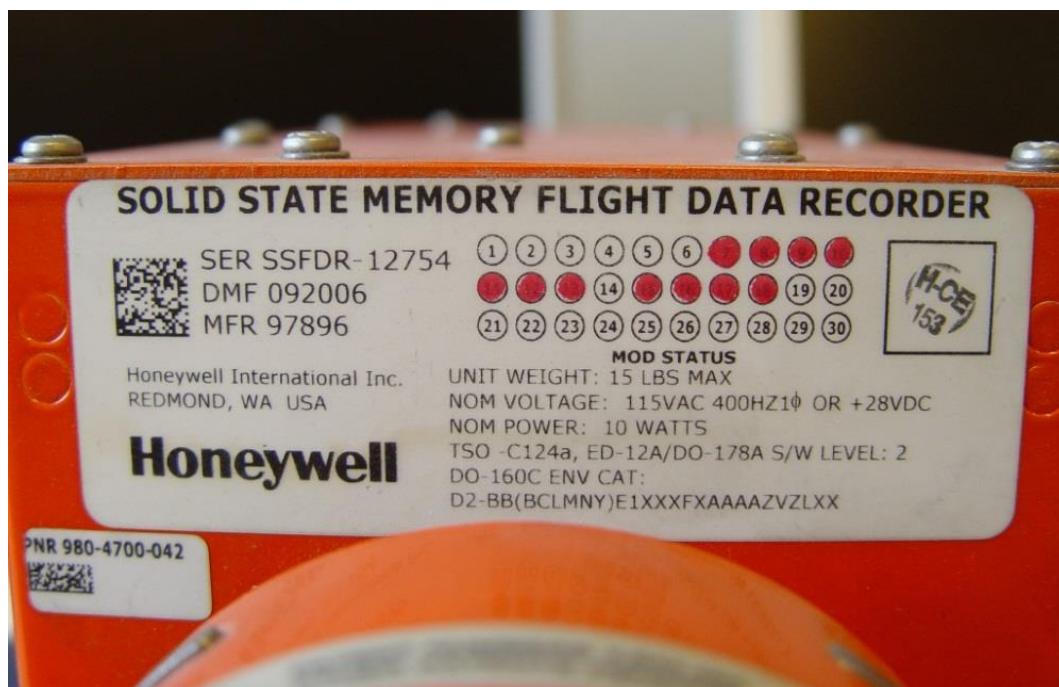
Image 1: Flight Data Recorder

The recorder had no visible damage. The stored data were read out and evaluated with Insight Analysis software. On the recorder there were 26 h of flight data found including the incident occurrence.

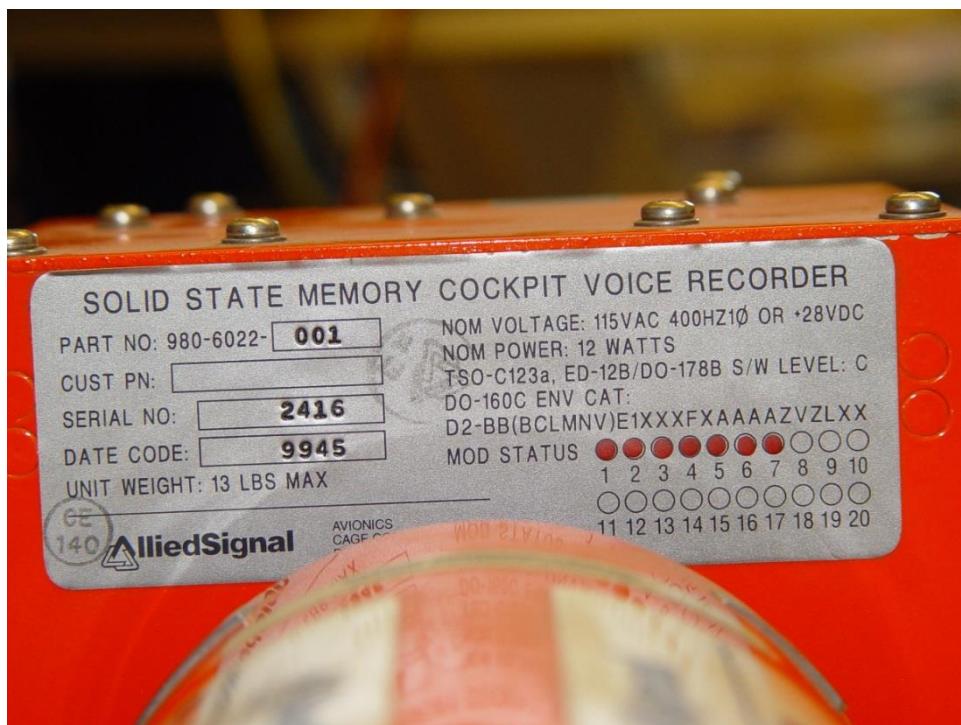
Image 2: Cockpit Voice Recorder

The recorder had no visible damage. The stored data were read out and stored at the BFU/Germany.

The different voices PIC, co-pilot, and Cabin Chief could be understood very easily. Most of the crew conversations could be understood accurately and easily. The transcript indicates several words or phrases that were not intelligible. Any loss in the transcript can be attributed to minor technical deficiencies, temporary interruptions in the recording system or to a large number of simultaneous cockpit/radio transmissions that obscure each other.

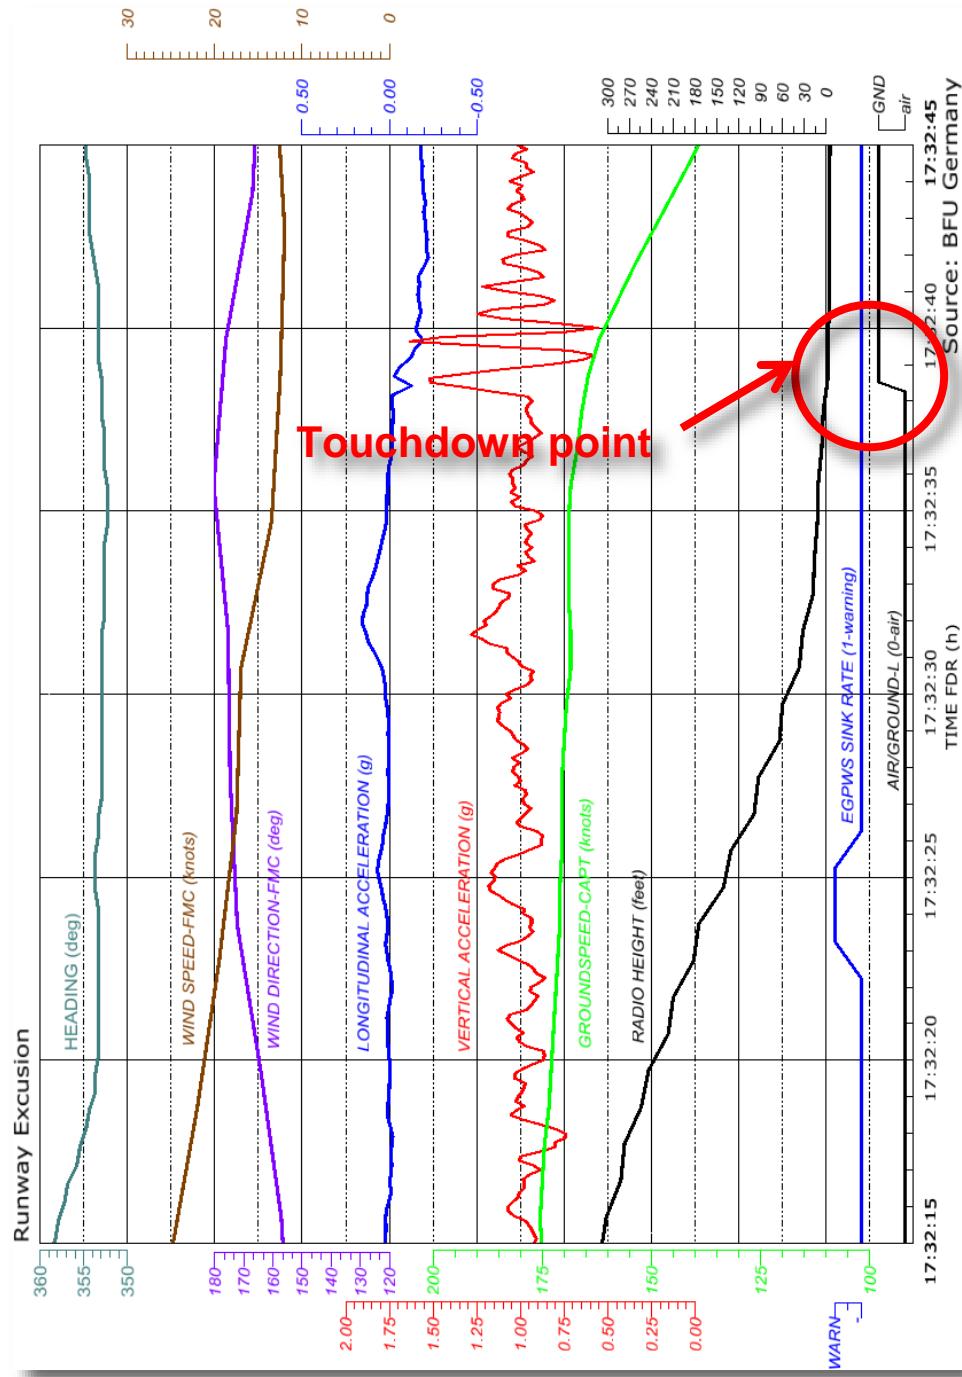
Image 4: FDR parameters of the approach phase

This image depicts the touchdown phase with the wind information.

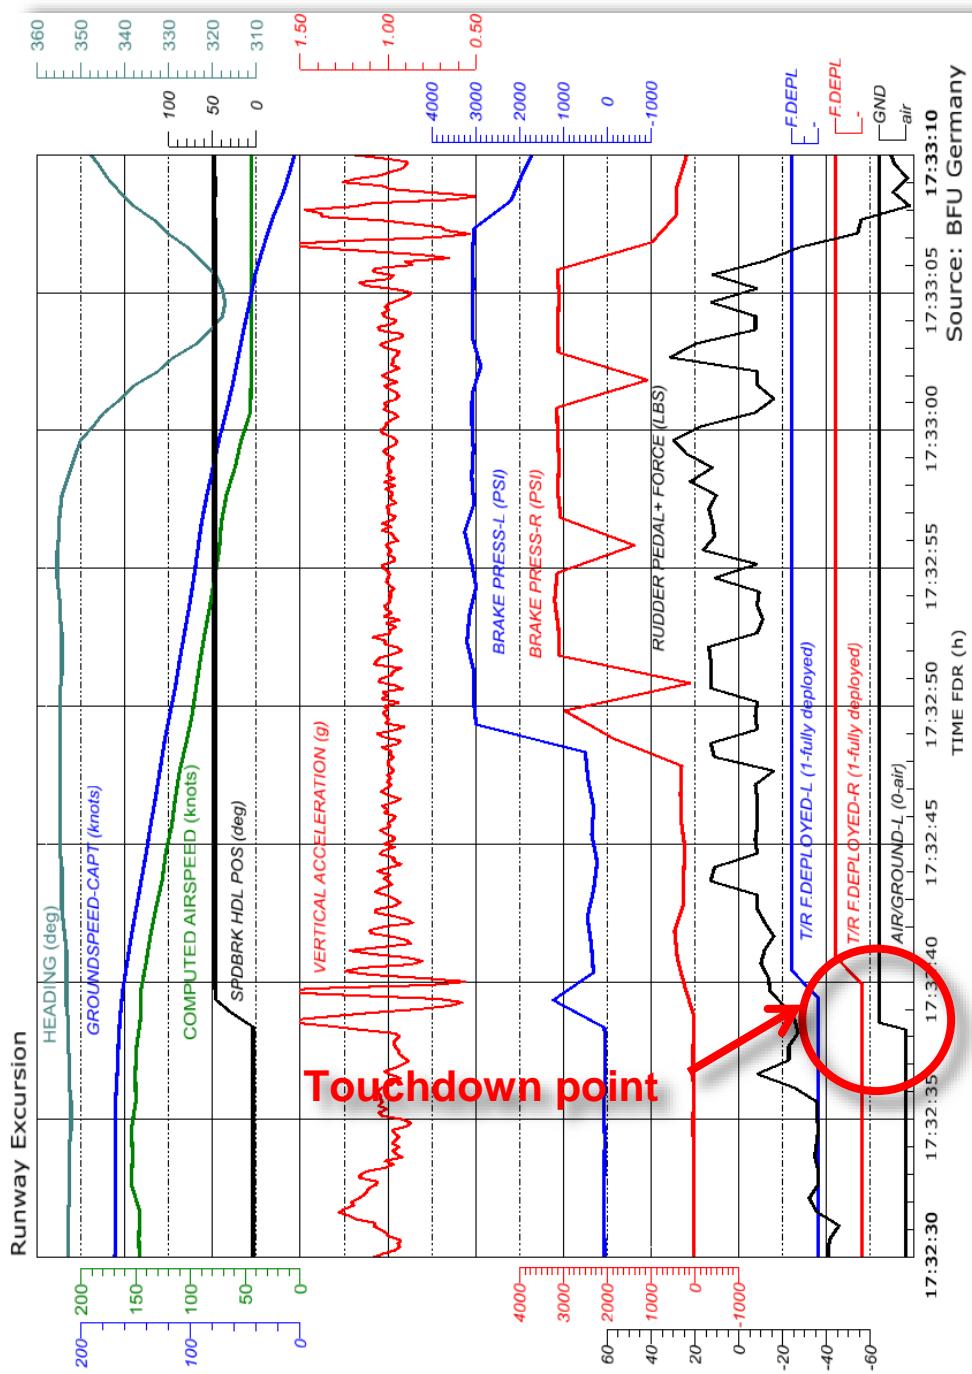
Image 5: FDR parameter of the touchdown phase

This image depicts the touchdown phase with the corresponding Brake Pressure in PSI and Rudder Pedal Position in degrees.

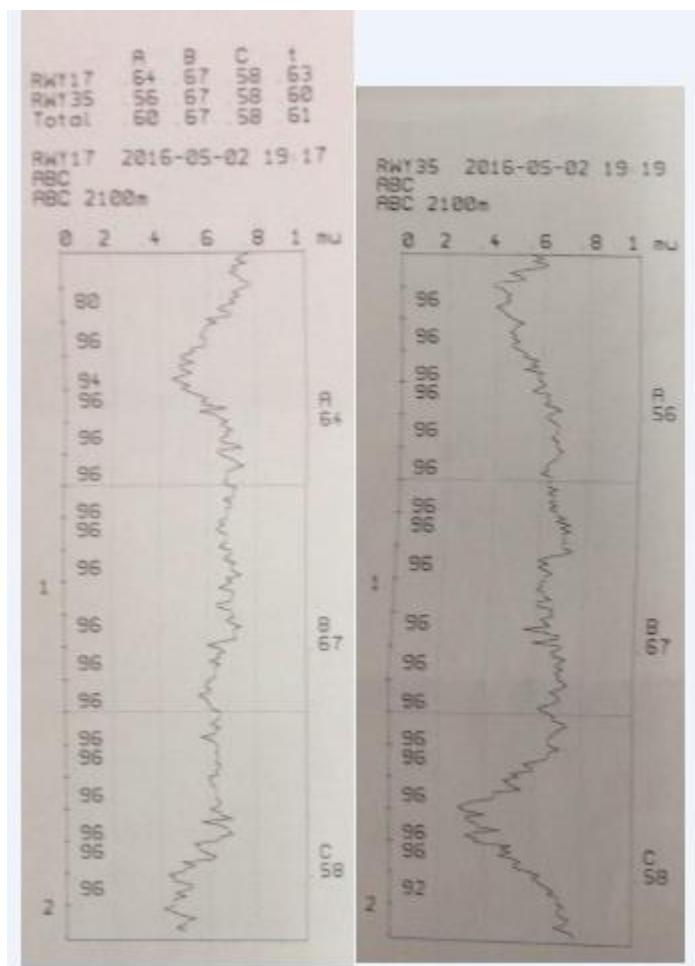
According to Pristina International Airport, breaking action measurement is not performed during the summer season and when it is raining. The breaking action is required only during the winter season and when there is a snowfall. Based on this data there were no braking action measurement performed before landing. After the runway excursion approx. 44 min, measurement of the breaking action was performed and breaking action was good.

Image 17: Braking action measurement (20:17 hour should be because they did not correct time) Source: Airport
