Technical report

IN-049/2019

Incident involving two Boeing 737-8AS aircraft, registrations EI-ENH and EI-DYR, on 11 September 2019 at Málaga Airport

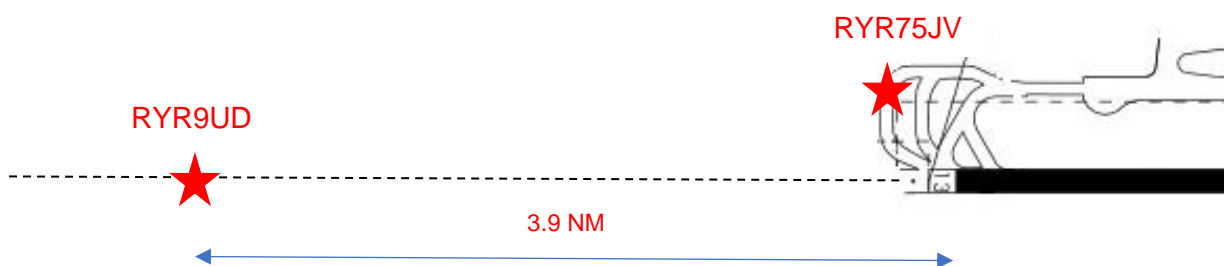
Illustration 4 Position of aircraft at 19:52:27 UTC, RYR75JV (right) and RYR9UD (left)

At 19:52:27 UTC, the trace shows aircraft RYR9UD established on final at 3.9 NM from the threshold of RWY13 with a ground speed of 168 kt. At that moment, the RYR75JV aircraft was at the HN-3 holding point signal.

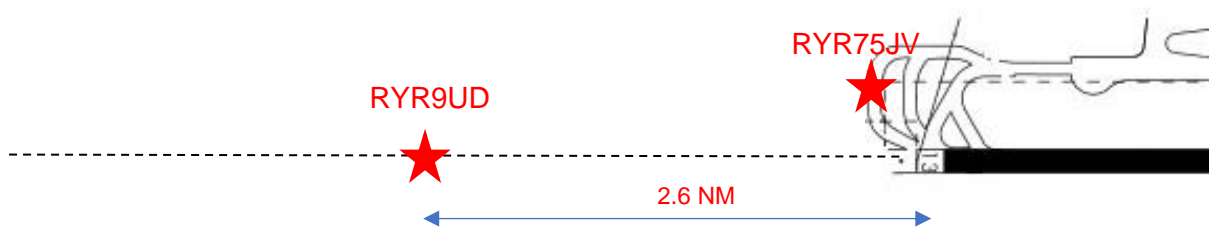
Illustration 5 Position of aircraft at 19:52:58 UTC

At 19:52:58 UTC, the trace shows aircraft RYR9UD established on final at 2.6 NM from the threshold of RWY13. At that moment, the RYR75JV aircraft had just passed the HN3 holding point signal.

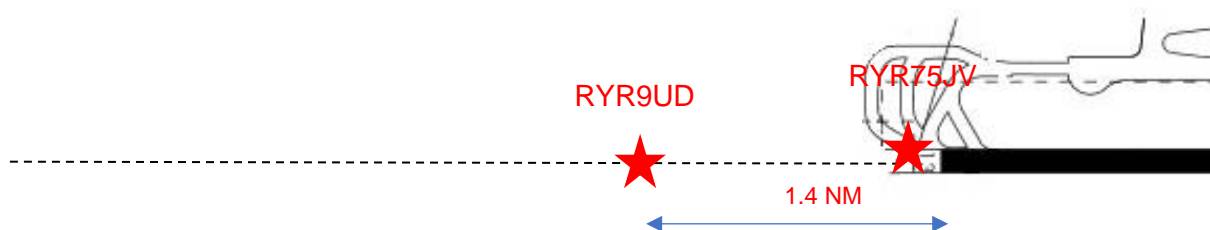
Illustration 6 Position of aircraft at 19:53:29 UTC

At 19:53:29 UTC, the trace shows aircraft RYR9UD established on final at 1.4 NM from the threshold of RWY 13 at an altitude of 500 ft AMSL, and aircraft RYR75JV proceeding to RWY 13, approaching the runway threshold.

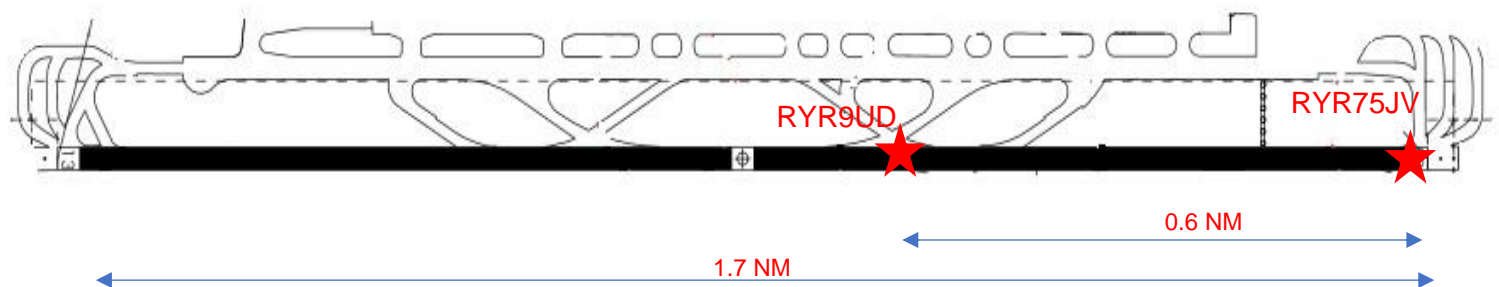
Illustration 12 Position of aircraft at 19:54:35 UTC

At 19:54:35 UTC, the trace shows aircraft RYR9UD decelerating during its landing roll-out on RWY 13, and aircraft RYR75JV on its initial climb, passing the threshold of runway 31 at an altitude of 700 ft AMSL. The distance between the two aircraft was 0.6 NM.

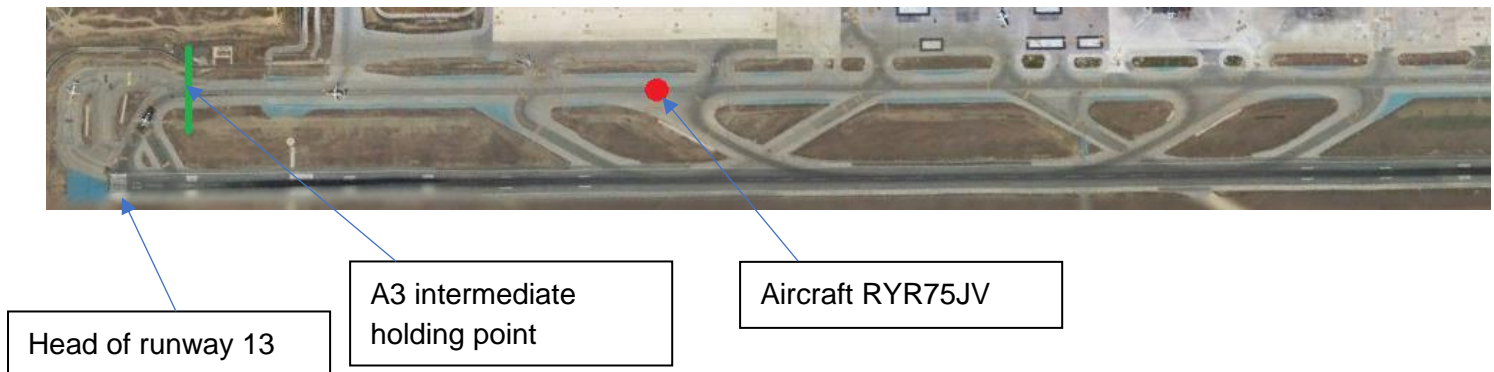
Illustration 13 Position of aircraft RYR75JV at 19:49:19 UTC

At 19:49:19 UTC, the GND controller instructed the RYR75JV aircraft to contact the LCL controller on the 118.150 MHz frequency and signed off. At that time, the RYR75JV aircraft was approximately 900 m from the A3 intermediate holding point, as shown in the following image:

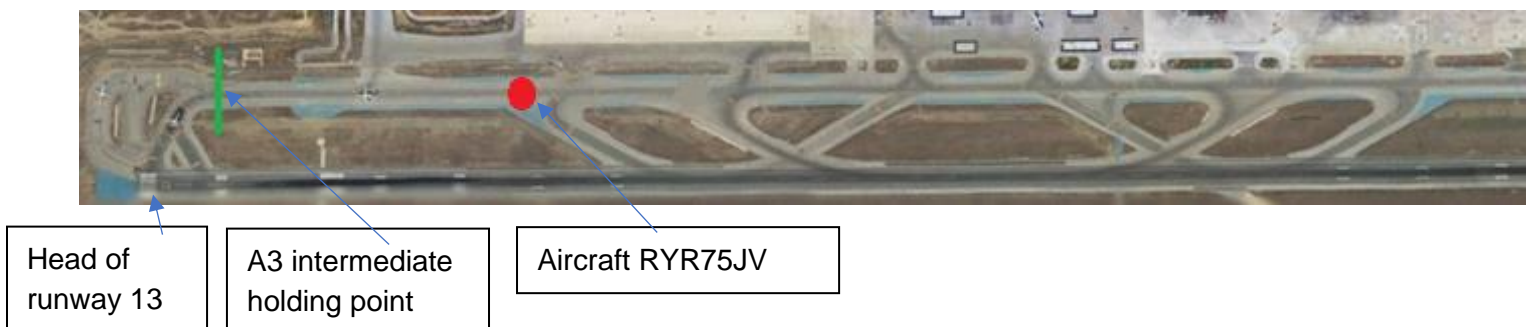
Illustration 14 Position of aircraft RYR75JV at 19:49:49 UTC

At 19:49:49 UTC, the LCL TWR LEMG controller instructed aircraft RYR75JV to hold short of the runway, and the crew acknowledged the instruction. At that moment, the RYR75JV aircraft was 600 m from the A3 intermediate holding point.

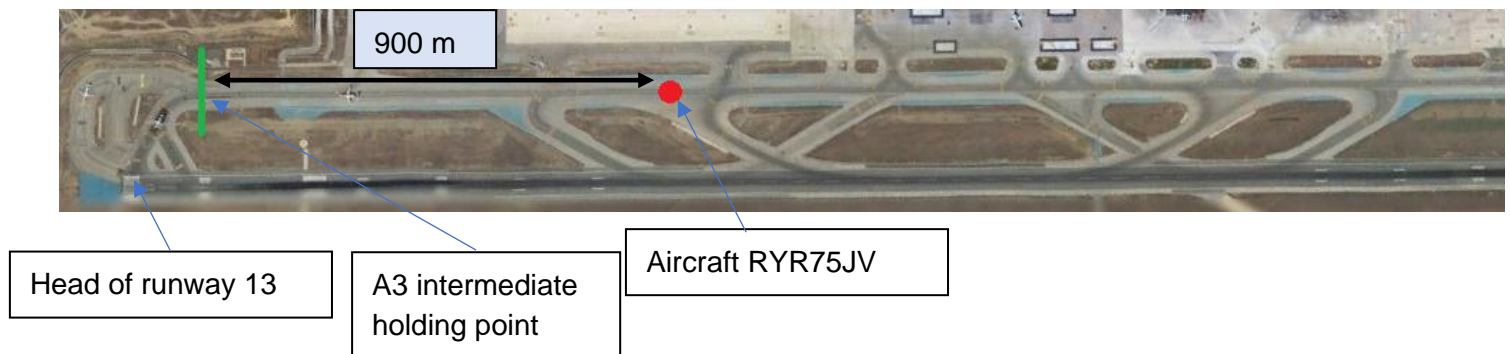
The following image shows the aircraft's position when it receives the instruction from the air traffic controller at the GMC position to taxi to the holding point for runway head 13 (19:49:19 UTC).

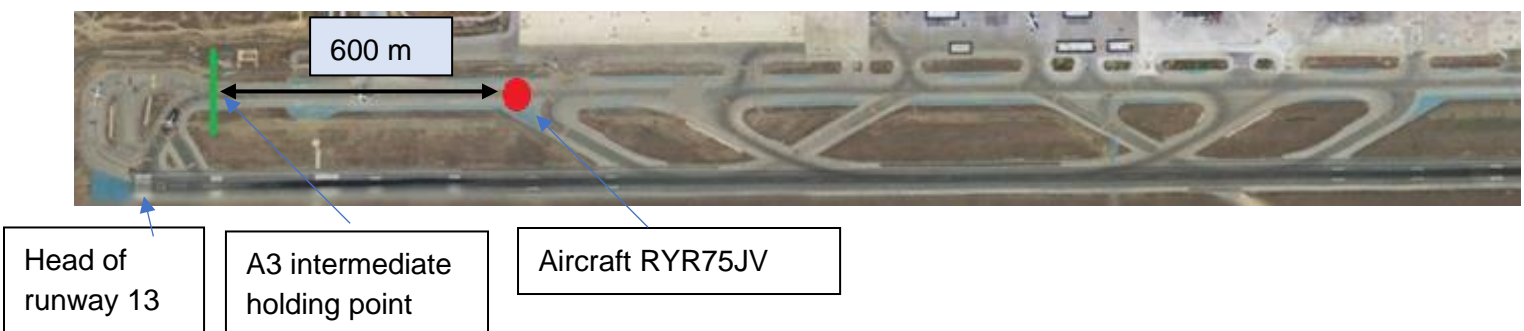
At 19:49:49 UTC, 30 seconds after the aircraft's last communication with the GMC position, the air traffic controller in the LCL position instructed aircraft RYR75JV to hold short of RWY 13. At that moment, the RYR75JV aircraft was 600 m from the A3 intermediate holding point.

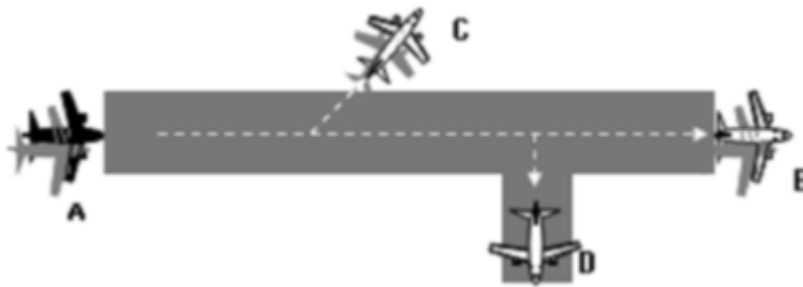
In the incident being analysed, the air traffic controller did not heed any of the three aforementioned instructions or provision 4.5.10.1.1 of the Air Traffic Regulations, which establishes the following:

“as a general rule, no aircraft on its final approach to land will be allowed to cross the runway threshold until the preceding aircraft taking off has passed over the end of the runway in use (B), initiated a turn (C) or until any recently landed aircraft (D) have cleared the runway.”

The landing was authorised when the aircraft was practically above the runway threshold, allowing it to cross said threshold while the outbound aircraft was still on the runway. Moreover, there was no degree of assurance that the regulatory separation could be maintained, as the aircraft on approach was travelling faster than the aircraft on take-off, increasingly reducing the separation between the aircraft. The air traffic controller failed to anticipate the required separation between the aircraft.
