Aircraft Serious Incident Report

Landed on Unauthorized Runway China Shanghai Airlines B737-800, B-1949 Gimhae International Airport RWY 18L 07 September 2019

Dec. 2020

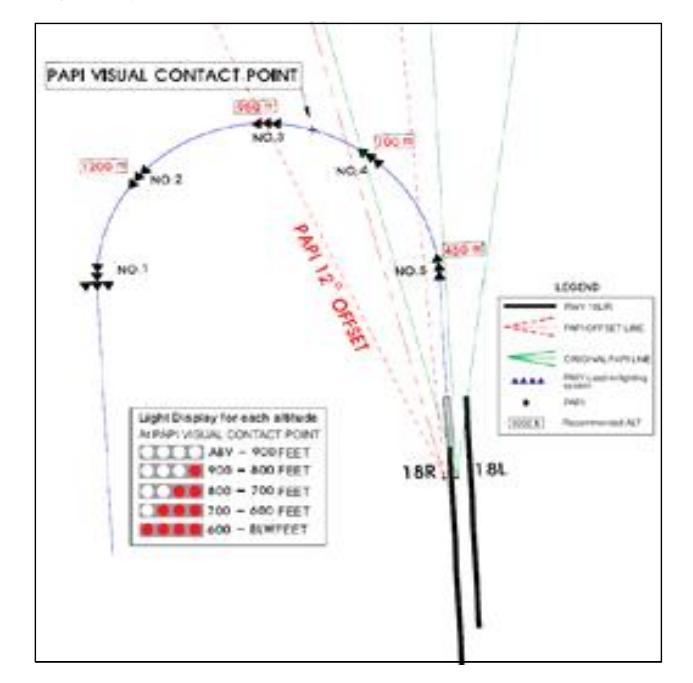
[Fig. 11] PAPI Offset Shape in the right on RWY18R

According to the Aeronautical Information Publication²⁸(AIP)'s RKPK AD 2.21 NOISE ABATEMENT PROCEDURES 2.2 approach 2) Circling Approach RWY 18L/R b) Display for RWY 18R PAPI Direction Adjustment Light, PAPI on the left side of RWY 18R is properly installed. However, as shown in [Fig. 12], PAPI on the right side is 12 degrees offset to the west so that aircraft conducting a circling approach is able to recognize approach angle as soon as possible for landing.
