Aviation Investigation Final Report

Location:	St Petersburg-Clearwater, Florida	Incident Number:	OPS21LA002
Date & Time:	April 29, 2021, 15:07 Local	Registration:	N306NV (A1); N370SD (A2)
Aircraft:	Airbus A319-112 (A1); Cessna M337B (A2)	Aircraft Damage:	None (A1); None (A2)
Defining Event:	Air traffic event	Injuries:	129 None (A1); 1 None (A2)
Flight Conducted Under:	Part 121: Air carrier - Scheduled (A1); Part 91: General aviation - Personal (A2)

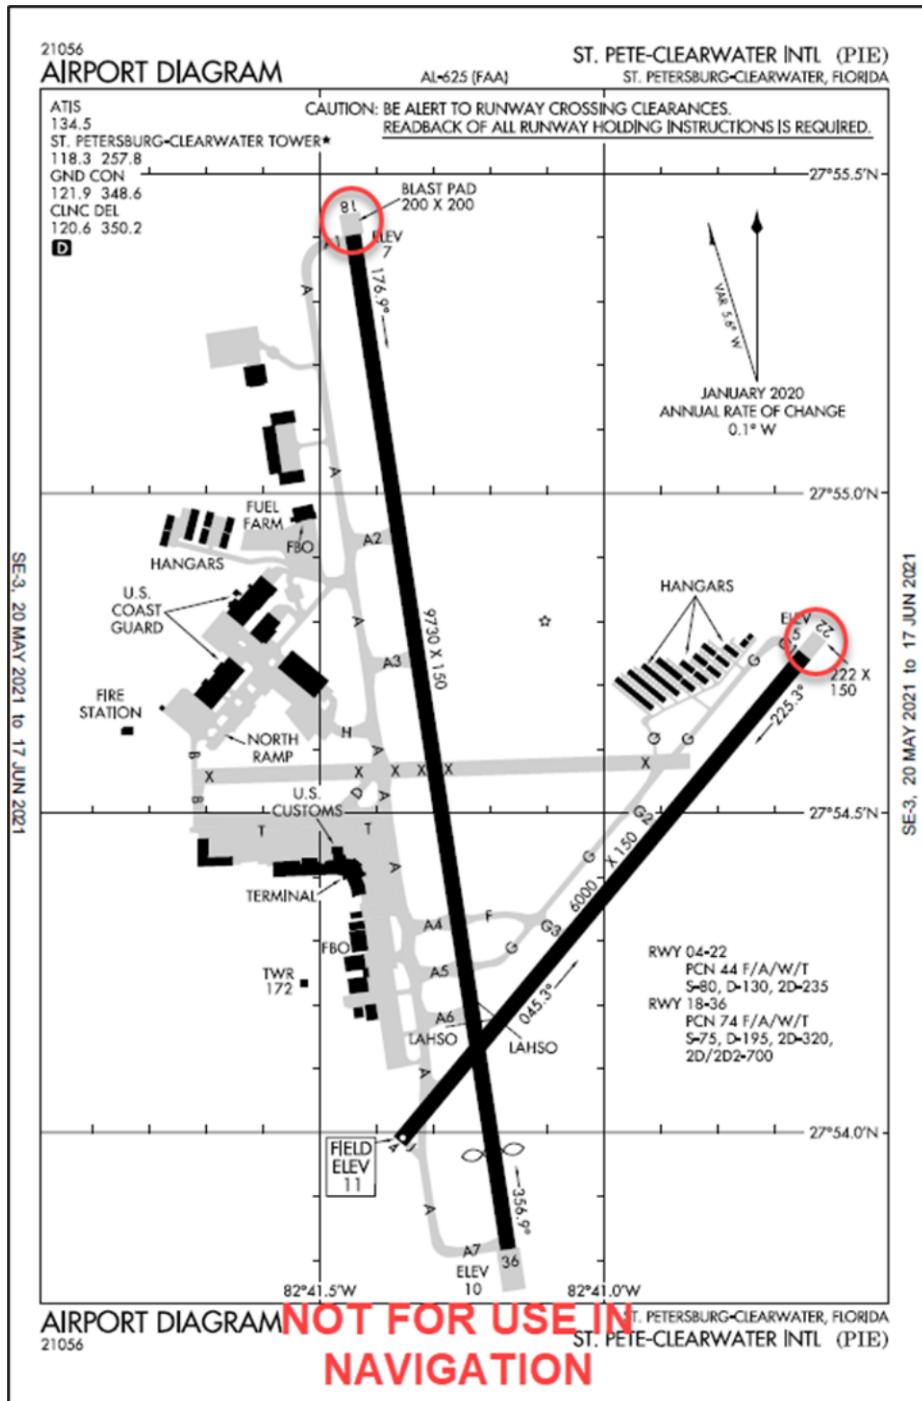
Figure 1 is the PIE airport diagram and shows the locations of runway 22 and runway 18 circled in red.

Figure 1. PIE airport diagram showing locations of runway 18 and runway 22.
