AIRCRAFT ACCIDENT AND INCIDENT INVESTIGATION AND PREVENTION BUREAU (AIB GHANA)

REPORT ON THE FUEL INCIDENTS INVOLVING SOUTH AFRICAN AIRWAYS, A330-300 AIRCRAFT REGISTRATION ZS-SXM

14TH-15TH APRIL 2022.

AIRCRAFT INCIDENT REPORT AIB/2022/04/14-15/INCID

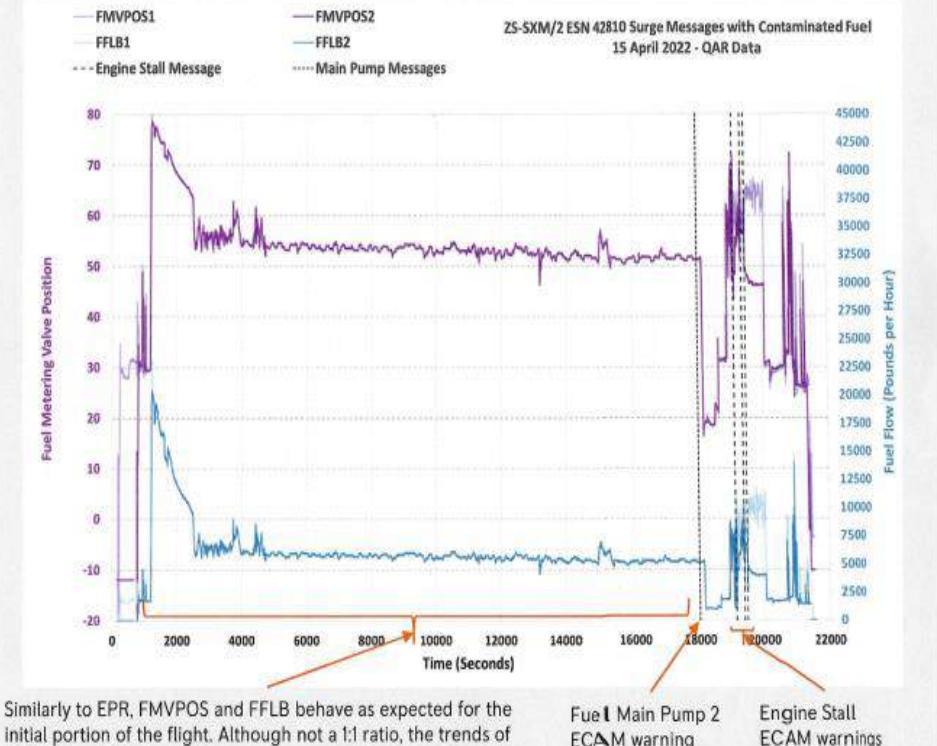
FMVPOS and FFLB should be similar, as the Fuel Flow should be proportional to the position of the Fuel Metering Valve.

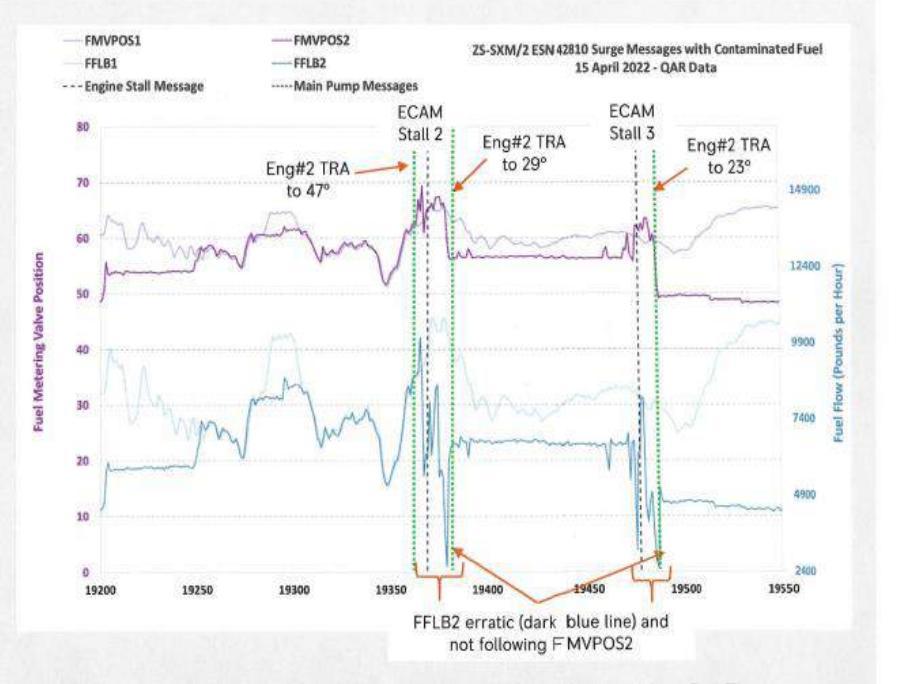
FMVPOS & FFLB – 2nd & 3rd Stall Warnings

Review of the engine data for the first Stall Warning could not confirm if the engine stalled or if the Surge/Stall Detection Logic was triggered erroneously due to the highly dynamic and abnormal fuel flow experienced during the event (see slide 12 for details of the Surge/Stall D etection Logic).

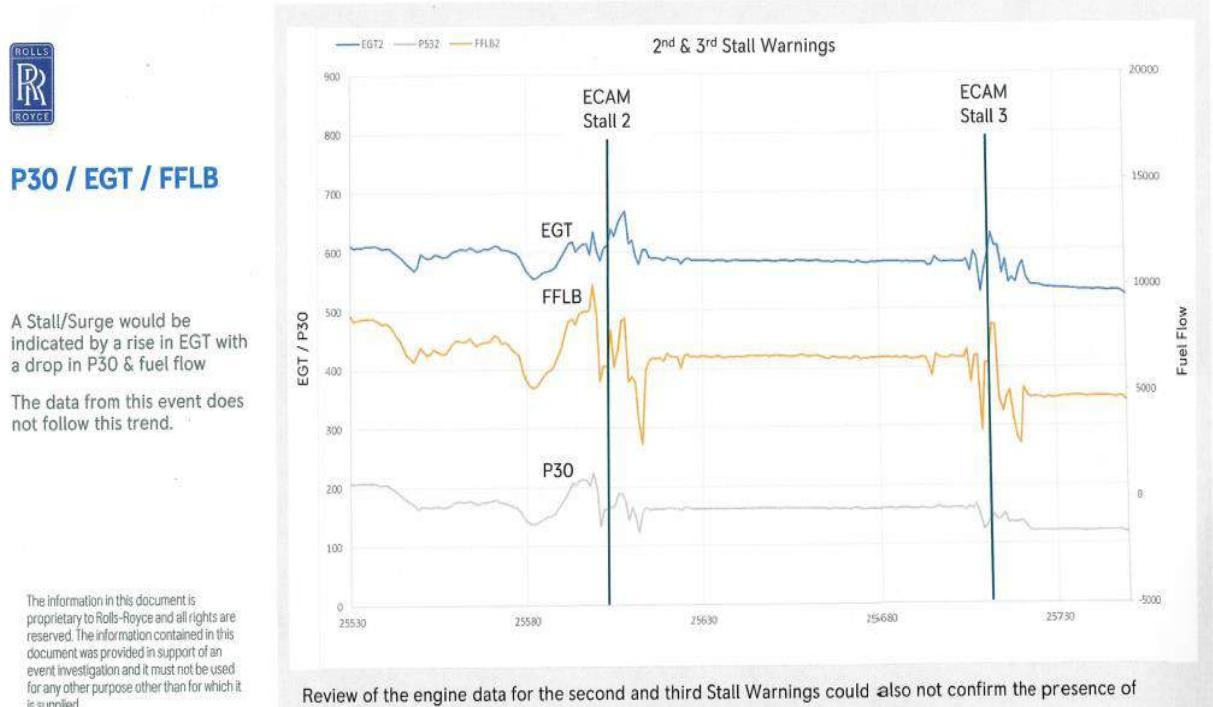
- The surge detection logic is a P30dot Vs. P30/P20 threshold on the Trent 700
- There is a bias applied on P30 and P30dot which is factored by the rate of change of fuel flow. This is to take transient manoeuvres into account and shift the above threshold in a way that there is more detection margin during a fuel flow reduction than during a fuel flow increase
- Based on how the biases are set it needs less change of P30 to trigger when rate of change of fuel flow is positive high
- Whole Engine System analysis concluded sudden change in fuel flow . such as that observed in the event flight, could cause compressor surge, but this can not be confirmed.
