# Investigation Report

Type of Occurrence: Accident

Type: A320-214

State File Number: BFU21-0555-2X

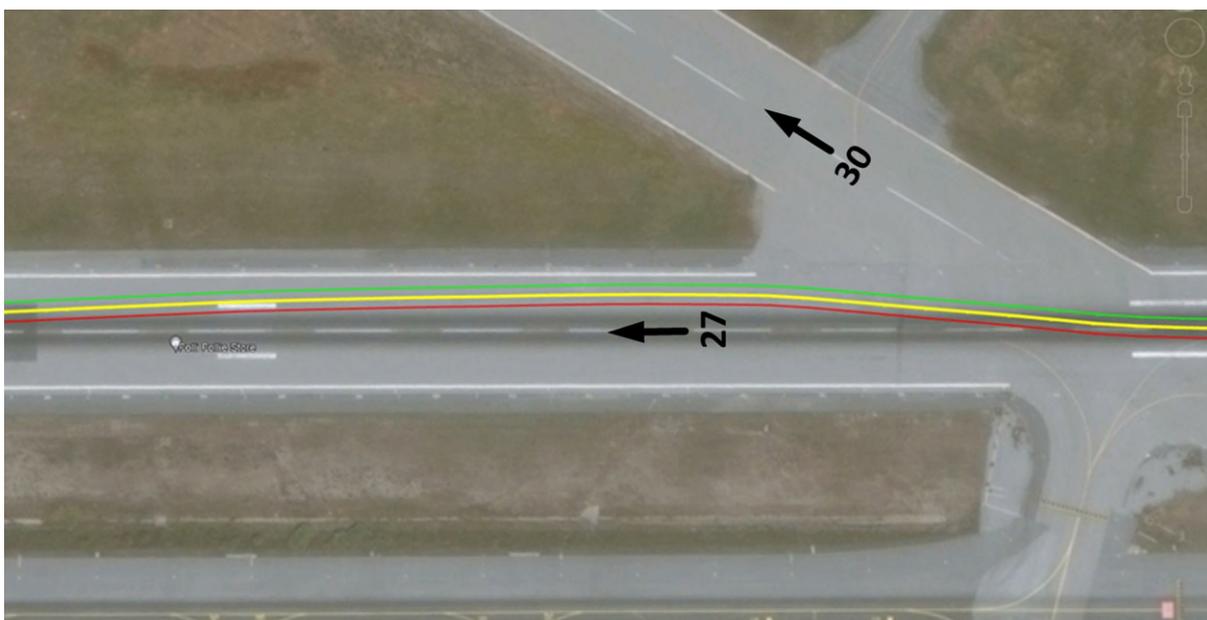
Fig. 2: Tracks of the rejected take-off on runway 27 at Heraklion Airport

Figure 2 shows the rejected take-off tracks, reconstructed by the aircraft manufacturer (red line: left main landing gear track, green line: right main landing gear track, yellow line: aircraft centre of gravity track).

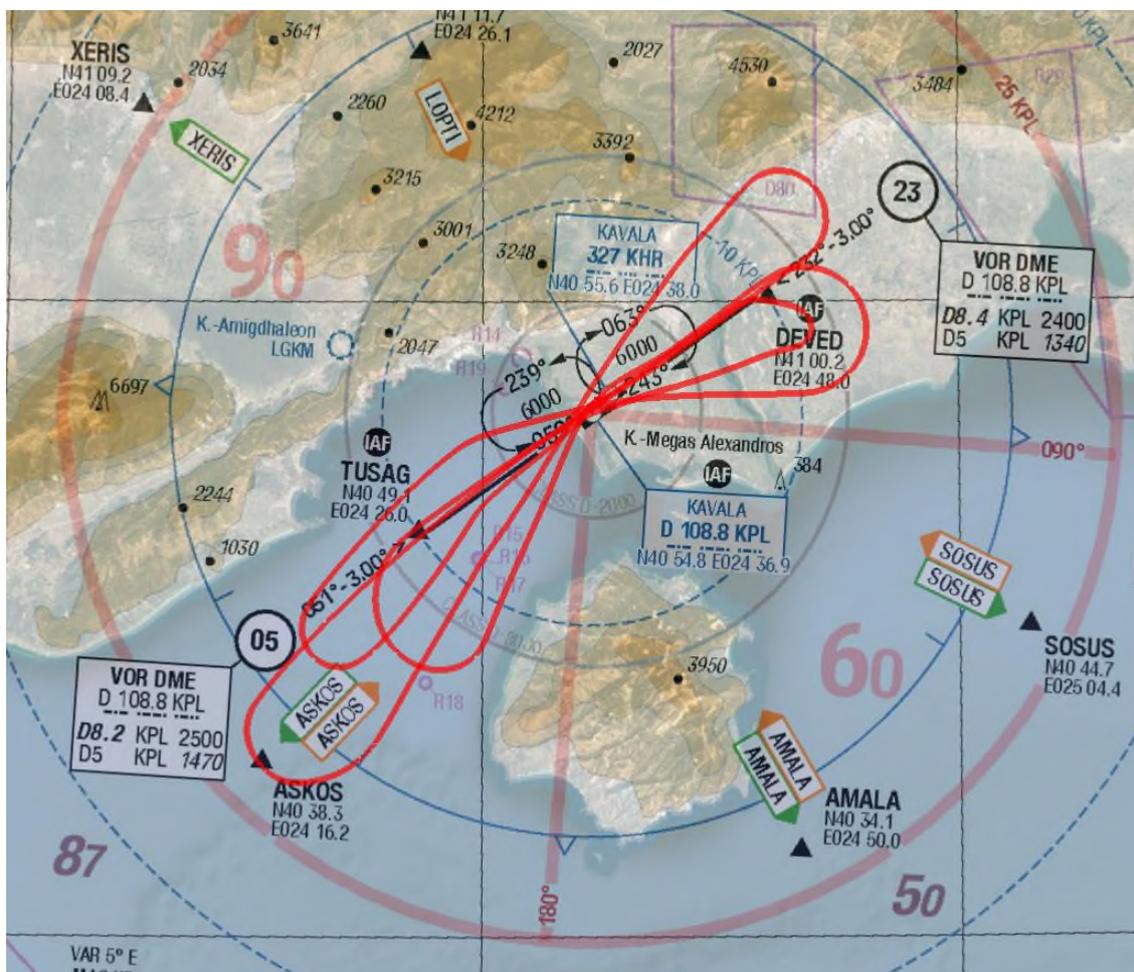
Fig. 3: Flight path of the aircraft involved

At 1950:15 hrs, the pilots levelled off at FL 100. In agreement with the tower controller they flew within the 25 NM radius of VOR KPL above the Minimum Sector Altitude (MSA) along radials of VOR KPL with headings almost parallel to the runway (Fig. 3). VOR KPL was overflown several times. Since there was no radar coverage, support via radar vectors was not possible.

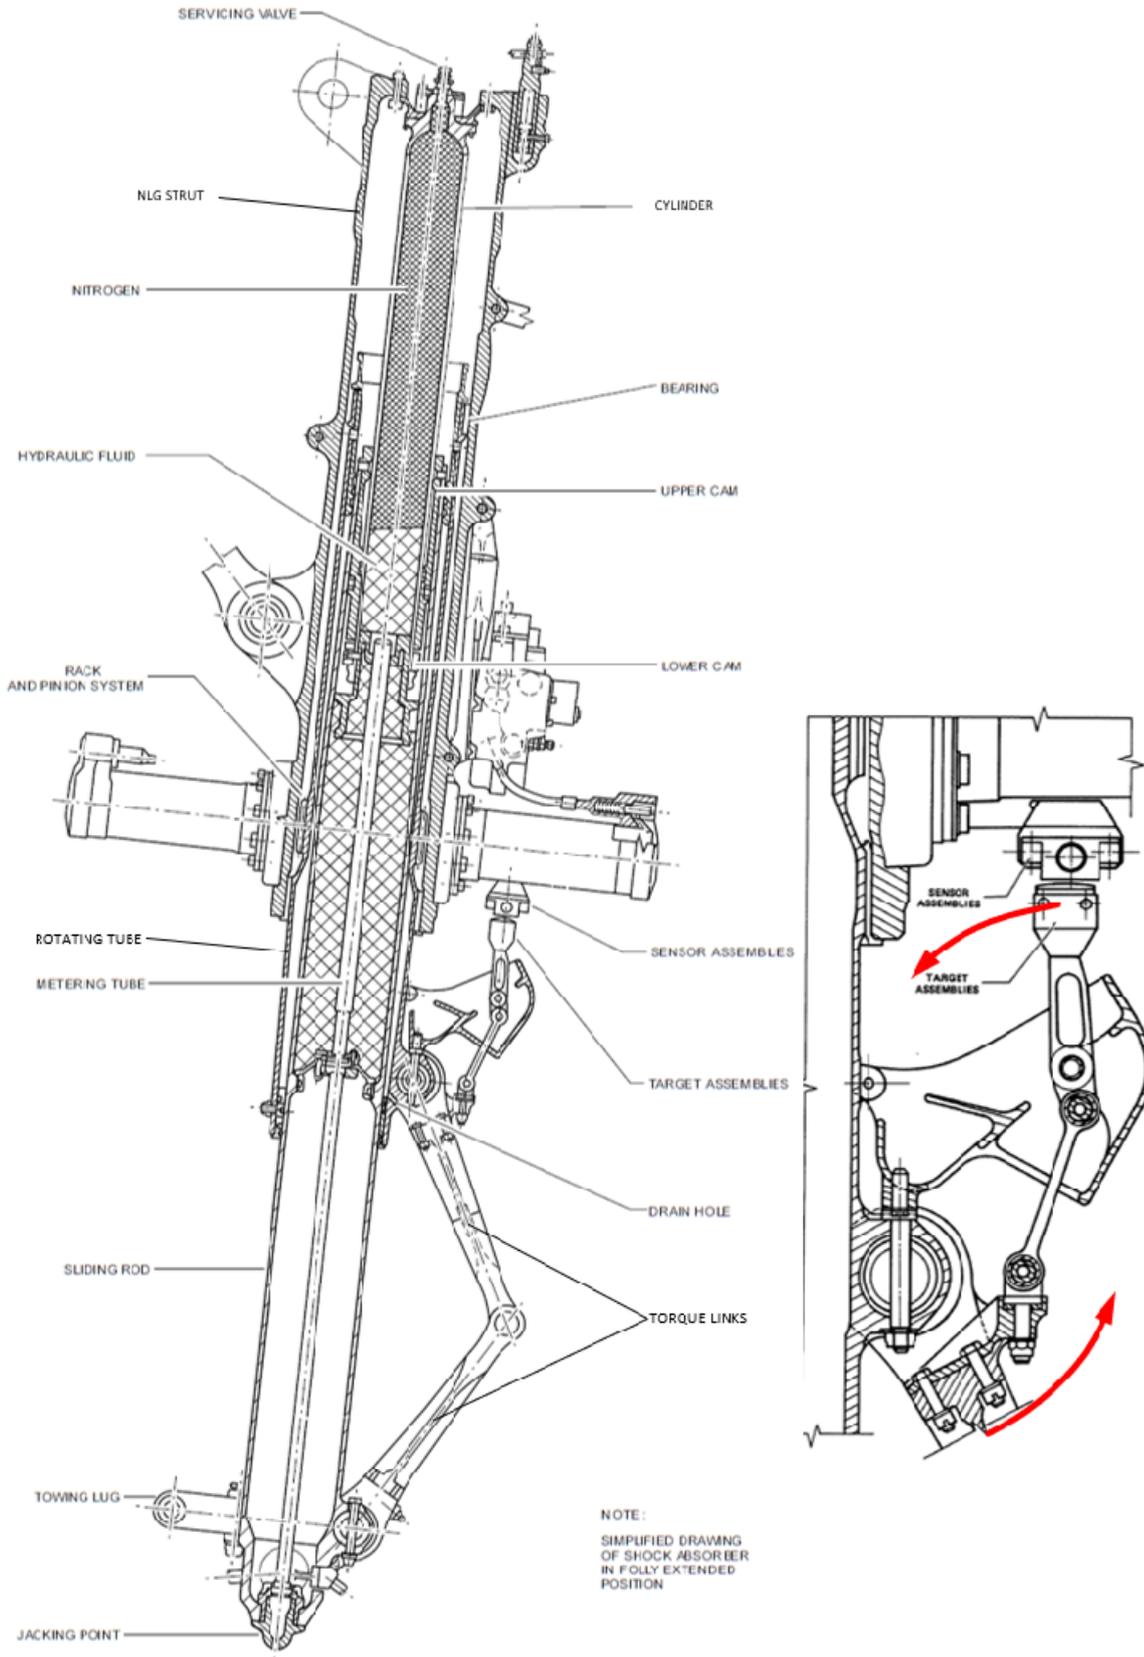
Fig. 4: Nose landing gear shock absorber in the extended position Source: Aircraft manufacturer, adaptation BFU

Figure 4 shows the nose landing gear shock absorber in the extended position, e. g. after take-off. In this case, the two target assemblies of the two respective sensor assemblies are just below these sensors so that the Landing Gear Control and Interface Units (LGCIU1 and LGCIU2) receive the signal "Flight" for the nose landing gear.

If the cylinder including the NLG strut moves downward due to the aircraft weight on the ground, the upper part of the torque link turns left (Fig. 4) so that the lever with the target assemblies moves forward via another link lever. As soon as the target assemblies are far enough away from the sensors the respective LGCIUs receive the signal "Ground".

The status "Ground" is maintained after take-off, if the sliding rod does not move to the extended position due to a damaged nose landing gear shock absorber in spite of the weight of the nose landing gear axle and wheels and the gas pressure of the absorber.

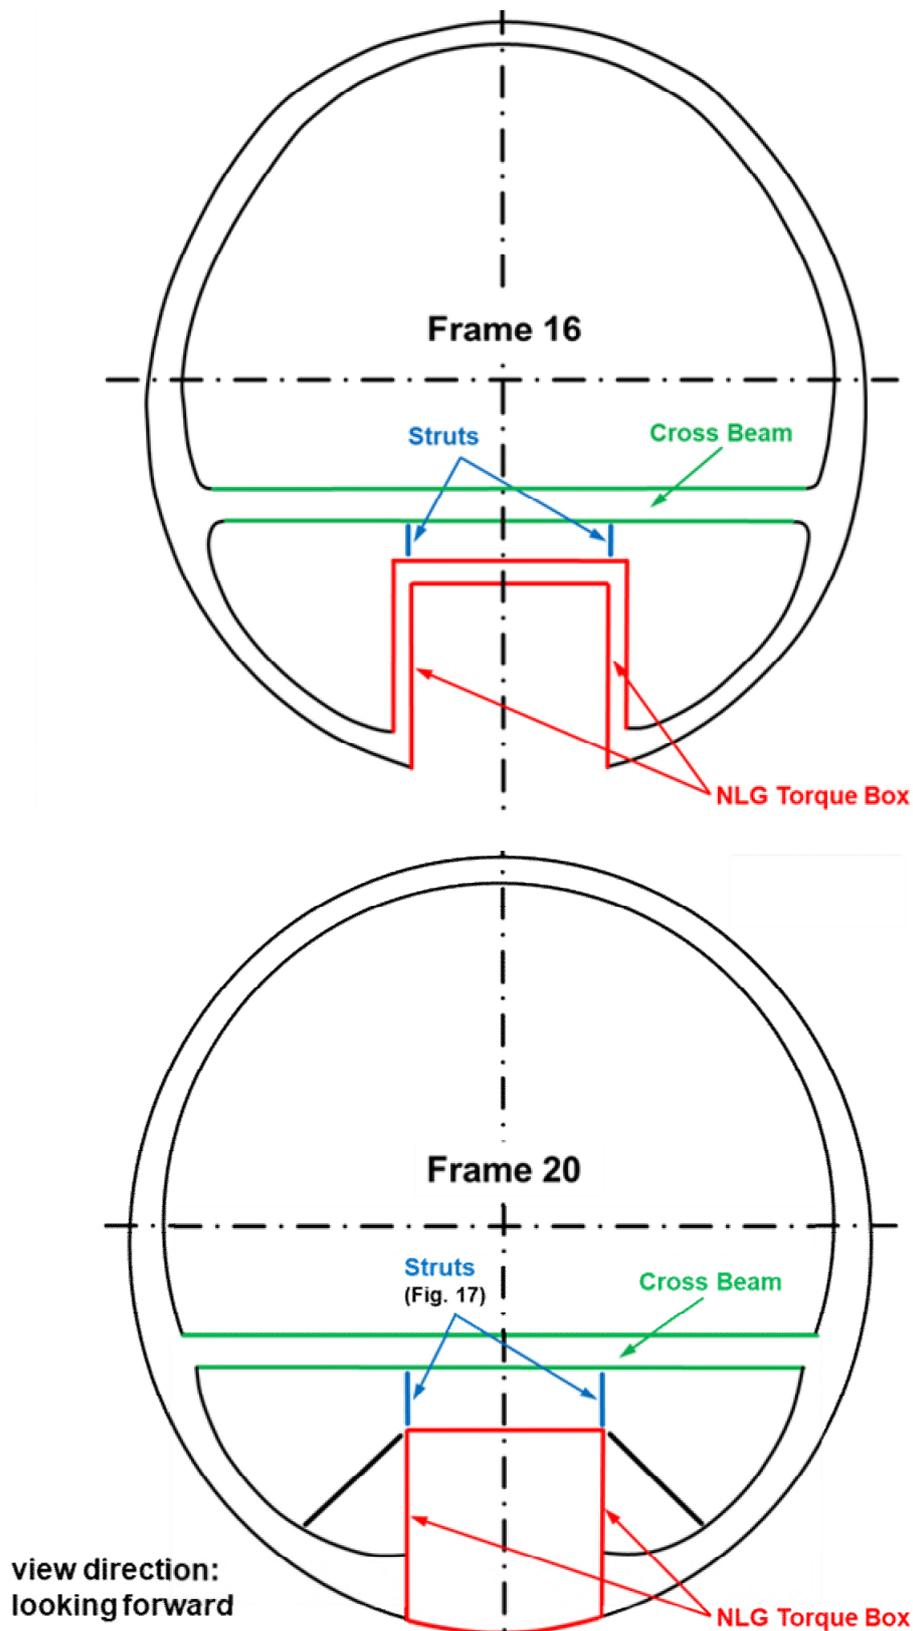
Fig. 6: Sketch of the fuselage cross section at Frame 16 and Frame 20

Figure 6 shows a sketch of the fuselage cross section of Frame 16 and Frame 20, both located in the area of the nose landing gear. The struts (blue) transfer the loads from the NLG Torque Box to the cross beams of the fuselage structure (green) located above.

The cross beams in the areas of Frame 20 and Frame 16 shown in Figure 6 (green) were deformed; in longitudinal as well as in cross direction.

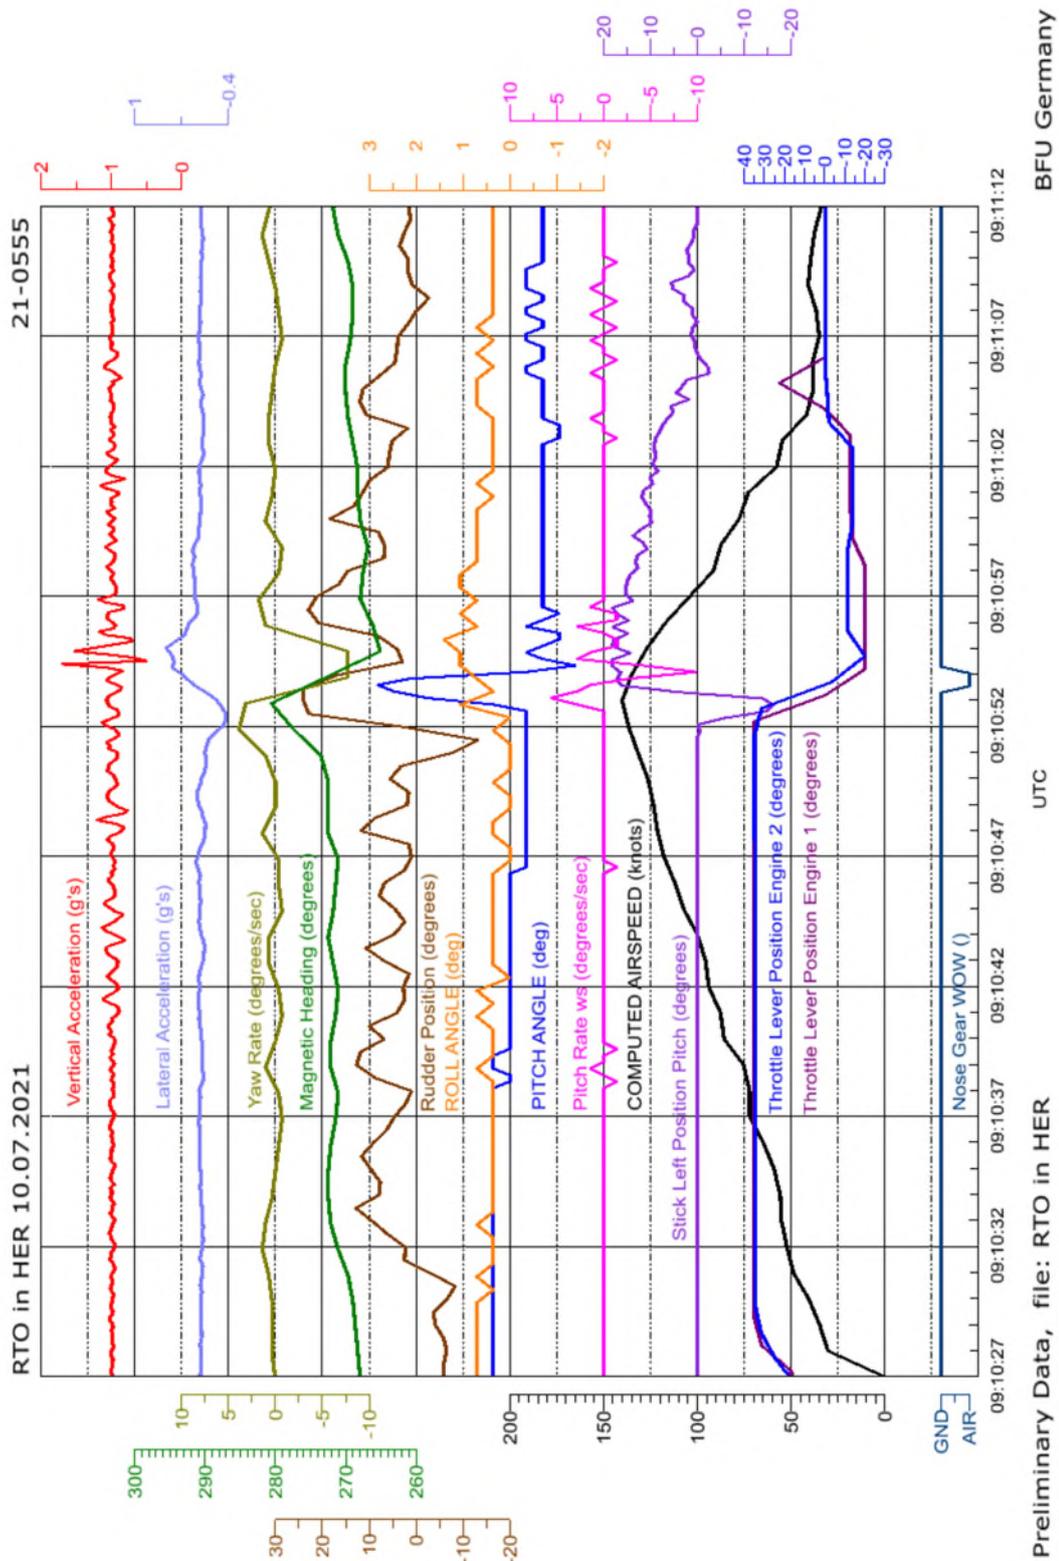
Fig. 8: FDR data of the rejected take-off at Heraklion on 10 July 2021

Figure 8 shows that at the time the rejected take-off was initiated, the PIC pulled the side stick back for about one second. The pitch angle increased to 2.8° and the Weight on Wheel (WOW) sensors of the nose landing gear reported the nose landing gear as in the air ("Air"). At 0910:54 UTC, a forward side stick input of the PIC, which initially remained constant, was recorded. At that moment, negative pitch rate increased to a maximum of -9.7°/s and the WOW sensors of the nose landing gear reported the nose landing gear on the ground ("GND"). At the time of the touch-down of the nose landing gear, a maximum yaw rate to the left of -8°/s existed. The yaw movement led the airplane back towards the runway centre line, the roll angle towards the right increased to a maximum of 1.4°. At the time the nose landing gear touched down again, a maximum vertical acceleration of 1.7 g was recorded. During the rejected take-off, lateral acceleration was between -0.36 g and +0.53 g.

Since the pitch rate (Fig. 8) was not directly available as FDR parameter, pitch was derived with respect to time. Therefore, it is subject to a certain inaccuracy. The aircraft involved was equipped with a Digital AIDS Recorder (DAR) which records the Pitch Rate significantly more accurately calculated by the ADIRUs (Air Data Inertial Reference Unit). Using the more accurate DAR pitch rate is used, the same maximum value of  $-9,7^{\circ}/s$  is obtained for the time of the nose landing gear touching down again.

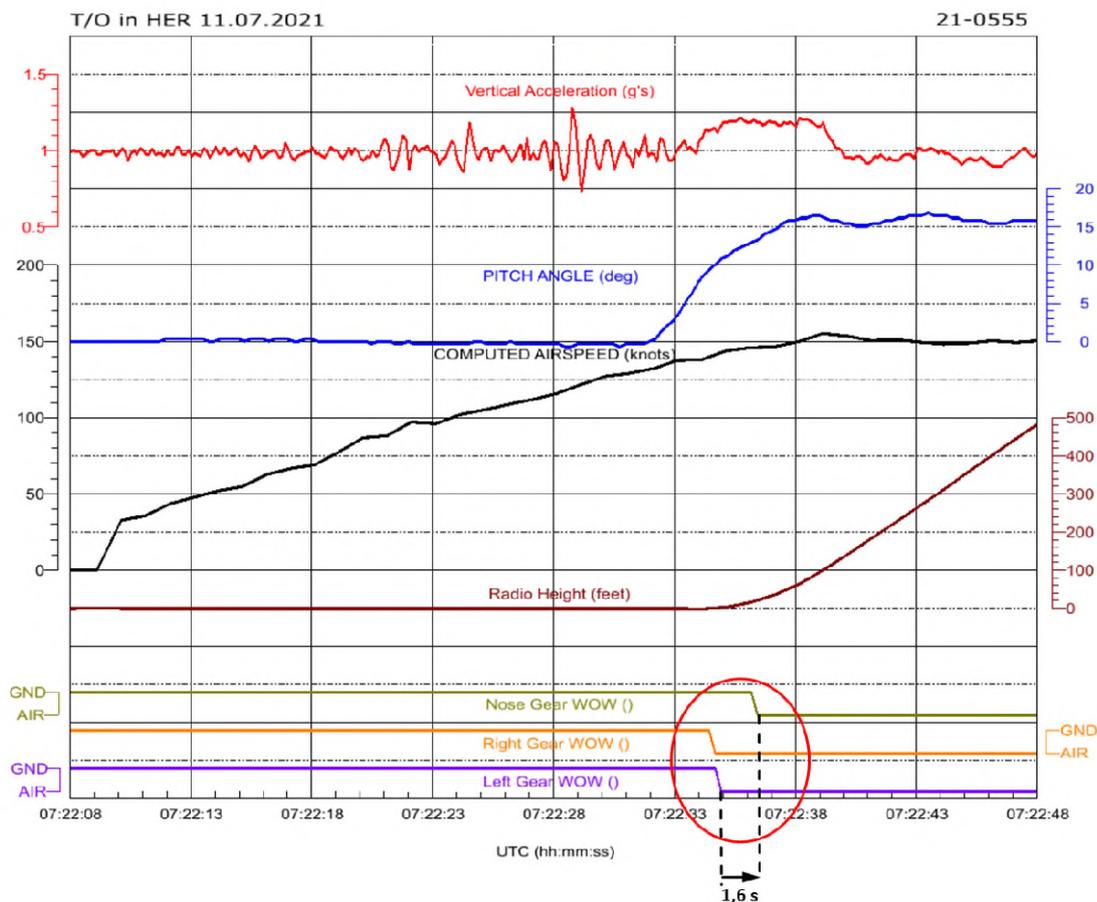
Fig. 9: FDR data of the take-off at Heraklion on 11 July 2021

The aircraft manufacturer determined at about 2.5 s after rotation and increase in pitch angle at about 0722:35 UTC, the respective WOW sensors (right and left gear WOWs) initially reported the main landing gears as in the air (“Air”). Only 1.6 s later, the nose gear WOW sensors reported position “Air”.

The common sequence during take-off that first the nose gear WOW and then the main gear WOW sensors report their respective gears as in the air differed only during this flight. All other flights recorded on the FDR, before the rejected take-off and on the flight from Düsseldorf to Kavala on 11 July 2021, show a normal sequence of the WOW positions between nose landing gear and main landing gear.

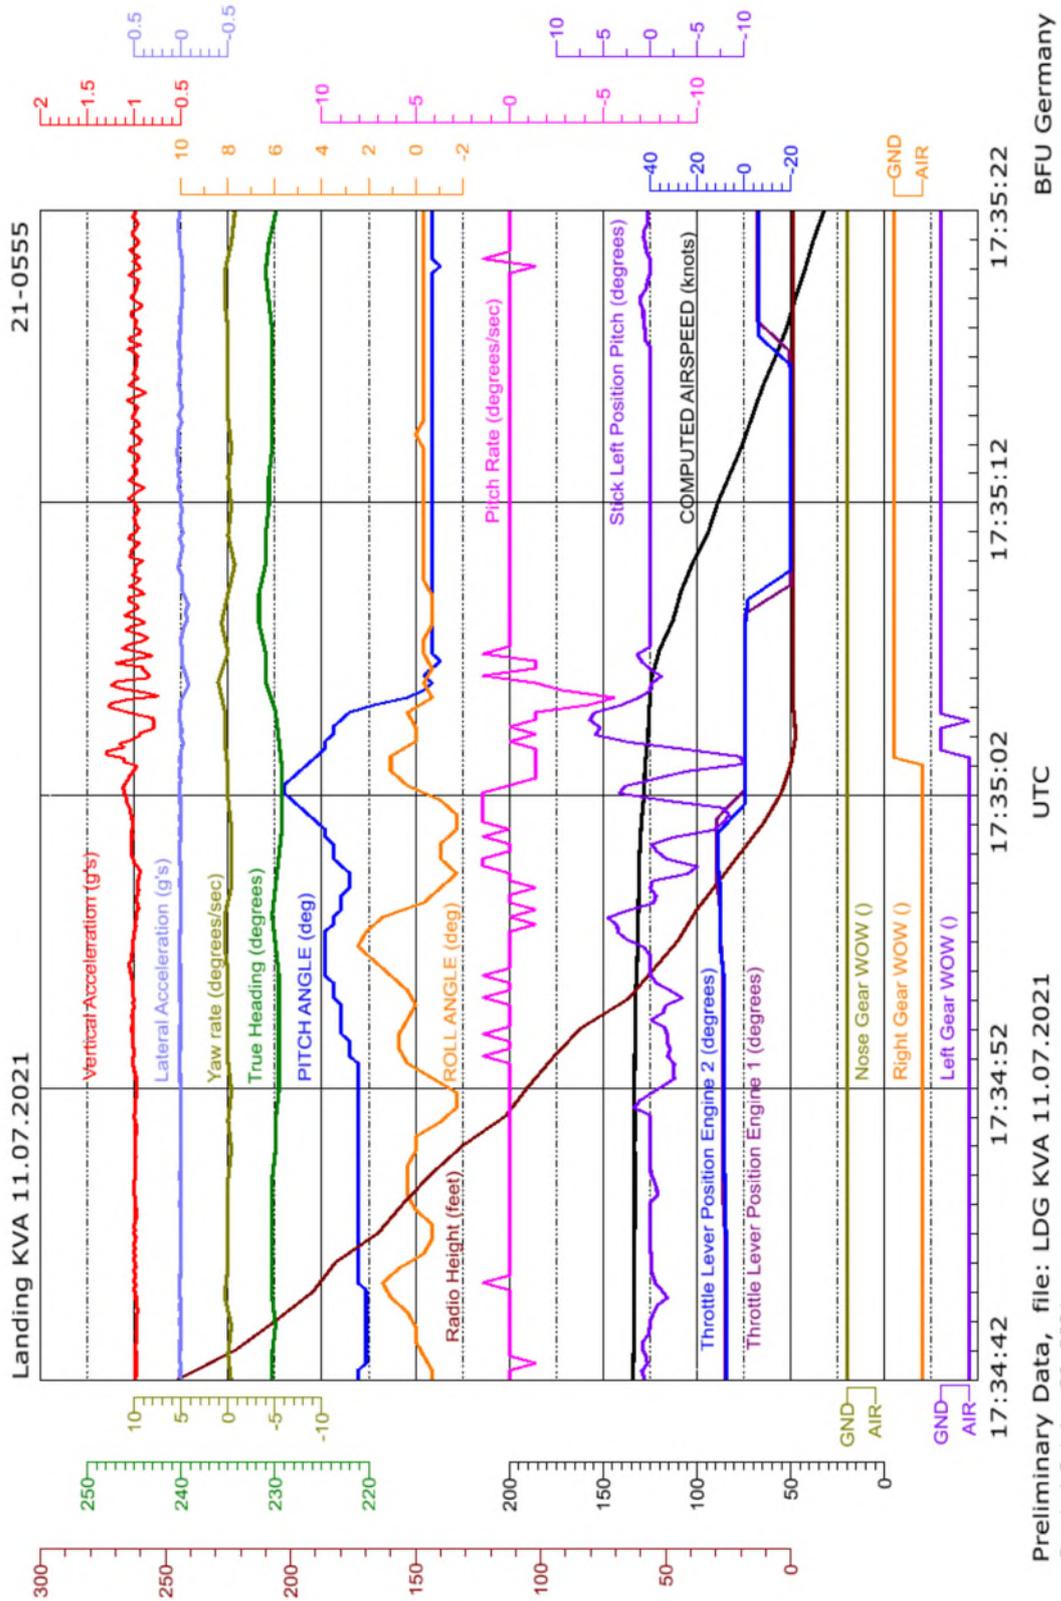
Fig. 10: FDR data of the landing at Kavala on 11 July 2021

The pitch rate depicted in Figure 10 is also subject to a certain inaccuracy, the same as the one in Figure 8. Using the more accurate DAR pitch rate, a lower maximum value  $-4,6^\circ/\text{s}$  (instead of  $-5,6^\circ/\text{s}$ ) is obtained during nose landing gear touch-down. Further considerations were based on this value.

During the landing at Kaval, shortly before the main landing gear touched down, at a radio height of about 50 ft, there was an oscillating movement of the PIC's side stick in pitch between pulling and pushing (Fig. 10). This movement was continued after touch-down of the main landing gear with a forward motion of the side stick towards push. As a result, the negative pitch rate increased during de-rotation phase to a maximum of  $-4,6^{\circ}/s$  at NLG touch down.

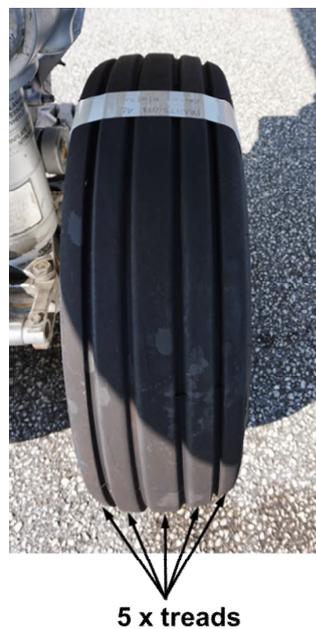
Fig. 13: Nose landing gear tire treads Source: BFU

Figure 12 shows the rubber abrasion traces of both nose landing gear tires shortly after they touched down again. The five rubber abrasion traces (Fig. 13) of the five treads of the left nose landing gear tire are clearly visible. A sixth rubber abrasion trace, which is darker, runs for about 5 m right of the two nose landing gear tire rubber marks.

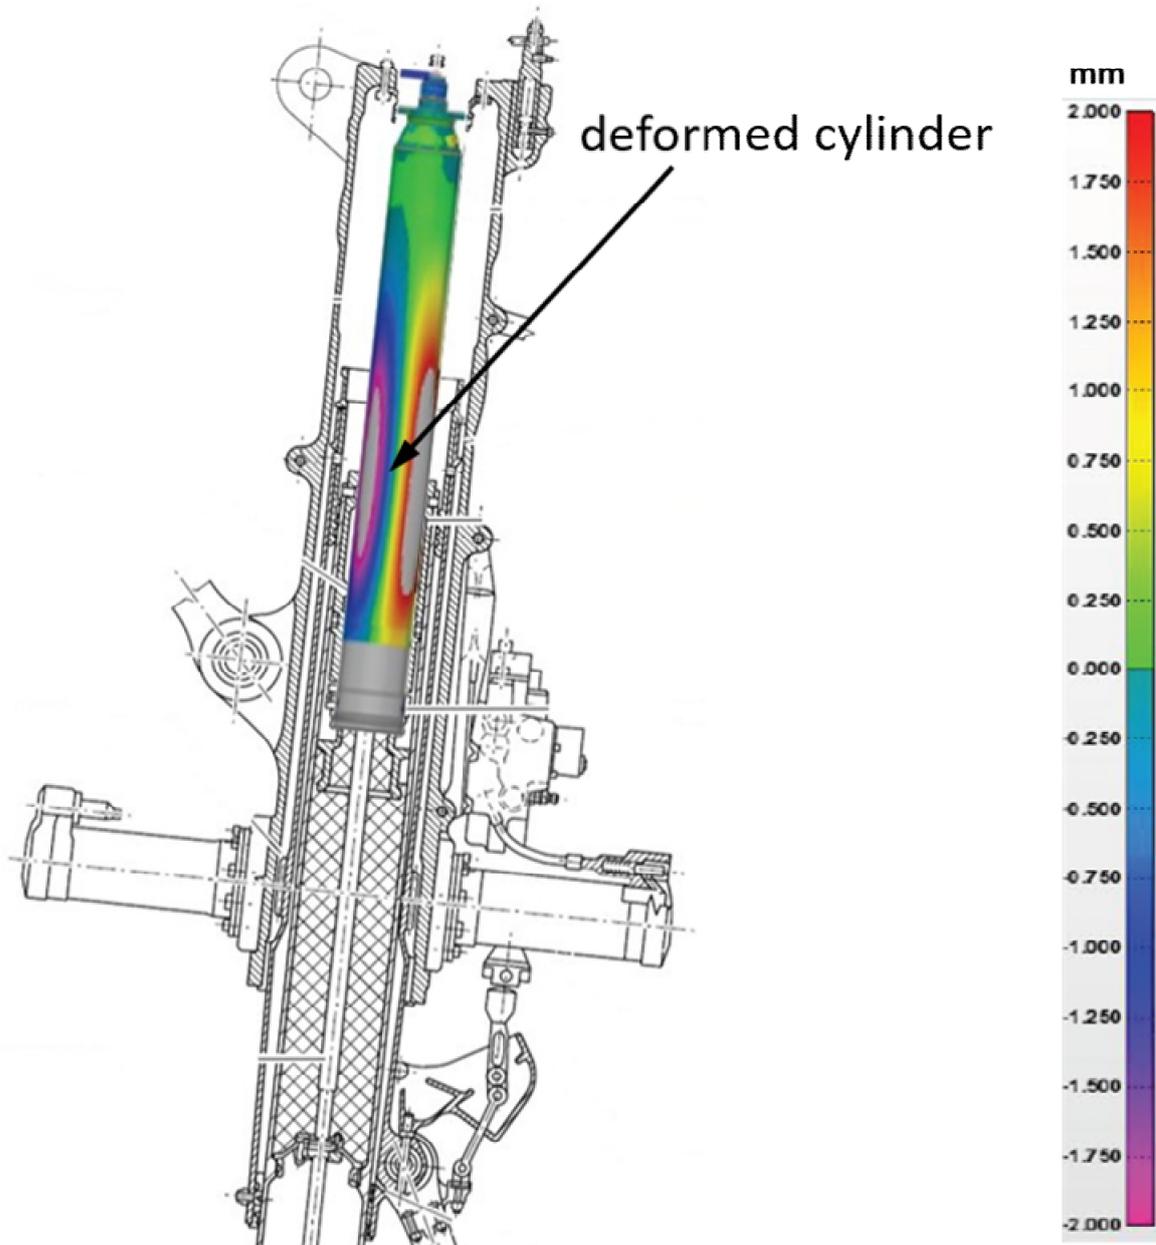
Fig. 23: Location of the deformed cylinder within the nose landing gear shock absorber

Figure 23 shows the cylinder's location within the nose landing gear shock absorber. The piston's deformation was measured using a 3D scan and are highlighted in colour (Fig. 23). Blue to violet areas are inward deformations and green to red are outward ones.

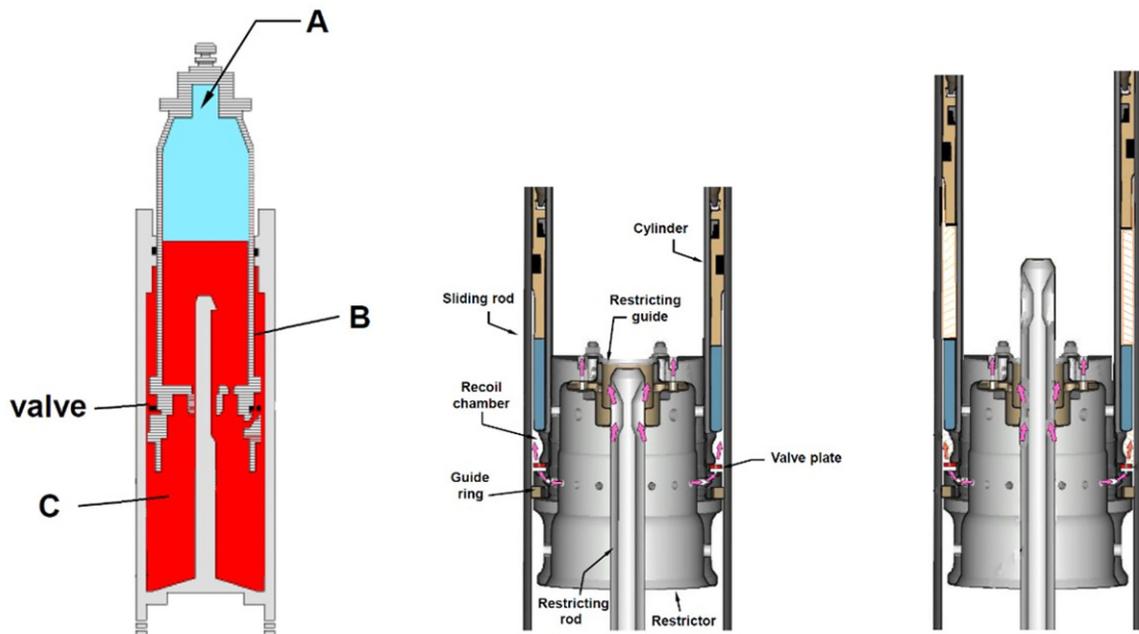
Fig. 25: The nose landing gear shock absorber's different chambers

According to the landing gear and aircraft manufacturers, the cylinder buckling is a characteristic damage pattern in case of nose landing gear touch-down with high de-rotation rate. It is caused by a high differential pressure between the cylinder's outside and the inside in the area of recoil chamber B. If the nose landing gear shock absorber's retraction speed exceeds the approval range, the recoil chamber B is filled faster with hydraulic oil by chamber C than chamber A. The nose landing gear shock absorber's different chambers are depicted in Figure 25.

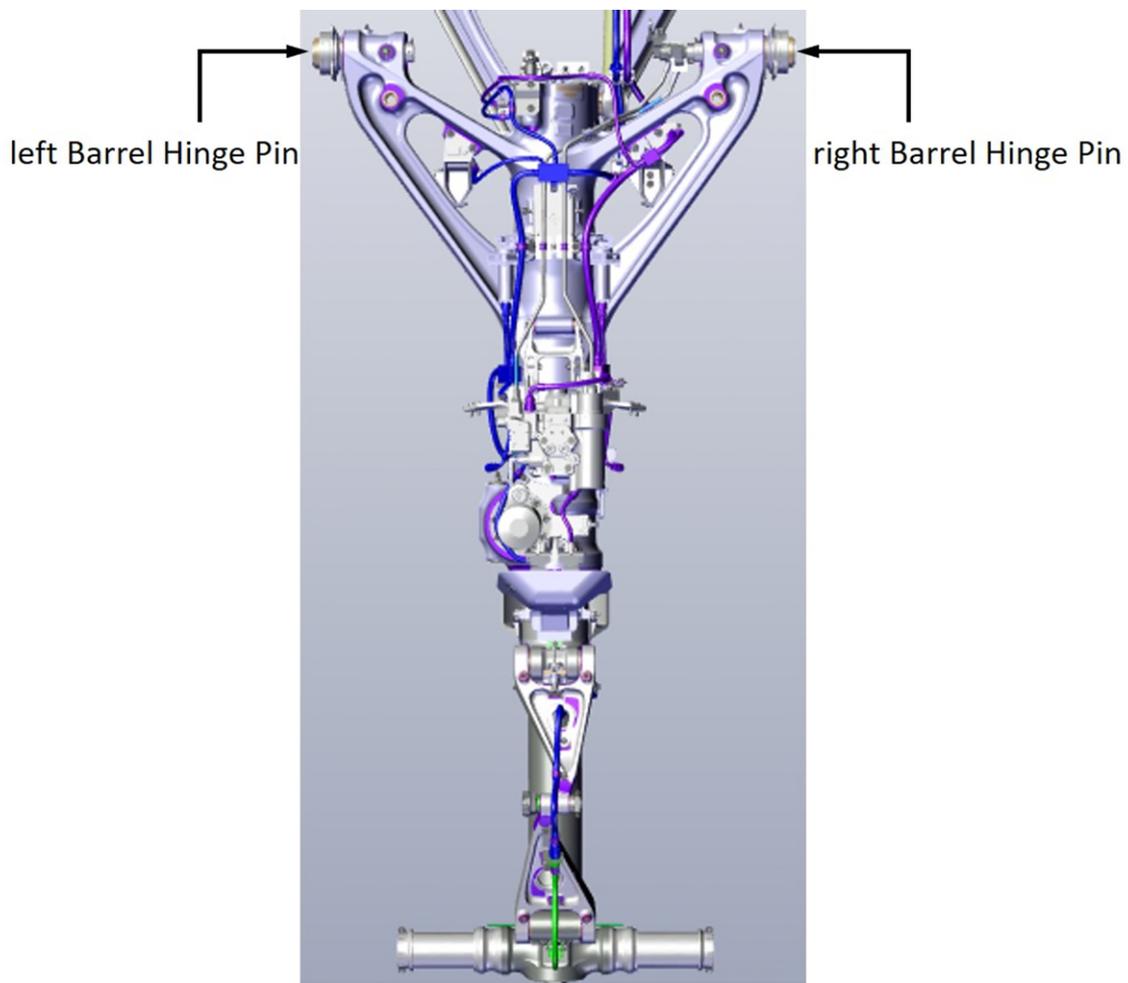
Fig. 28: Location of the barrel hinge pins (view in flight direction)

During the nose landing gear examination, the two barrel hinge pins were found to be deformed to various degrees. The barrel hinge pins are one of the main connection components between the nose landing gear and the attaching elements of the front fuselage structure. Therefore, they are located at the main force transmission points to the front fuselage structure (Fig. 28).
