Air Accident Investigation Sector

- Final Report -

AAIS Case Nº: AIFN/0006/2023

Tail Strike

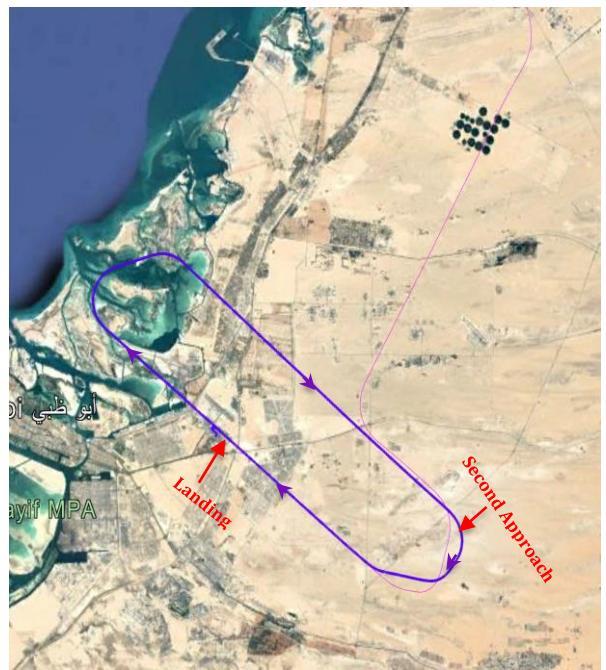
From 0847:57 onwards, Approach controller directed WAZ25GR by providing vectors for an ILS approach to runway 31L (figure 2).

Figure 2. WAZ25GR flight path after go-around, second approach, and landing (blue thick-line) following instrument approach chart of OMAA ILS Runway 31L

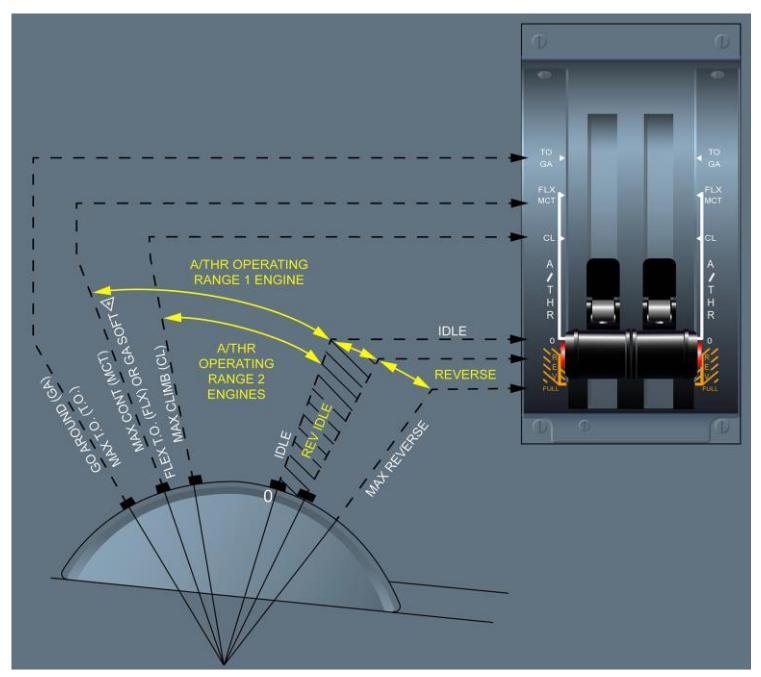
The sector has six positions separated by mechanical detents or stops as shown in figure 4.

Figure 4. Thrust levers
