EFFECTS OF IN-FLIGHT FIRE EXPOSURE OF ALUMINUM AND COMPOSITE FUSELAGE MATERIALS

2008 FAA Fire Safety Highlights

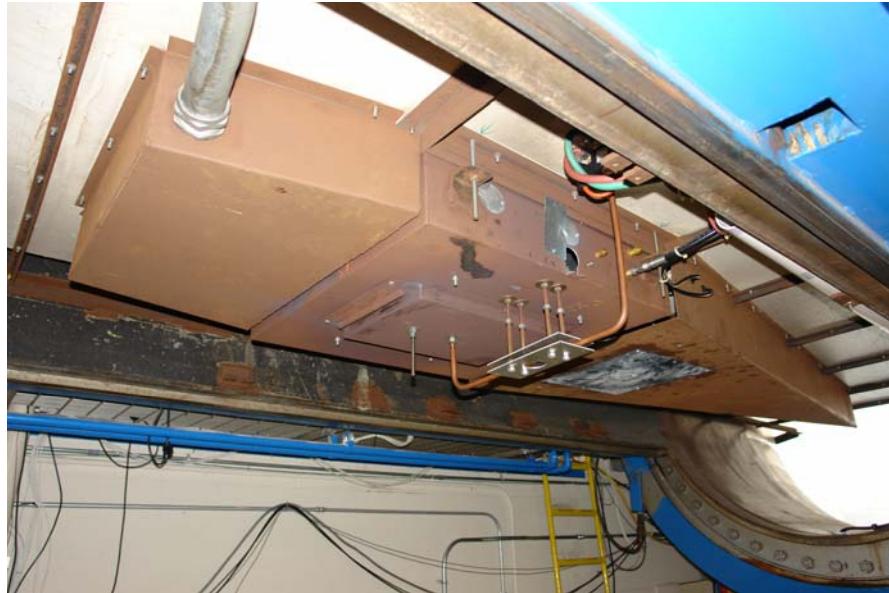
A series of tests were performed in the FAA Technical Centers Airflow Induction Facility to determine the relative performance of both aluminum and composite hull materials when exposed to an internal fire while in flight. A test fixture was designed to simulate in-flight airflow over the test panels. The underside of the fixture was fitted with an enclosed box that housed the heat sources. Two heat sources were utilized to expose the underside of the test panel, an electric heater and a live fire. The electric source was used to determine the relative heat conduction properties of each type of material under ground and in-flight conditions. The live fire intensity was sized to expose the test panels to a condition that was severe enough to melt through the aluminum panel under ground conditions, but not in-flight. The aluminum and composite test panels were exposed to each of these heat sources under airflows that simulated both ground and in-

flight conditions. The heat transfer and conduction properties were measured with both thermocouples and FLIR infrared cameras.
