# flight safety

September–October 2012

**Aviation communication** | mind your language  
**Fatigue regulations** | wake-up call on fatigue rules

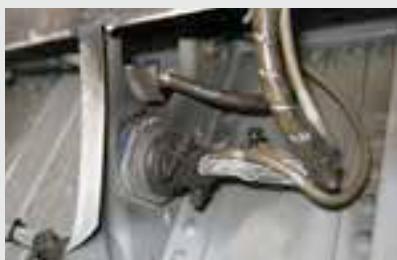
## Beech 1900D Flight control wiring short circuit. SDR 510014835 (photo following)

Flap wiring system short-circuited to ground. Water in wiring following heavy rain caused short circuit. TSN: 9473 hours/9555 landings.

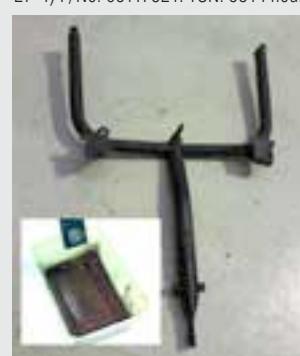
### Cessna 172E Control column corroded. SDR 510014997 (photo below)

Significant internal corrosion of control yoke found during inspection iaw Cessna SEB01-3. (SDRer AWB 27-4) P/No: 05117821. TSN: 5314 hours/576 months.

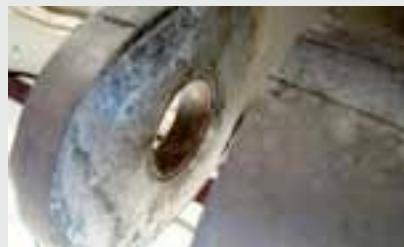
**SDR 510014916**

LH nose landing gear/control yoke support tunnel P/No: 2413001-5 cracked from rudder torque tube bearing attachment hole. Investigation also found the RH tunnel P/No: 243001-8 cracked in the same location. P/No: 24130015L2430018R. TSN: 10,326 hours.

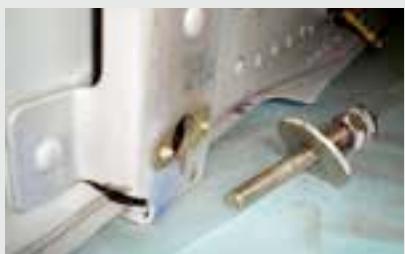
### Cessna 172R Horizontal stabilizer nut plate missing. **SDR 510014976 (photo below)**

Elevator down stop bolt anchor nut plate missing. Sheared rivet tails still in the mounting. Stop bolt had been fastened to the vertical stabiliser casting with AN970-3 washers and loose nuts. Aircraft had only 28 hours TSN. P/No: MS210783.

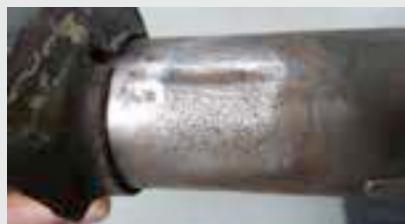
### Cessna 182P Main landing gear leg corroded. **SDR 510015088 (photo below)**

RH main landing gear leg corroded in area of step bracket attachment. Area of corrosion approximately 31.75mm by 6.3mm (1.25in by 0.25in) in area and 2.54mm (0.1in) in depth. Investigation found the glue attaching the step bracket was partially delaminated allowing moisture ingress between the bracket and leg that contributed to the corrosion. P/No: 07416302. TSN: 10,779 hours.

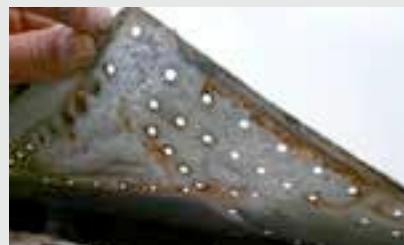
### Cessna 310R Vertical stabiliser rib corroded. **SDR 510014922 (photo below)**

Fin root rib and skin attachment rivets corroded. Initial investigation found an AN3 bolt instead of a rivet attaching skin. When paint removed, more rivet heads separated. P/No: 08313031. TSN: 6842 hours.

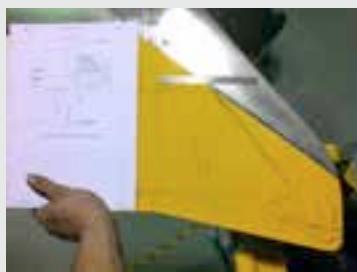
#### **SDR 510014853 (photo following)**

Main rotor blade delaminated at tip cap. Area of delamination approximately 100mm by 100mm (4in by 4in) from Stn 5420 to tip cap. Suspect caused by water ingress. P/No: 7090103109. TSN: 2041 hours.

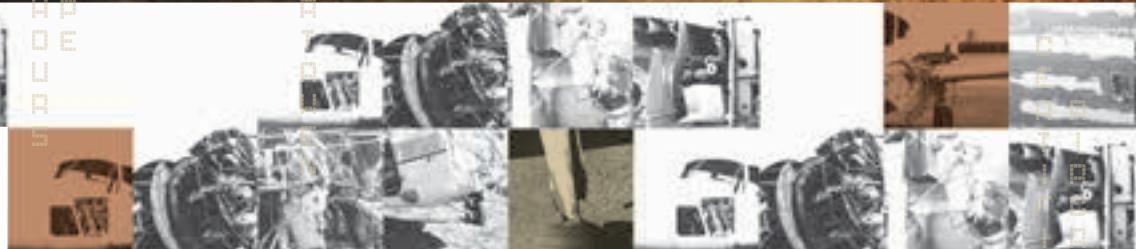
**AGEING AIRCRAFT PROTOTYPE MATRIX TOOL**

The Prototype Matrix Tool provides feedback to the owner of the aircraft that their aircraft may be susceptible to ageing related issues. All feedback is provided in a relative scale, dependent on the inputs provided. The colour scale provides an indication to the owner as to the ageing risk and impacts to which they may want to 'Take a Closer Look' at how their aircraft may be affected by the ageing process.

The paper not only includes a link to the new e-learning, but also a link to the recently developed prototype matrix tool. This tool is a world-first, locally developed, web-based CASA educational initiative for aircraft owners. It allows an owner (or potential owner) to enter objective engineering data for their specific aircraft and receive an indication as to how likely it is that their aircraft could be susceptible to ageing issues. The data includes factors such as how long ago certain components or systems have been overhauled or replaced, how the aircraft is operated, how and where the aircraft is stored, and so on. The cumulative impact of all these variables is displayed on a colour-coded continuum (from red to green) indicating how likely the individual aircraft is to need additional attention because of ageing issues.

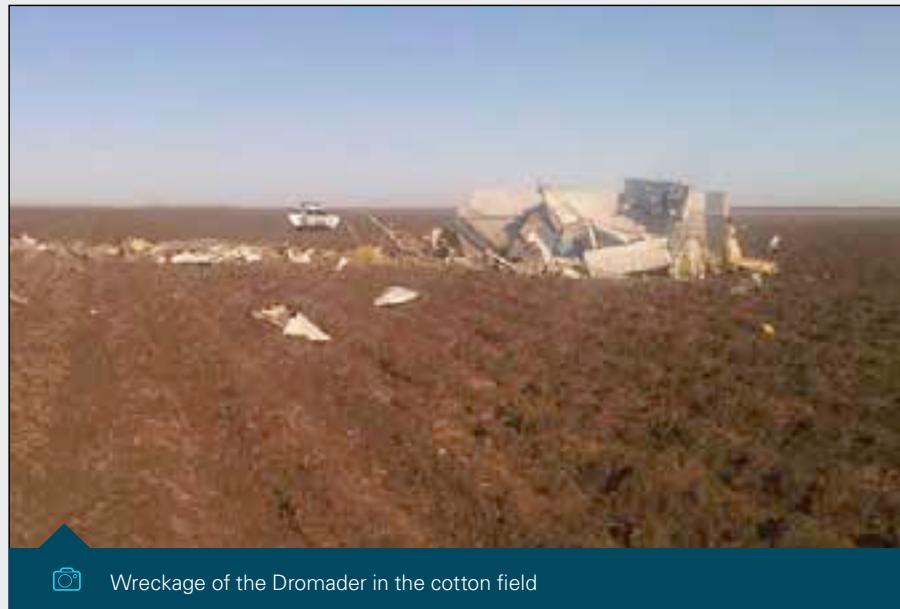
Wreckage of the Dromader in the cotton field

ATSB investigators found that the aircraft had departed from controlled flight during a turn at low altitude, and the pilot was unable to recover before impact with the ground. The investigators could not conclusively determine the reasons why this had happened. However, they did identify a significant safety issue surrounding the potential for excessive shifting of the aircraft's centre of gravity as the contents of the aircraft's chemical/spray tanks were dumped or dispensed.
