# Air Accident Investigation Sector

### — Final Report —

AAIS Case №: AIFN/0011/2017

## Pilot Incapacitation

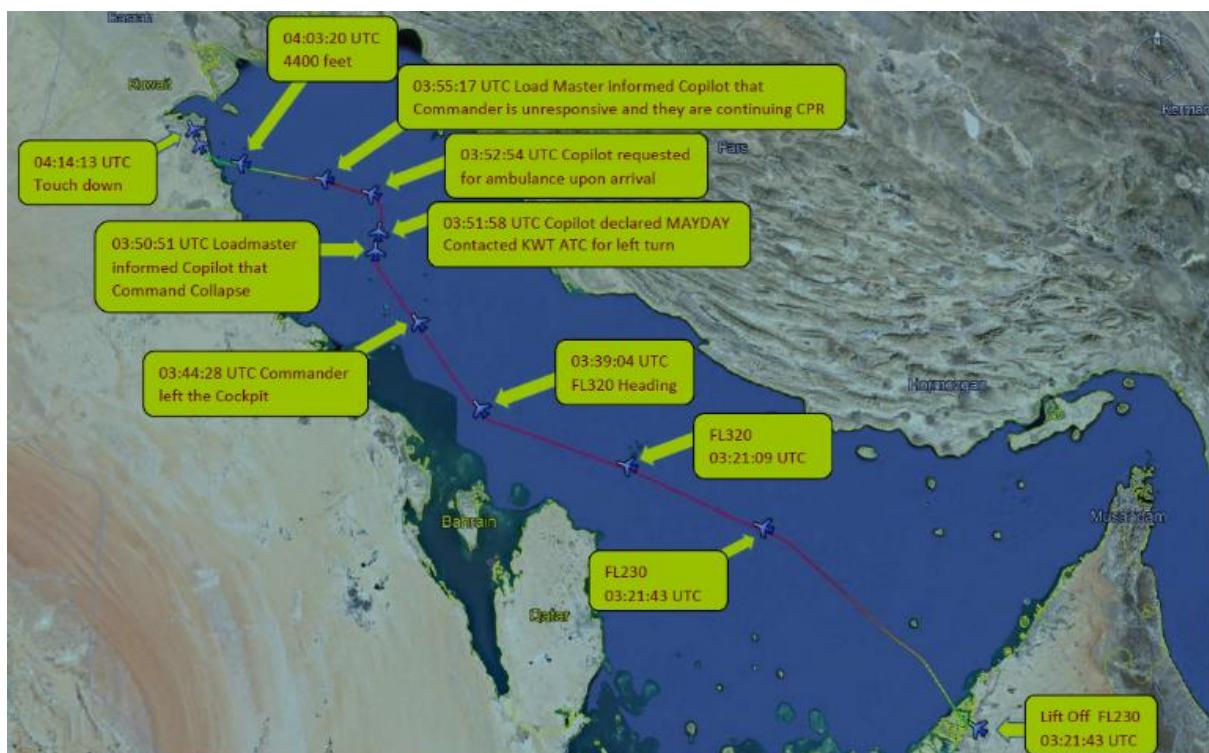
Figure 1. Flight path of ETD 927

Figure 1 illustrates the main events of flight ETD 927.
